**FOREST AND WILDLIFE RESEARCH CENTER**

**Seventh Annual Evaluation of Phase II MSU/RTA Alternative Preservative Study**

**June 5, 2019**

## **Seventh Annual Evaluation of Phase II MSU/RTA Alternative Preservative Study**

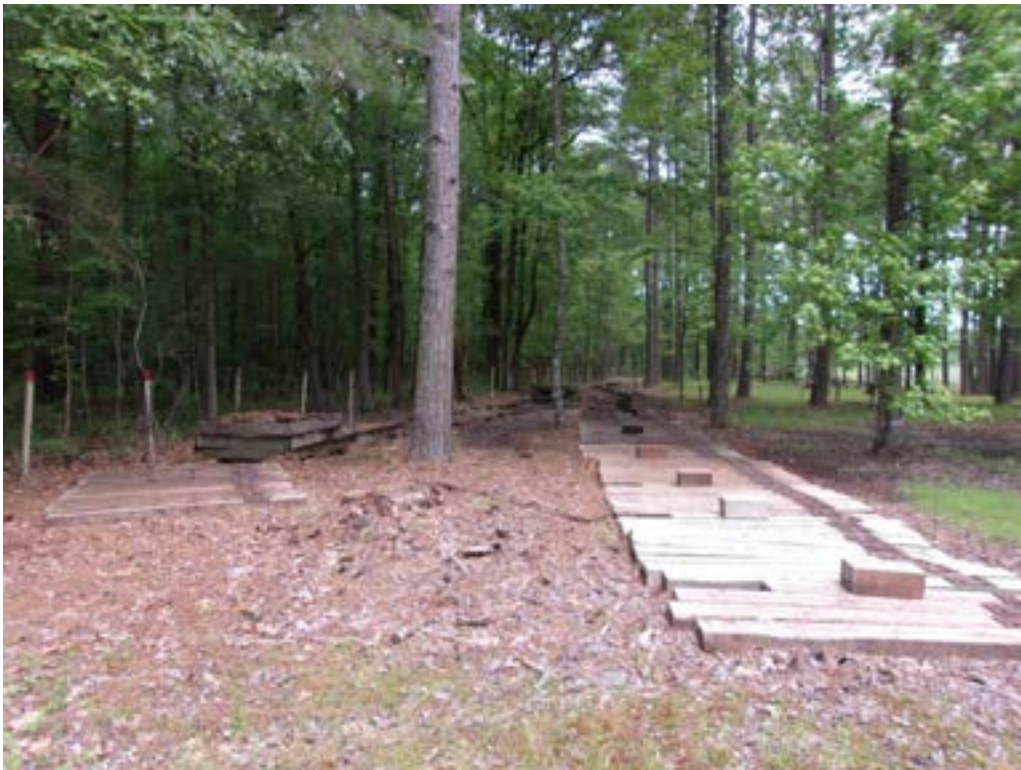
Ties at Site 1 appeared to be more moist/wet due to the increased shade and leaf litter at this site and thus more signs of decay were noted at this site.

**Figure A** - Site 1 (MSU Dorman Lake Test Site) at the time of inspection.

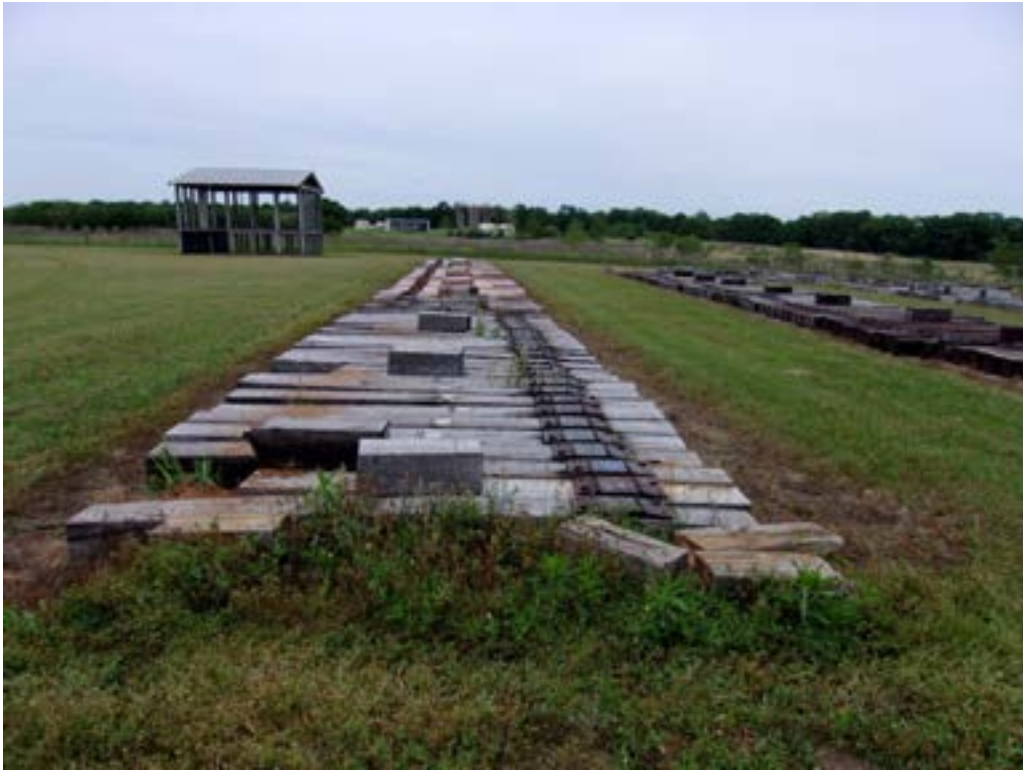
No unexpected results were found. As noted in previous reports, Site 2 ties appeared to be a drier probably due to more direct sunlight exposure allowing for more checking. However, an increase in Formosan termite activity was noted.

**Figure B** - Site 2 (MSU Formosan Termite Research Facility) at the time of inspection.

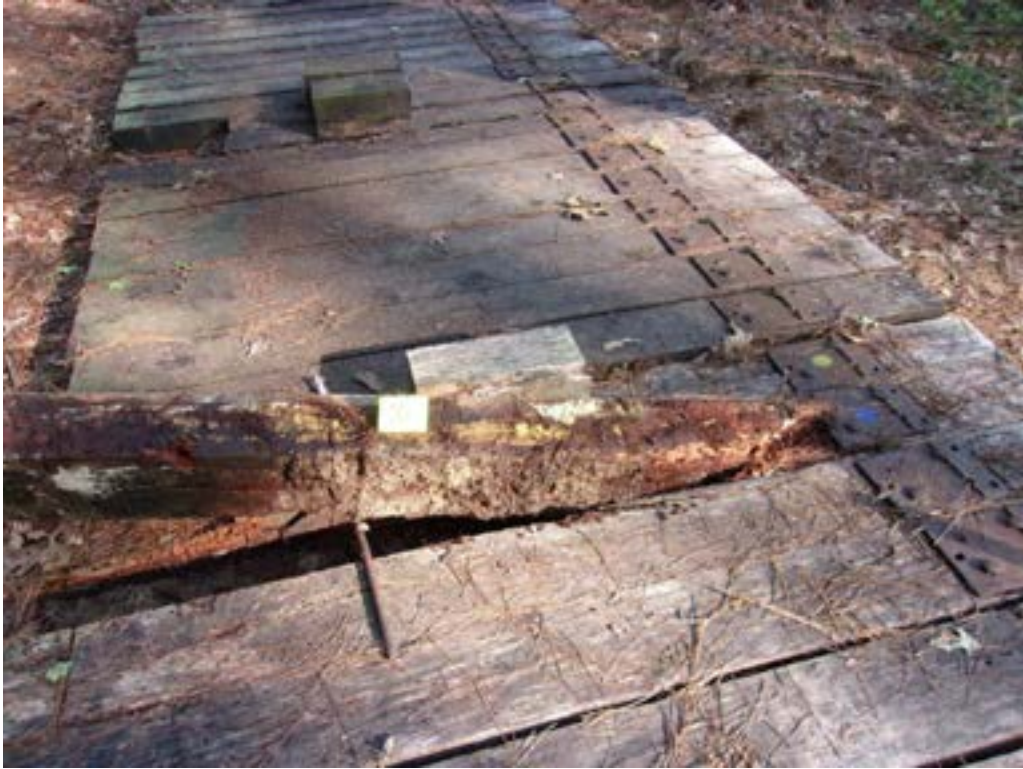
**Figure 5** – Tie #22 failed untreated red oak with heavy decay and termite damage.

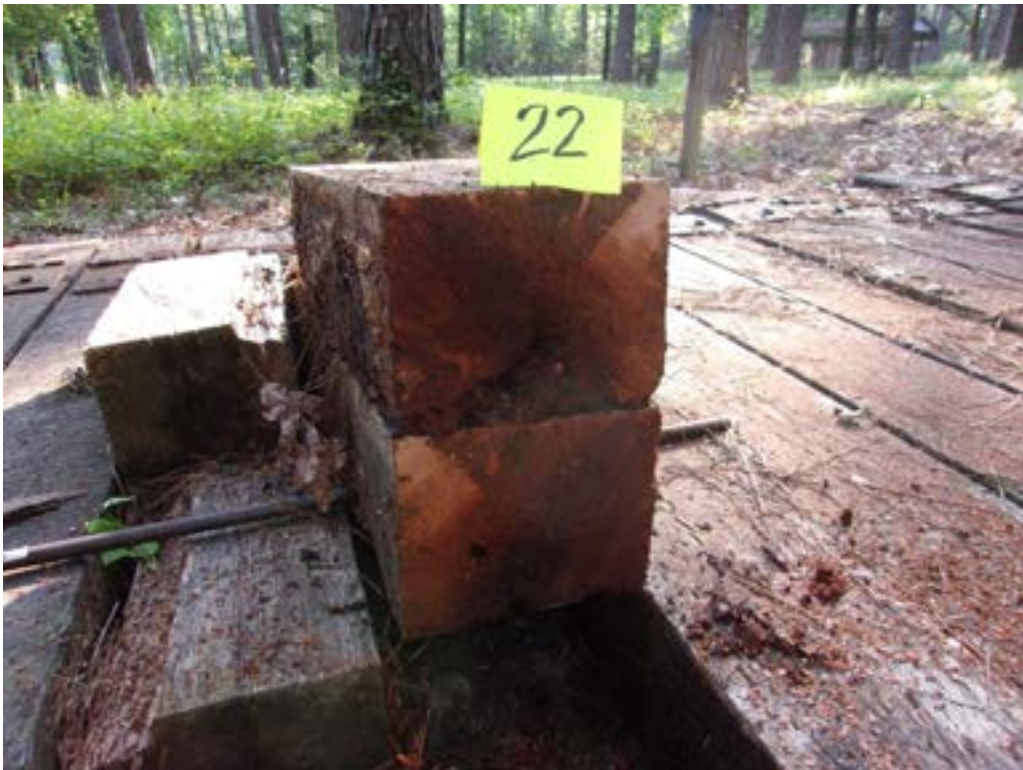
**Figure 6** – Tie #22 untreated red oak with extensive decay.

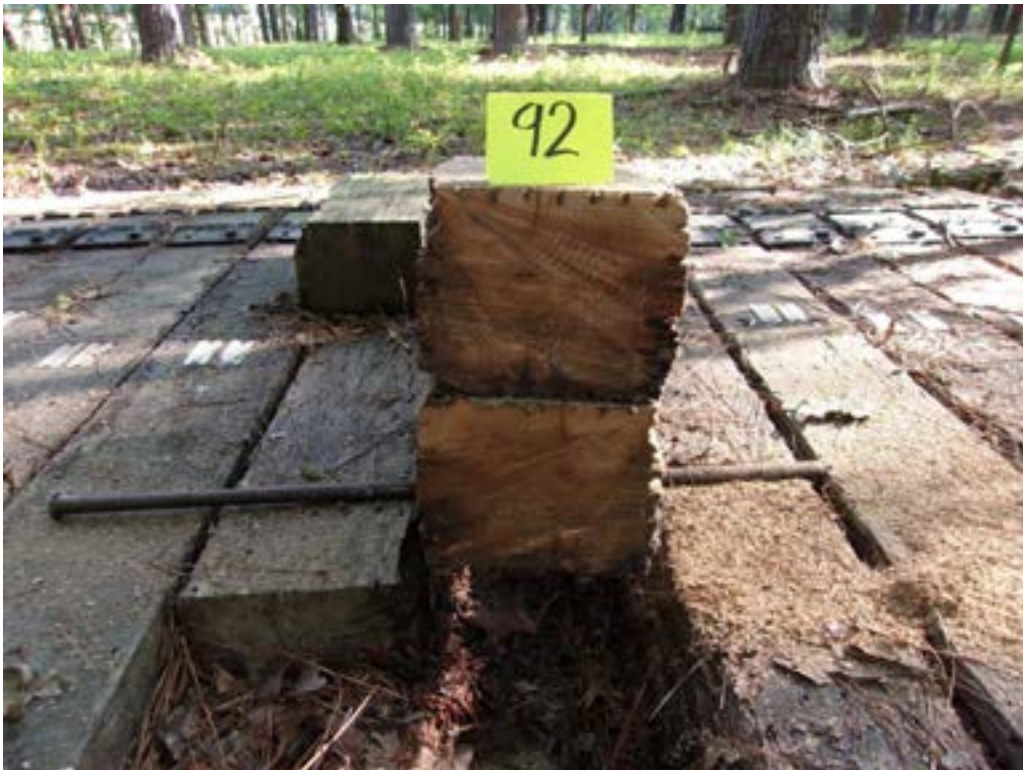
**Figure 20** – Tie #92 untreated white oak with decay visible.

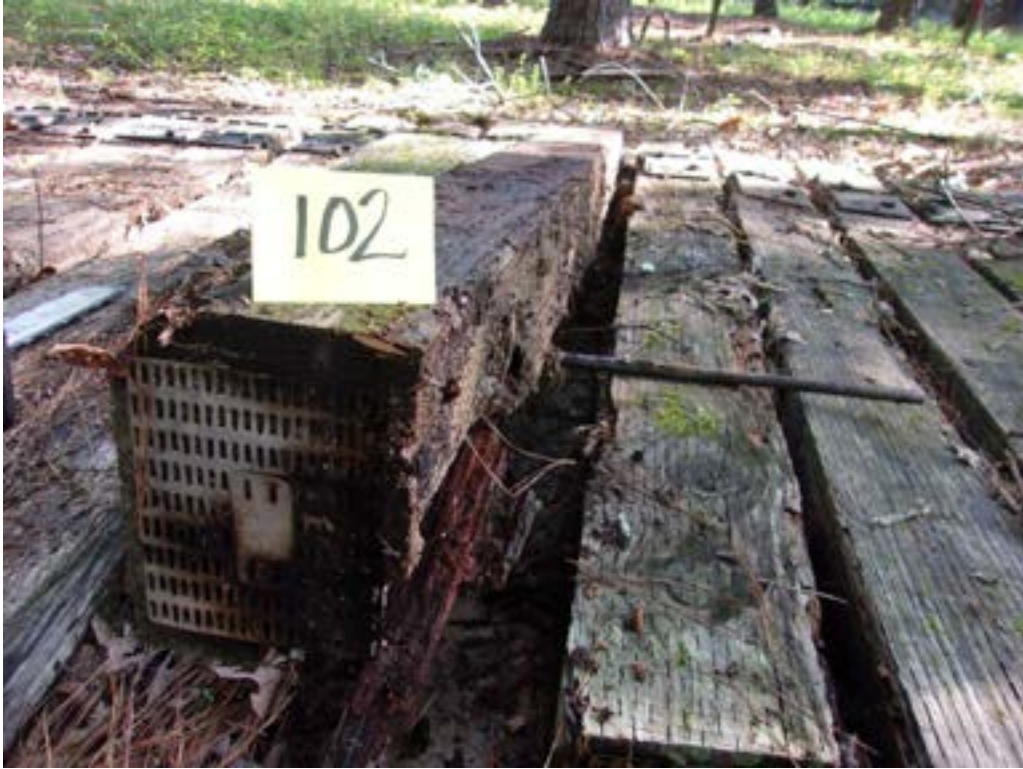
**Figure 21** – Tie #102 untreated Douglas fir with decay and active termites (*Reticulitermes*).

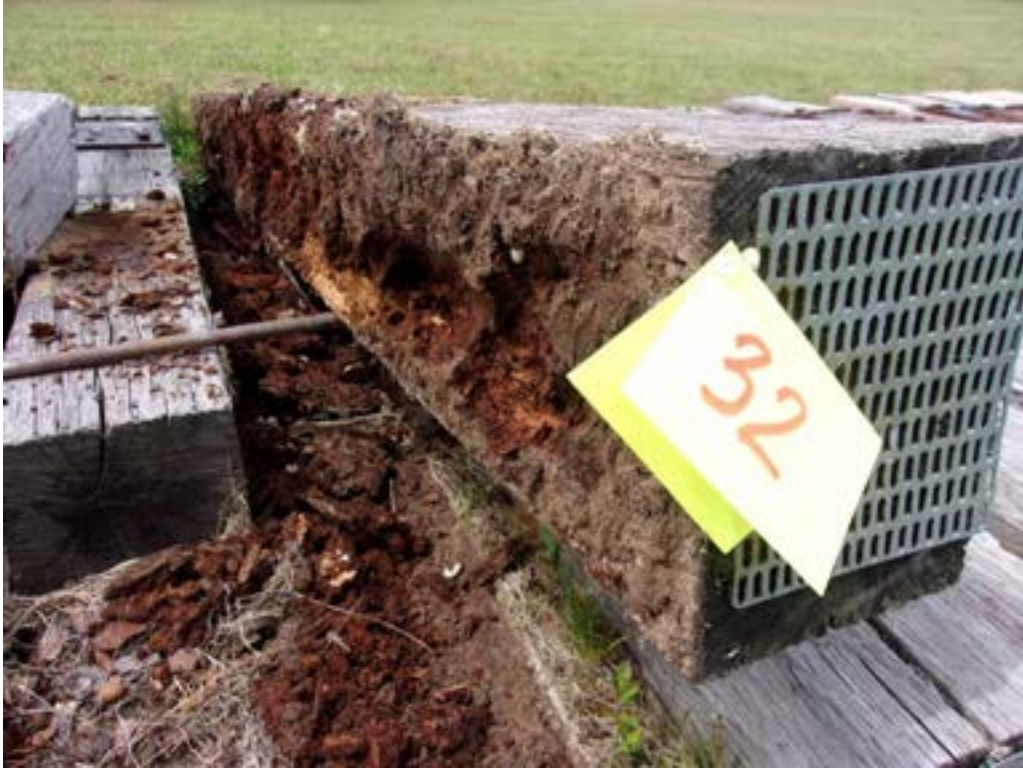
**Figure 59** – Tie #32 untreated white oak with decay and beetle damage.

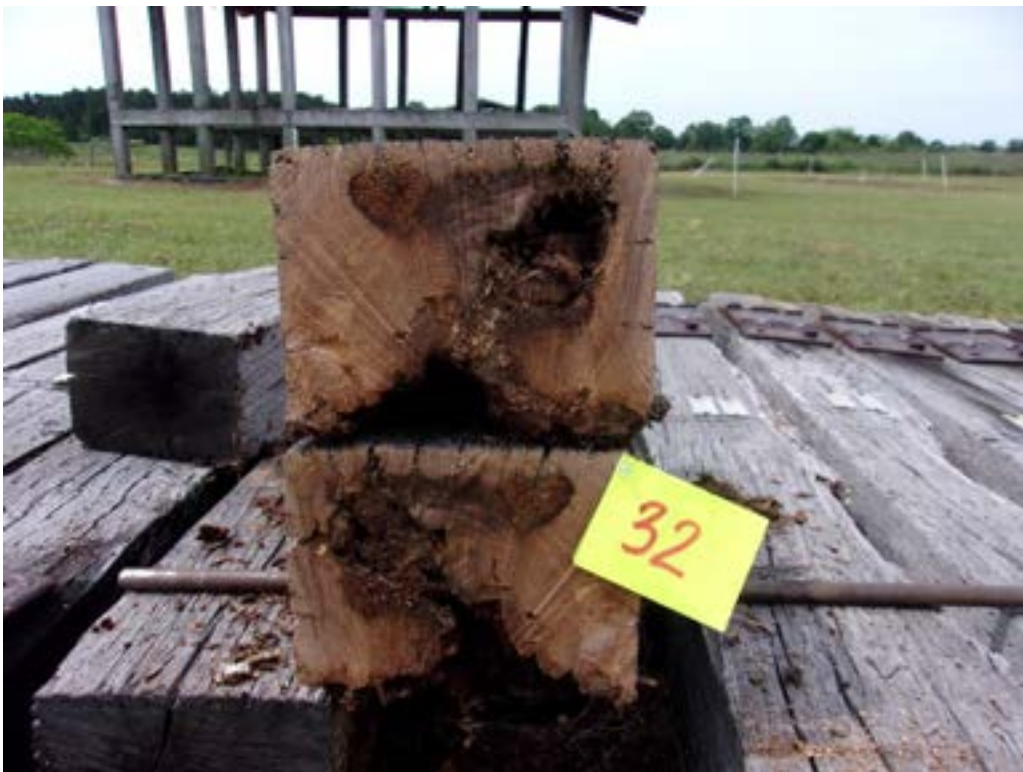
**Figure 60** - Tie #32 untreated white oak with extensive decay.

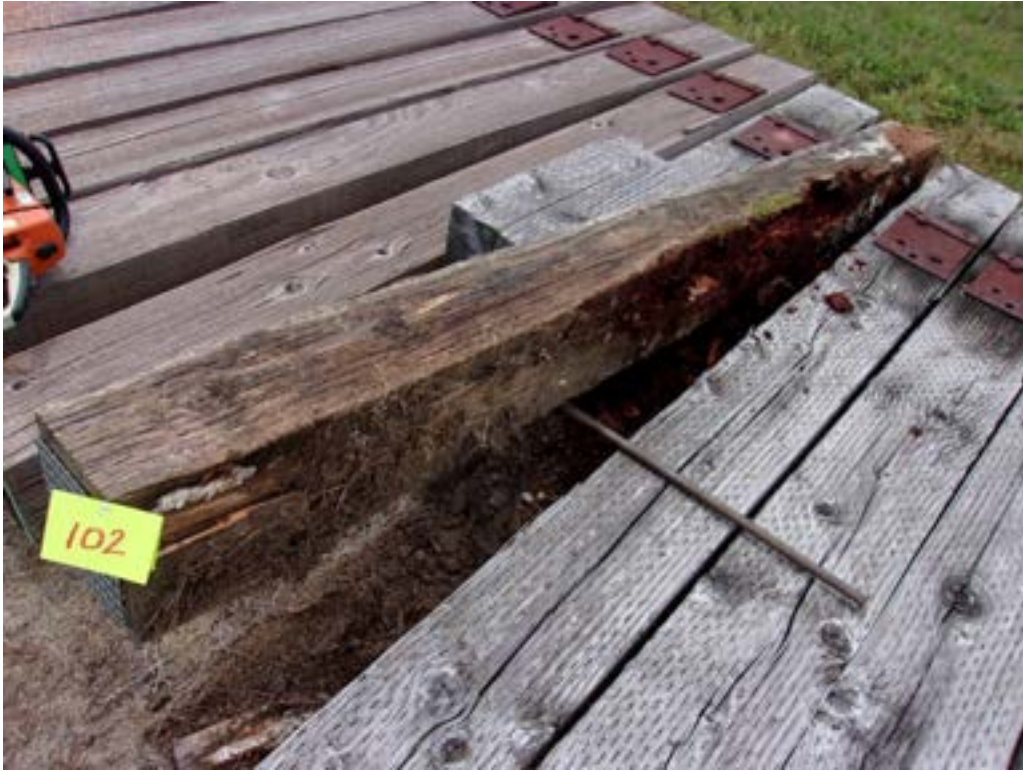
Figure 73 – Tie #102 untreated Douglas fir with decay.

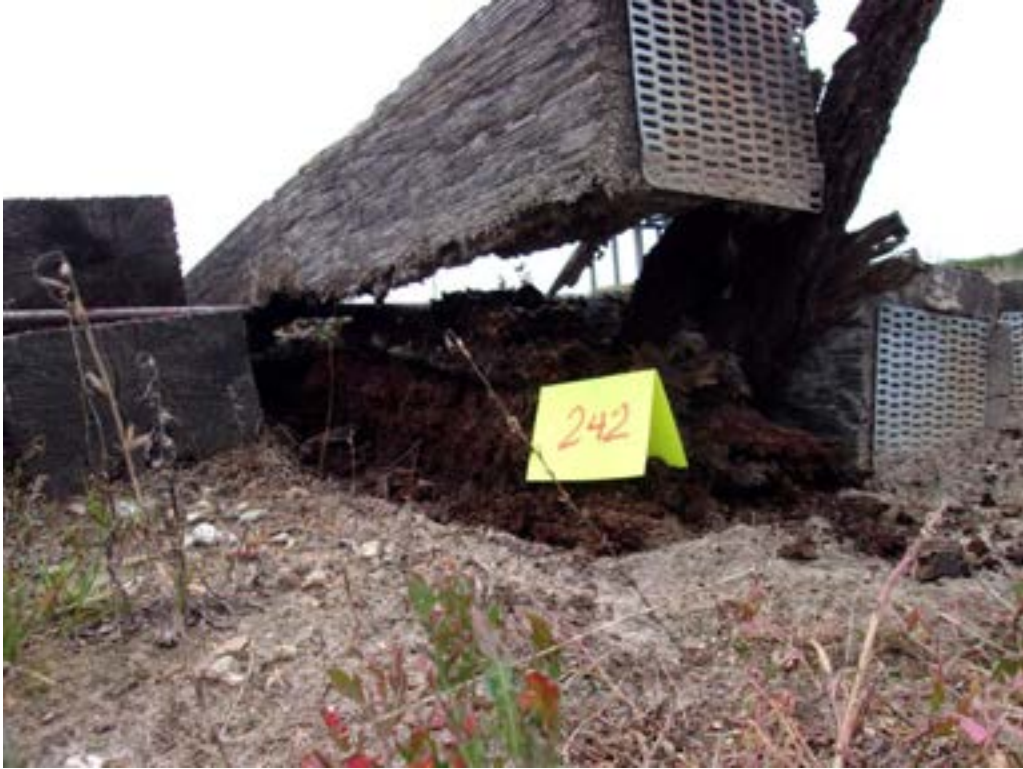
**Figure 103** – Tie #242 untreated red oak with heavy decay and Formosan termites.

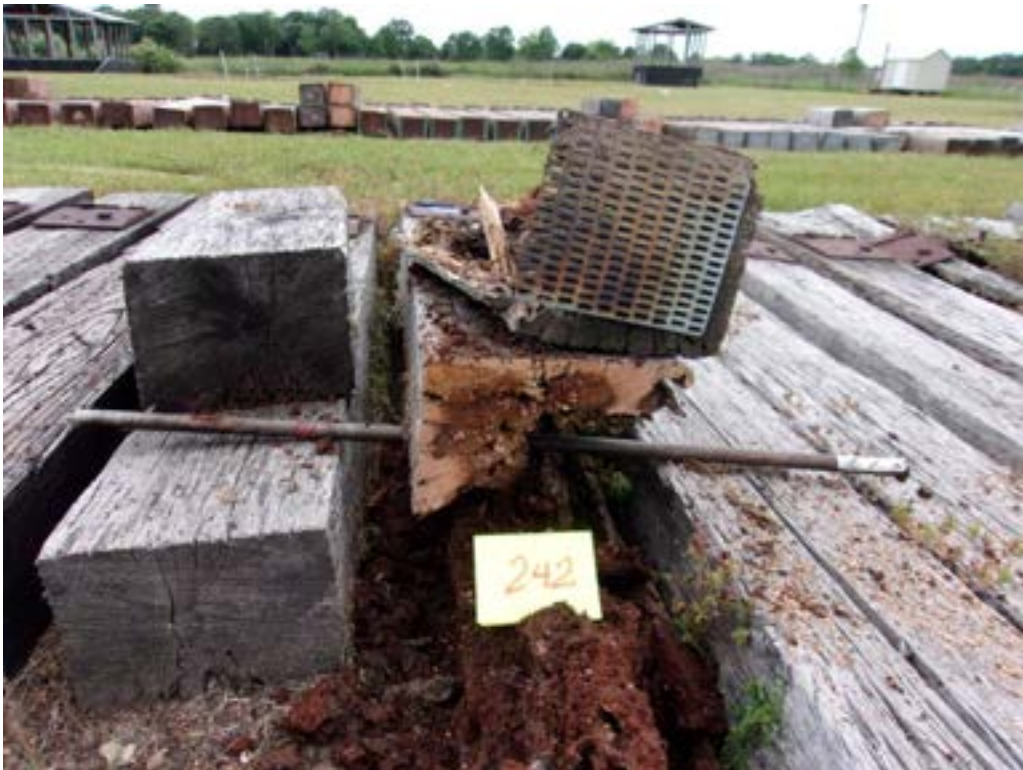
**Figure 104** - Tie #242 untreated red oak with heavy decay and termite damage.
