FOREST AND WILDLIFE RESEARCH CENTER

DEPARTMENT OF SUSTAINABLE BIOPRODUCTS

Ninth Annual Evaluation of Phase II MSU/RTA Alternative Preservative Study

May 17, 2021

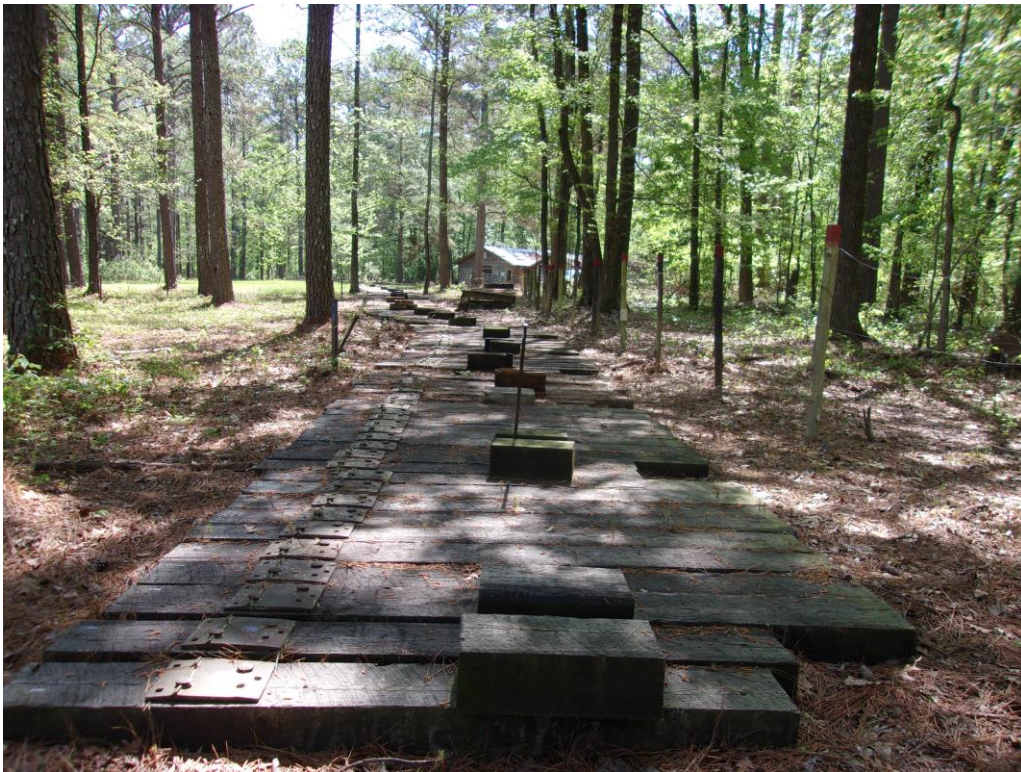
Ties at Site 1 were more moist/wet due to the increased shade and leaf litter at this site and thus more signs of decay were noted at this site.

Figure 1 - Site 1 (MSU Dorman Lake Test Site) at the time of inspection.

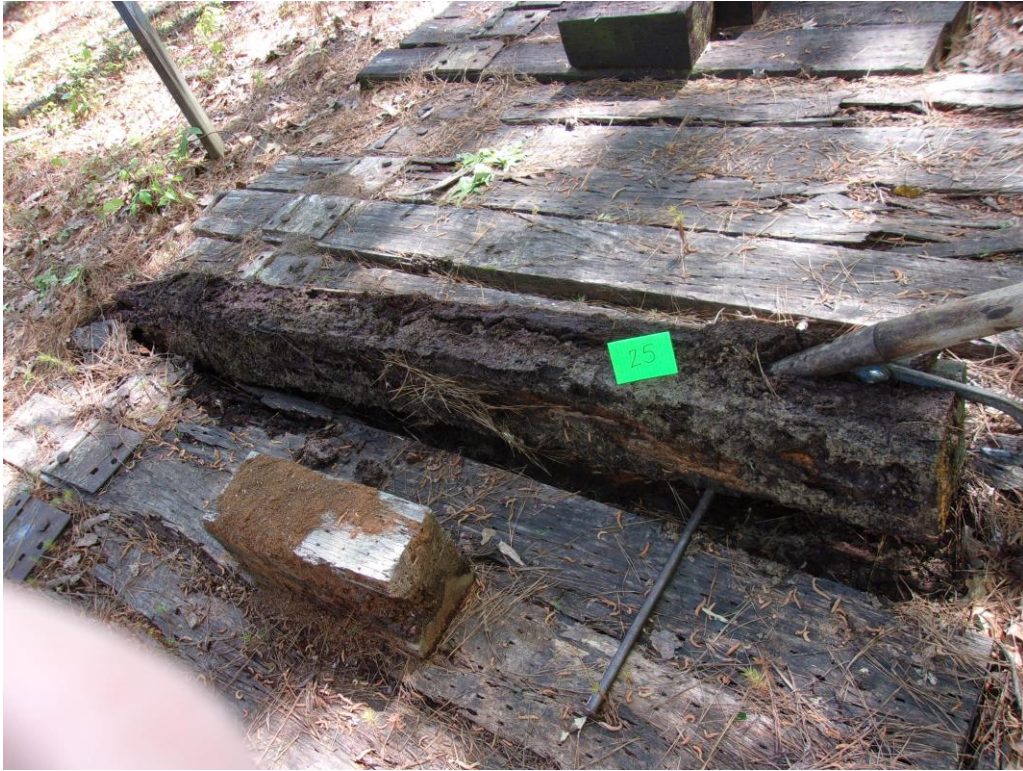
Figure 2 - Tie 25 showing signs of severe deterioration

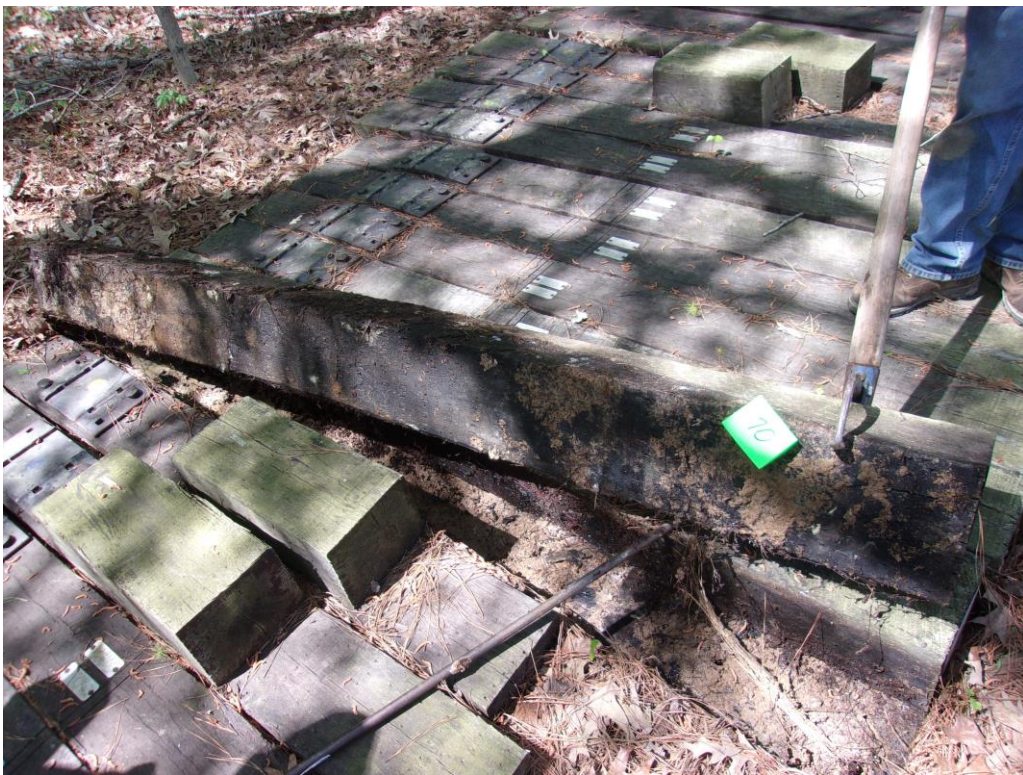
Figure 3 - Tie 70 showing no signs of decay or termite damage.

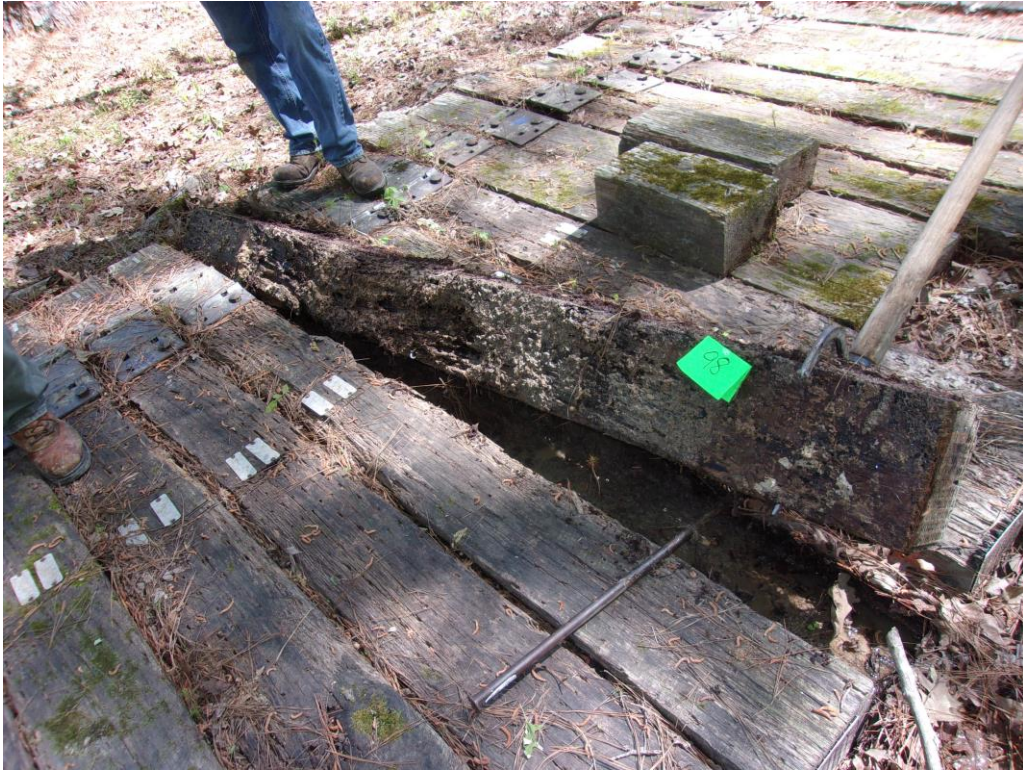
Figure 4 - Tie 70 with decay and light termite damage.

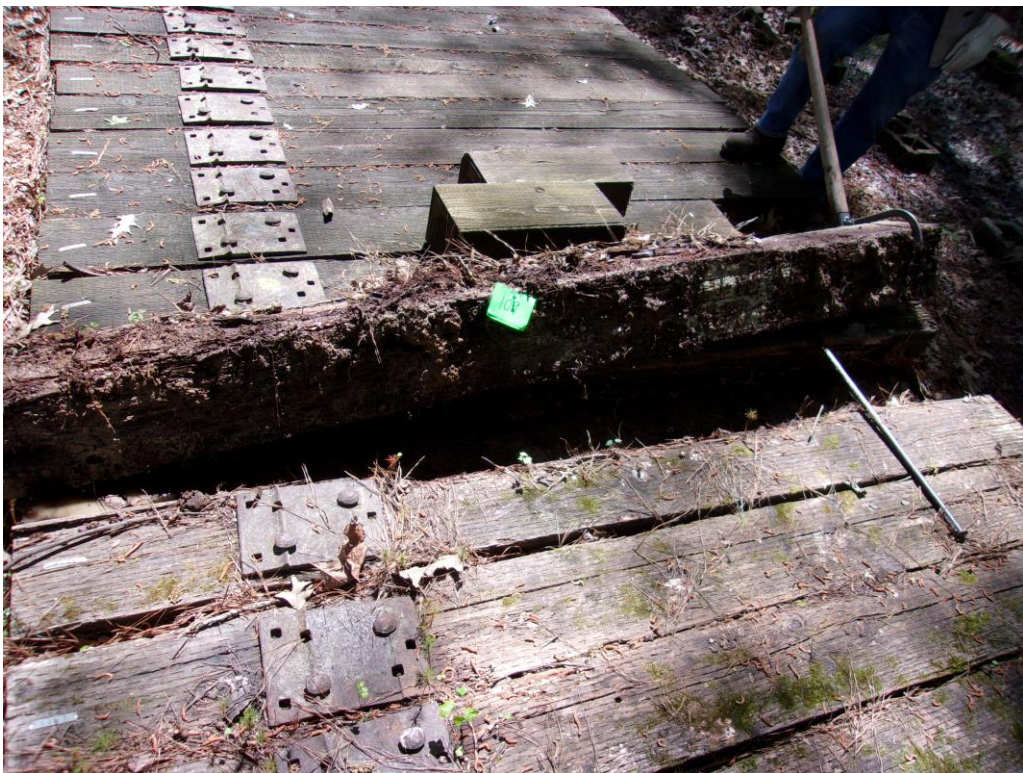
Figure 5 - Tie 109 with decay.

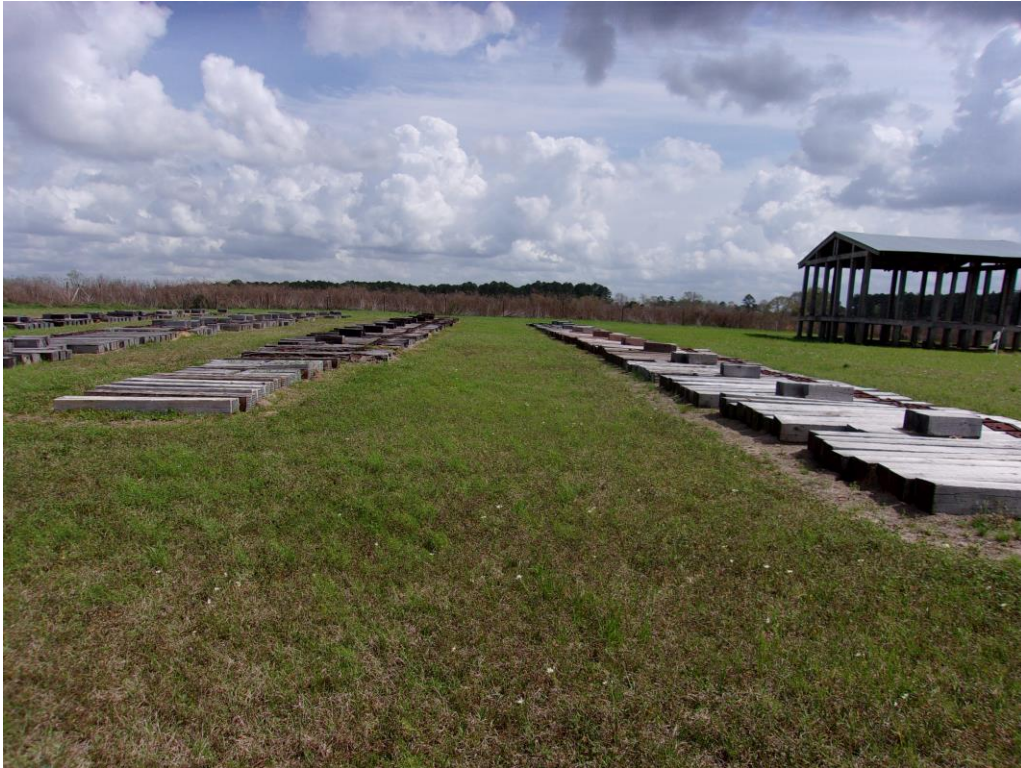
As noted in previous reports, Site 2 ties appeared to be a drier probably due to more direct sunlight exposure allowing for more checking. However, an increase in Formosan termite activity was noted again this year.

Figure 6- Site 2 (MSU Formosan Termite Research Facility) at the time of inspection.

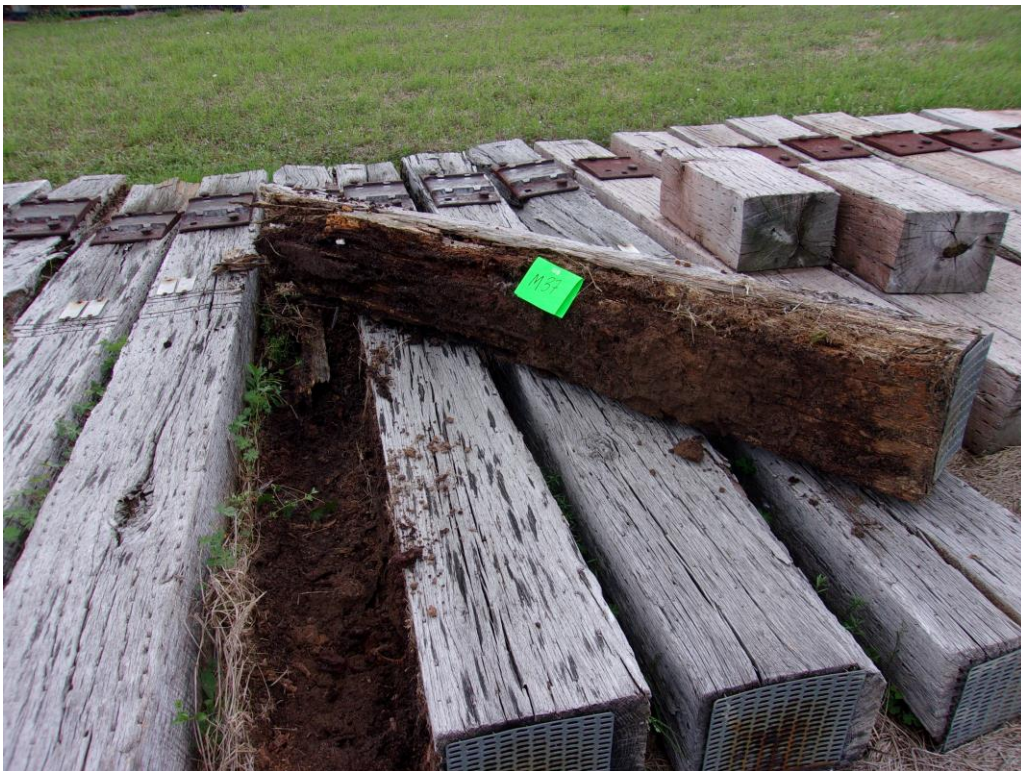
Figure 7 – Tie 37 which failed from decay and also had termite damage.

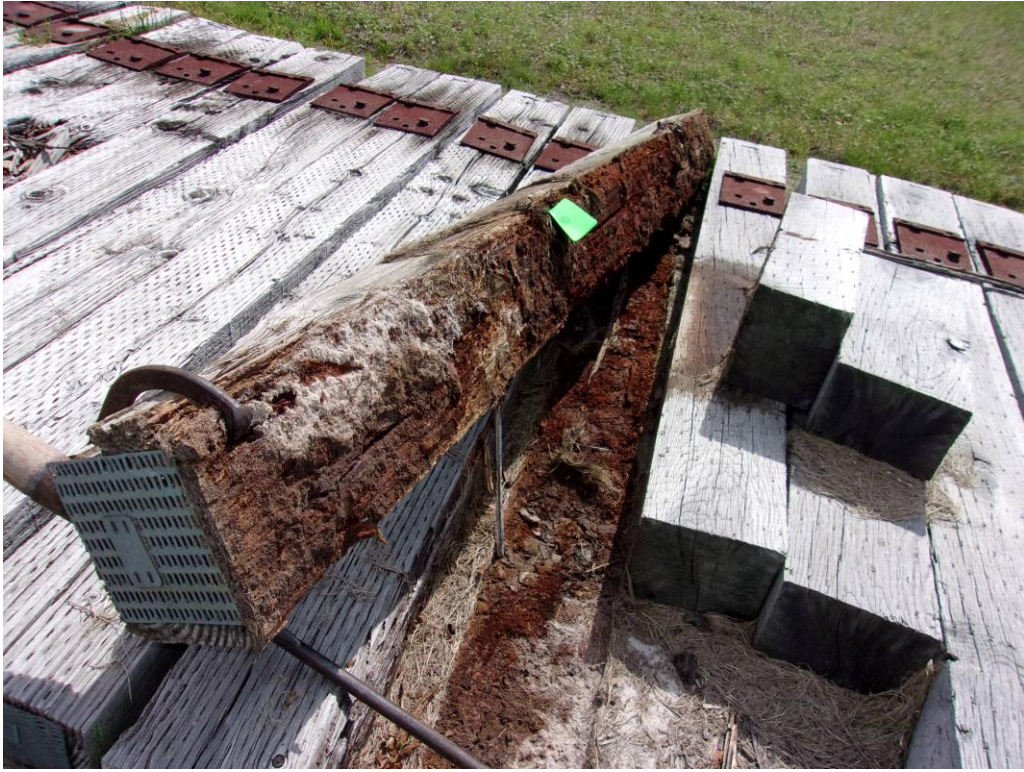
Figure 8 - Tie 110 with decay and light Formosan termite damage.

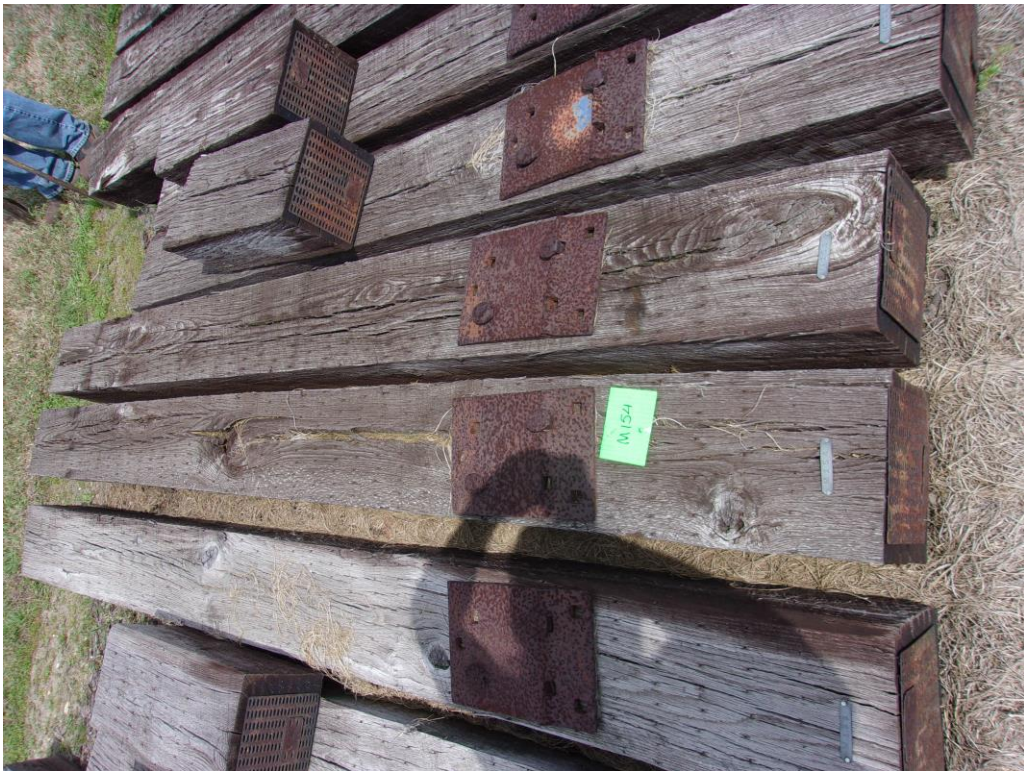
Figure 7 – Tie 154 with large check holding moisture.
