FOREST AND WILDLIFE RESEARCH CENTER

Fifth Annual Evaluation of Phase II MSU/RTA Alternative Preservative Study

Railway Tie Association

June 1, 2017

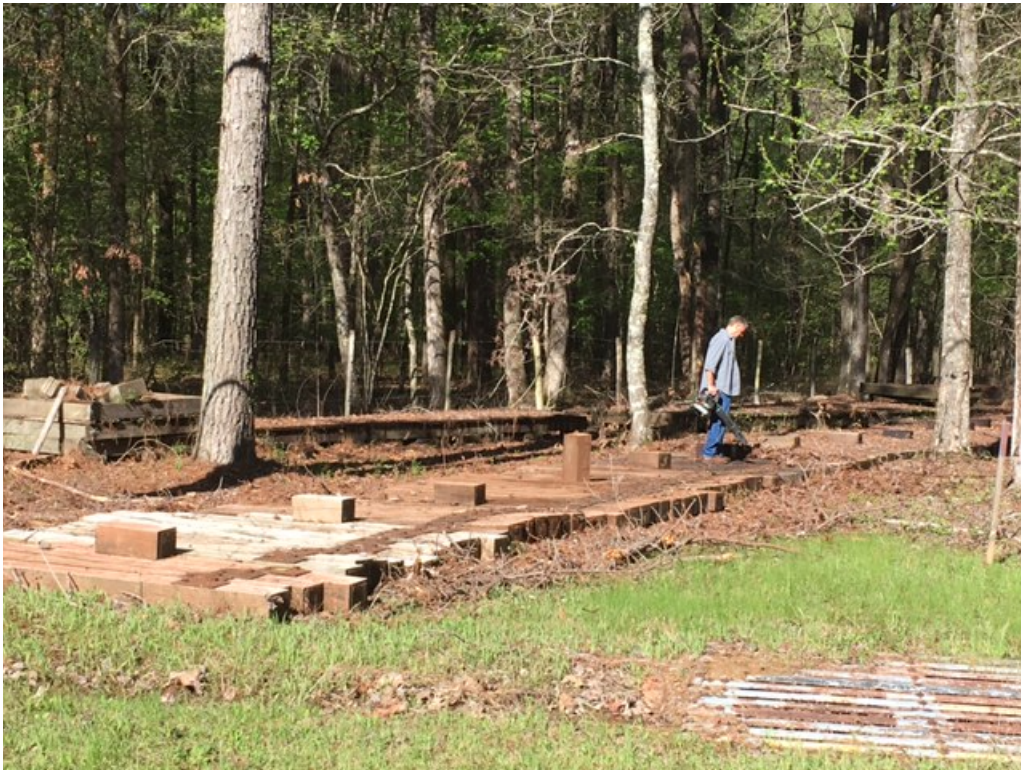
No unexpected results were found. As noted in previous reports Site 2 ties appeared to be a drier probably due to more direct sunlight exposure allowing for more checking. Ties at Site 1 appeared to be more moist/wet due to the increased shade and leaf litter at this site and thus more signs of decay were noted at this site.

Figure 1 - Site 1 (MSU Dorman Lake Test Site) at the time of inspection.

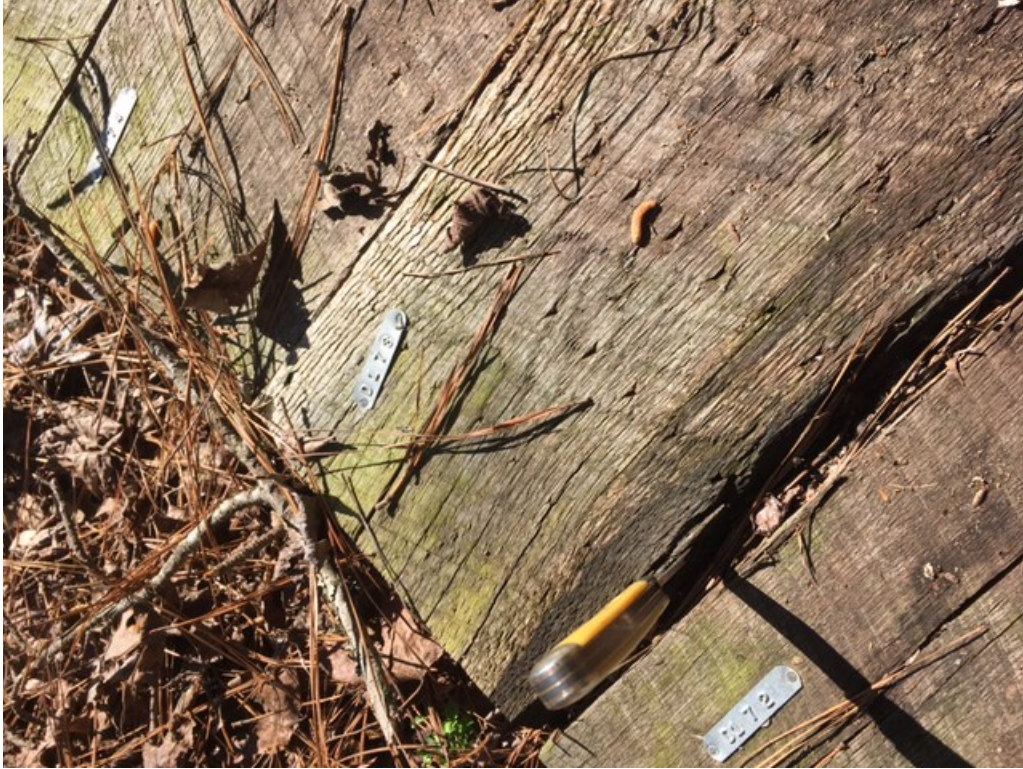
Figure 2 - Tie #173 with light decay.

168	706			10	10				
169	710			10	10			CK	
170	701			10	10				
171	747	WO-ACZA	x		x	x	x	cut 2016	
172	746			10	10			CK	
173	742			9.5	10				
174	741			10	10			CK	
175	744			10	10				
176	749			10	10				
177	748			10	10			CK	
178	743			10	10				
179	745			10	10				
180	750			10	10				
181	803	DF-P2	x		x	x	x	cut 2016	
182	802			10	10			CK	
183	806			10	10			CK	
184	808			10	10				
185	807			10	10			CK	
186	805			10	10			CK	
187	804			10	10				
188	810			10	10				
189	809			10	10				
190	801			10	10			CK	
191	544	WO-ACZA-ET	x		x	x	x	cut 2016	
192	543			10	10				
193	542			10	10			CK	
194	541			10	10				
195	549			10	10				
196	548			10	10			CK	
197	547			10	10			CK	
198	546			10	10				
199	545			10	10			CK	
200	550			10	10			CK	
201	664	DF-ACZA-DOT-ET	x		x	x	x	cut 2016	
202	663			10	10				
203	662			10	10			CK	
204	661			10	10				
205	669			10	10			CK	
206	668			10	10				
207	667			10	10				
208	666			10	10				
209	665			10	10			CK

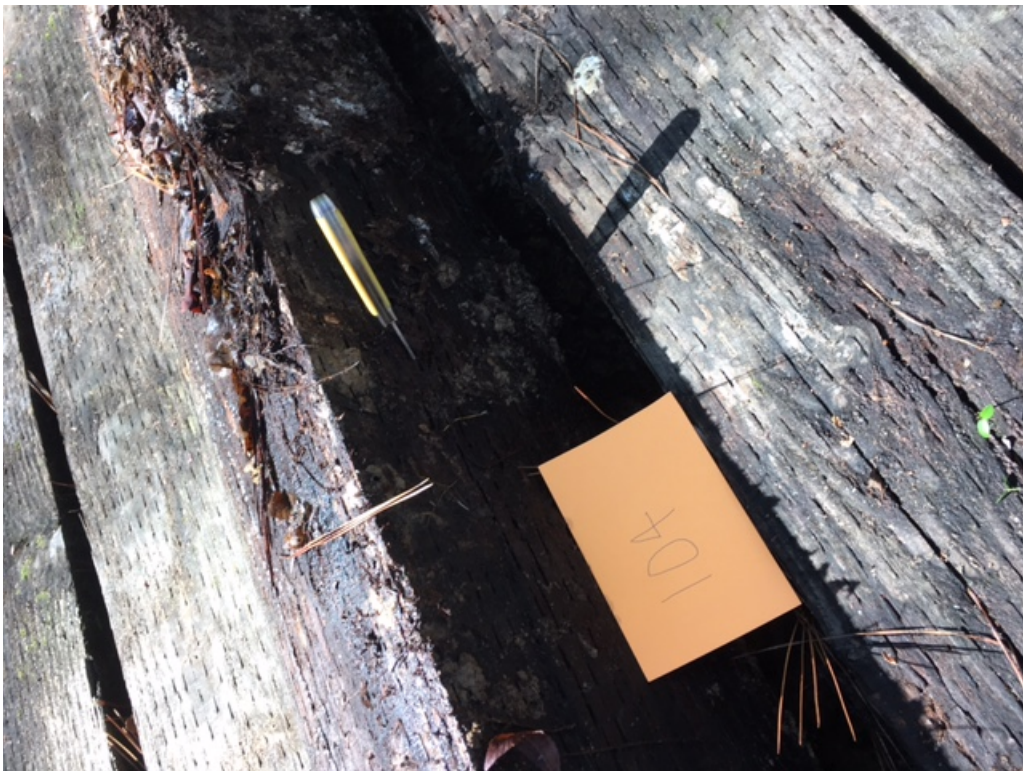
Figure 3 - Tie #104 with decay and trace termite damage.

92	WO-Unt		9	10				
	93	WO-Unt		9	10				
	94	WO-Unt		9	10			CK	
	95	WO-Unt		8	10				
	96	WO-Unt		9	10				
	97	WO-Unt		9	10				
	98	WO-Unt		9	10				
	99	WO-Unt		8	10			FB	
	100	WO-Unt		8	10				
Lonza	101	784	DF-Unt.	x		x	x	cut 2016	
	102	783		9	10				
	103	782		8	9				
	104	781		8	9.5			FB/CK	
	105	789		9	9				
	106	788		9	9				
	107	787		9	9				
	108	786		9	9			FB	
	109	785		9	9				
	110	790		9	9

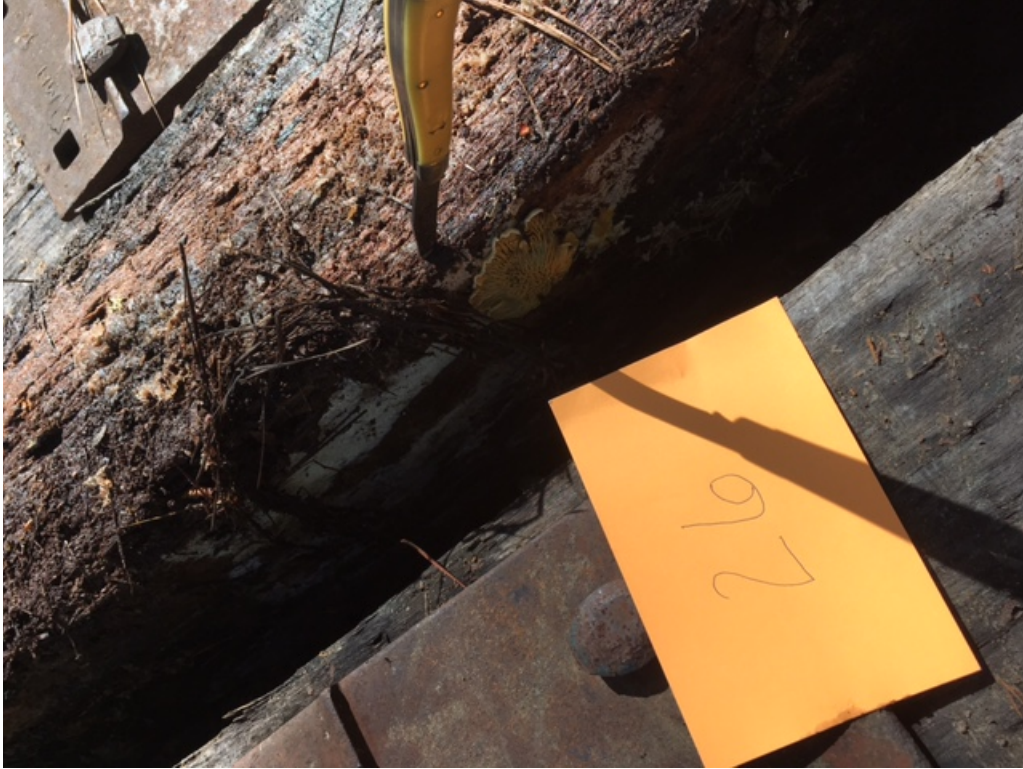
Figure 4 - Tie #26 with decay and slight termite damage.

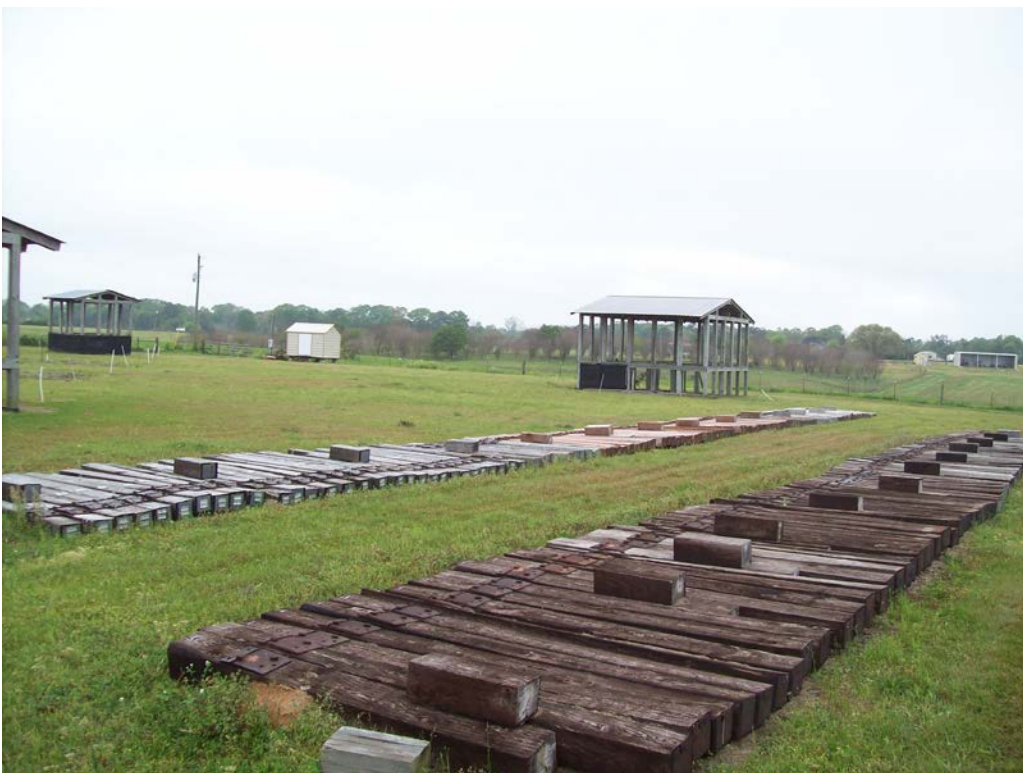
Figure 5 - Site 2 at the time of inspection.

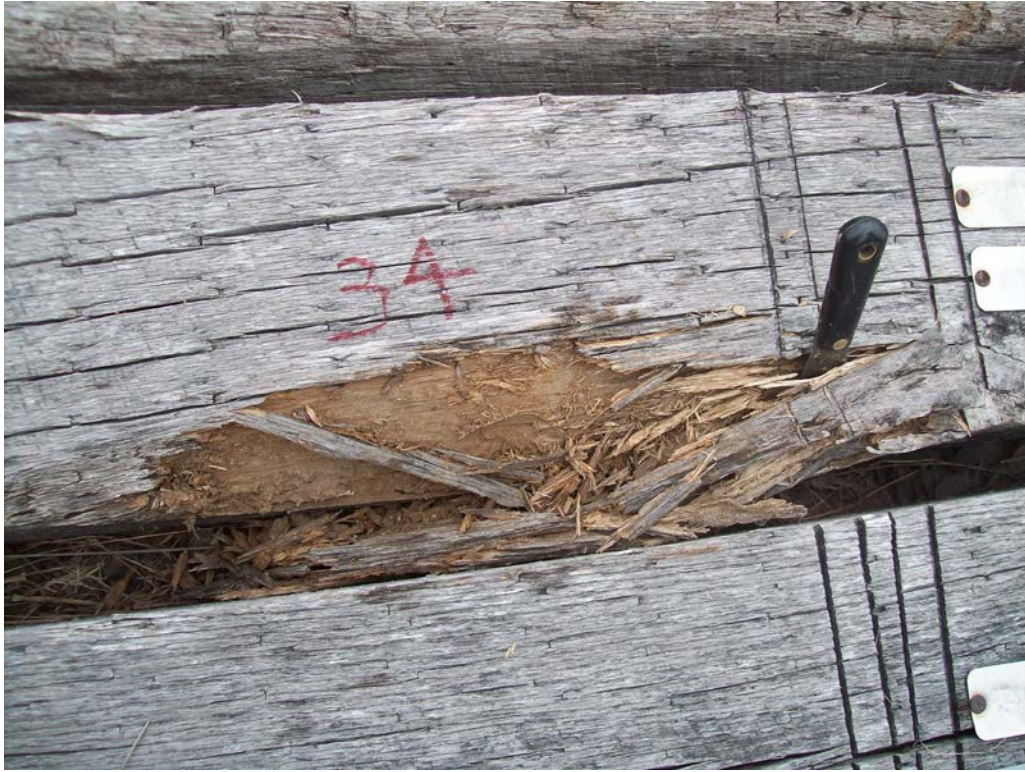
Figure 6 - Tie #34 with decay and slight termite damage.

32	Unt. - WO	9	10			FB		
33	Unt. - WO	9.5	10			FB		
34	Unt. - WO	9	9.5			DK top S end/retics		
35	Unt. - WO	10	10			check		
36	Unt. - WO	10	10			check		
37	Unt. - WO	9	10					
38	Unt. - WO	9.5	10					
39	Unt. - WO	9.5	9.5			DK top S end		
40	Unt. - WO	8	10			FB/beetle dmg		
Lonza	41	572	WO-DOT-ACZA-ET	x	x	x	x	cut 2016
	42	573		10	10			
	43	574		10	10			
	44	575		10	10			check
	45	576		10	10			
	46	577		10	10			
	47	578		10	10			
	48	579		10	10			check
	49	580		10	10

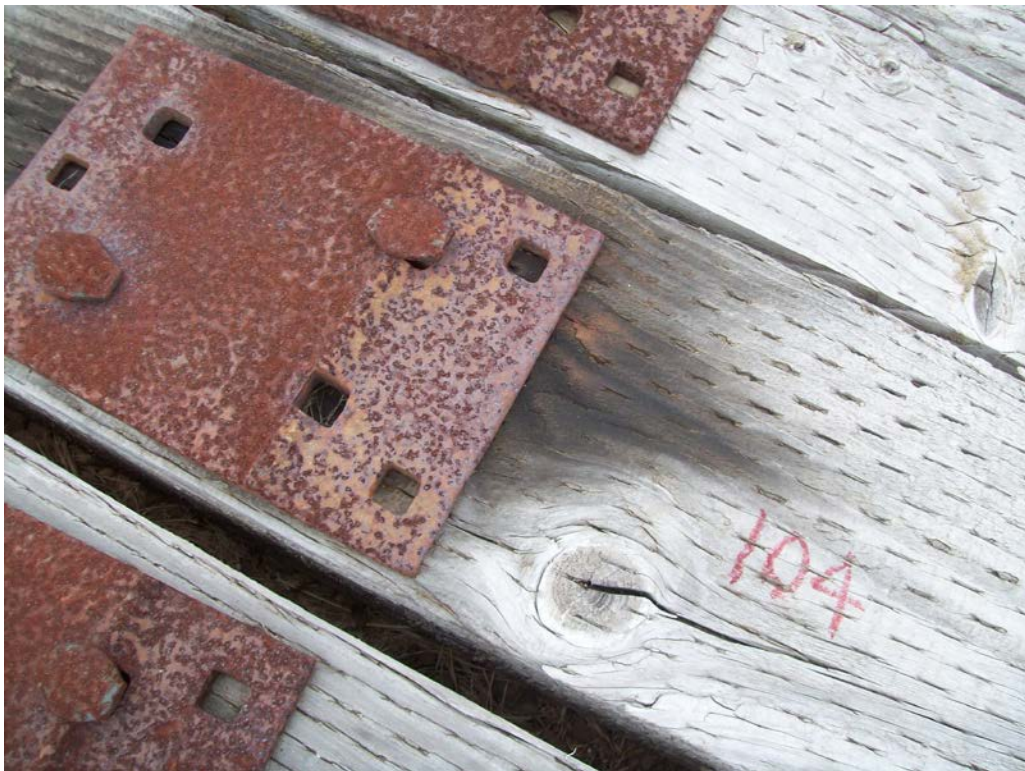
Figure 7 - Tie #104 with "iron stain".

99	696			10	10			end plate corroded
100	700			10	10			end plate corroded
101	795	DF-Unt.	x		x	x	x	cut 2016
102	794			10	10			check/IS
103	793			10	10			check/IS
104	792			10	10			check/IS
105	791			10	10			check/IS
106	800			9.5	10			FB/IS
107	799			10	10			check/IS
108	798			10	10			FB/check/IS
109	797			10	10			check/IS
110	796			10	10			check/LP
111	755	WO-ACZA	x		x	x	x	cut 2016
112	754			10	10			end plate corroded
113	753			10	10			end plate corroded
114	752			10	10			end plate corroded/check/LP
115	751			10	10			end plate corroded
116	760			10	10			Knot/burl under plate area N end
117	759			10	10			end plate corroded
118	758			10	10			check/end plat corroded
119	757			10	10			check/end plat corroded
120	756			10	10			end plate corroded
121	712	RO-ACZA	x		x	x	x	cut 2016
122	713			10	10			end plate corroded
123	714			10	10			end plate corroded
124	715			10	10			end plate corroded
125	717			10	10			end plate corroded

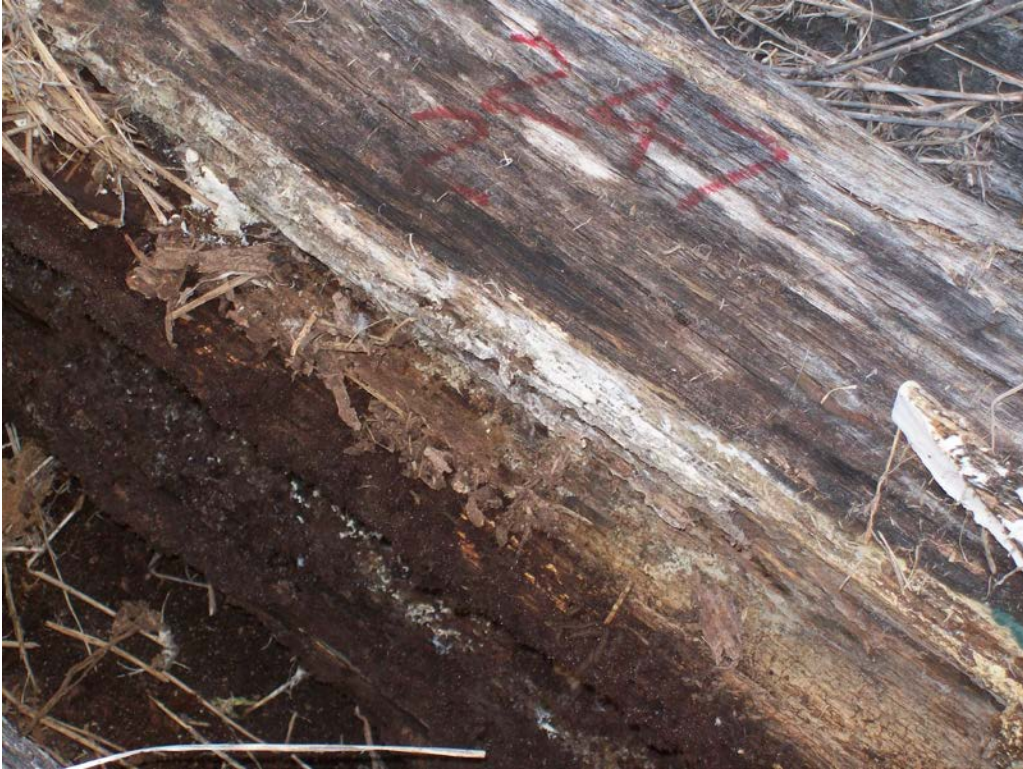
Figure 8 - Tie #247 with severe decay and trace termite damage.

241	blank tag	Unt. RO	x		x	x	x	cut 2016
242	blank tag			9	10			FB
243	blank tag			9	10			
244	blank tag			9	10			FB
245	blank tag			9	10			
246	blank tag			9	10			
247	blank tag			6	9.5			FB/split/gator
248	blank tag			9	10			FB
249	blank tag			8	10			split/gator
250	blank tag			9	10
