Misreading Rail Flaw Size

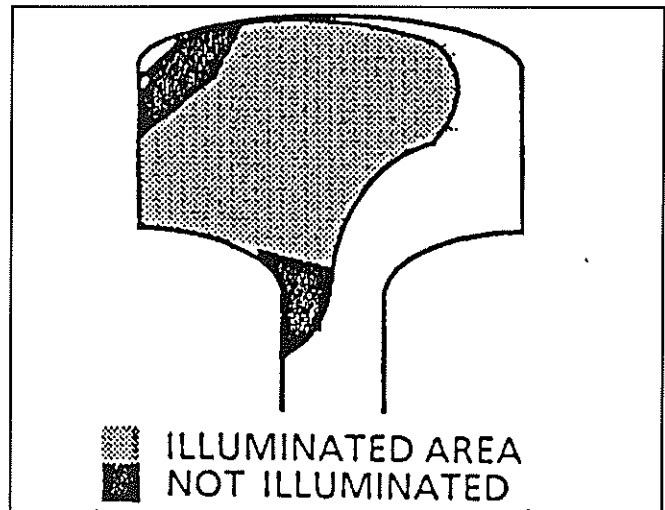
Figure 1 — UT View of Large Flaw

The first source of error can be due to the inability of the ultrasonic beam to illuminate the parts of the crack surface near the gage corner and in the head-web fillet area. This is shown in Figure 1, and occurs usually with flaws larger than 65 percent of the head area.

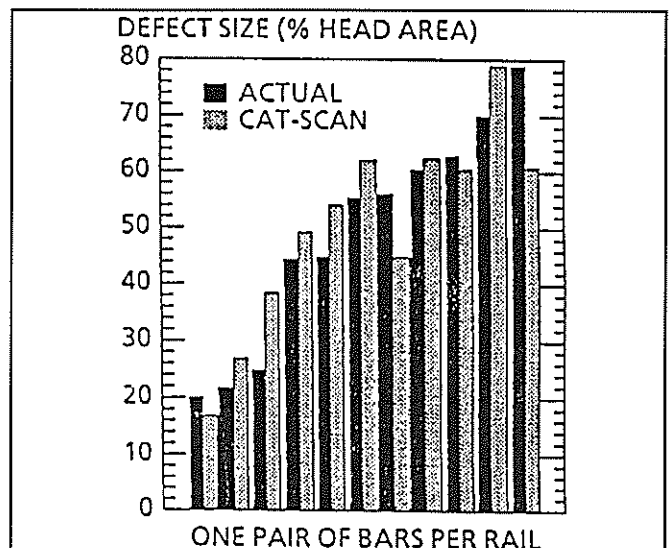
Figure 2 — CAT Scan Error vs. Flaw Size

crack surface. It is a phenomenon which results in an underestimation of the flaw size, or because of a finite beam width can result in an overestimation of the flaw size. Typical errors of the kind are presented in Figure 2.

It compares defect size from CAT-scan readings against actual size obtained by breaking and examining the rail.

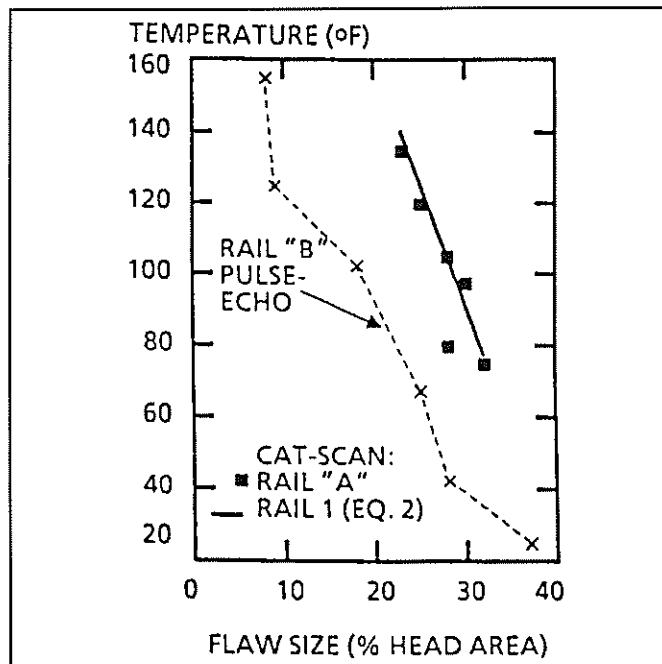
Figure 3 — Apparent Flaw Size vs. Rail Temperature

A third source of error, discovered through laboratory testing, originates from changes in rail temperature. Thus, it was found that flaw size decreased as the temperature increased and the rail was put into compression. These results, which were observed both in the laboratory and in the field, are presented in Figure 3. It illustrates the variation in flaw size with rail temperature. The differences are quite significant, and could be of real importance in the monitoring of internal rail defects for ultrasonic or possibly other inspection techniques. While temperature is not a variable that can be controlled in the field, knowledge of this error phenomenon is useful in compensating for it under field measurement conditions.
