**MISSISSIPPI STATE
UNIVERSITY™**

**FOREST AND WILDLIFE RESEARCH CENTER
DEPARTMENT of SUSTAINABLE BIOPRODUCTS**

Fourteenth Annual Evaluation of MSU/RTA Alternative Preservative Study

August 22, 2022

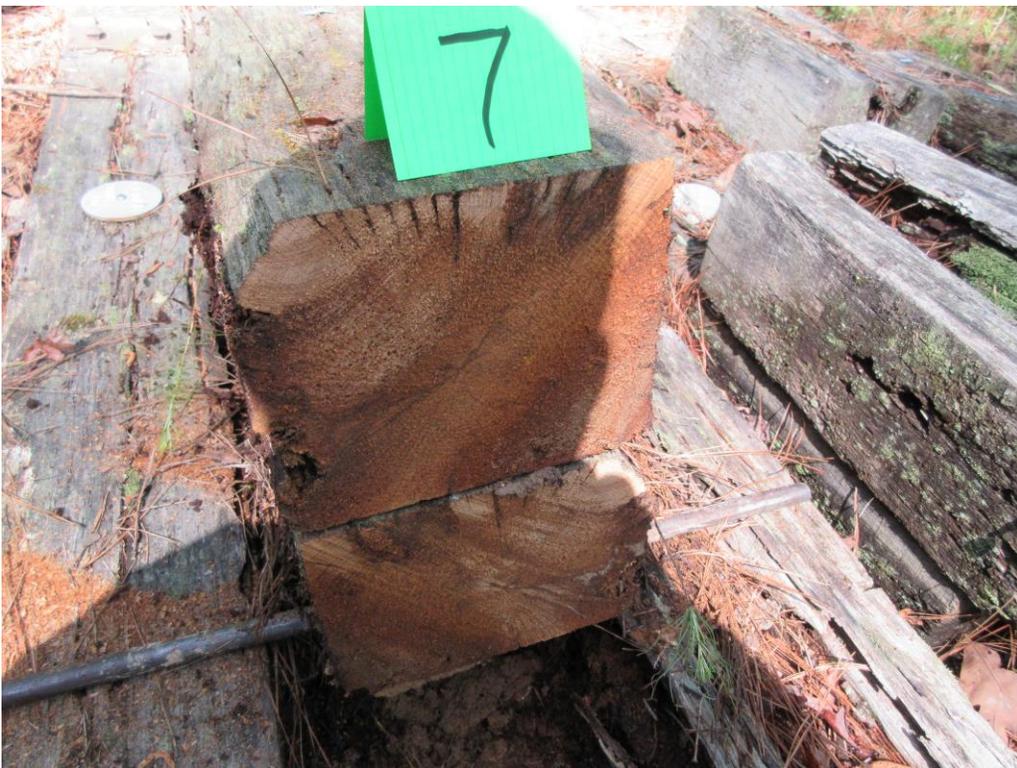
A1 - Tie #7 (Cedarcide/white oak) with heavy decay.

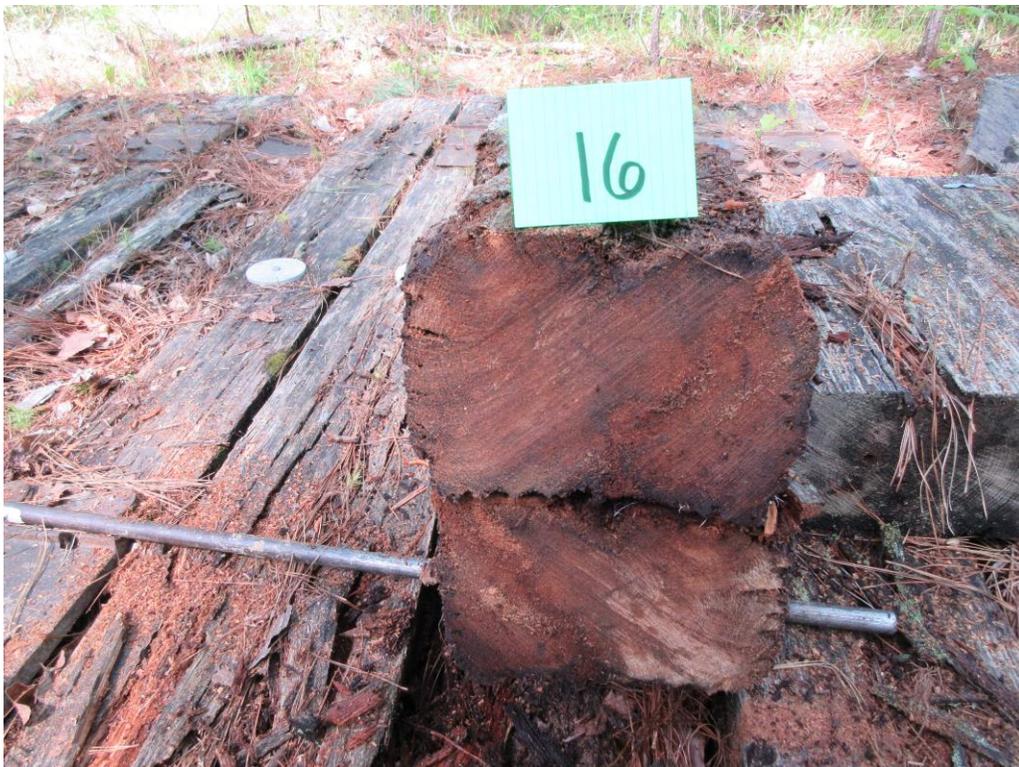
A3 – Tie #16 (Cedarcide/red oak) with extensive decay.

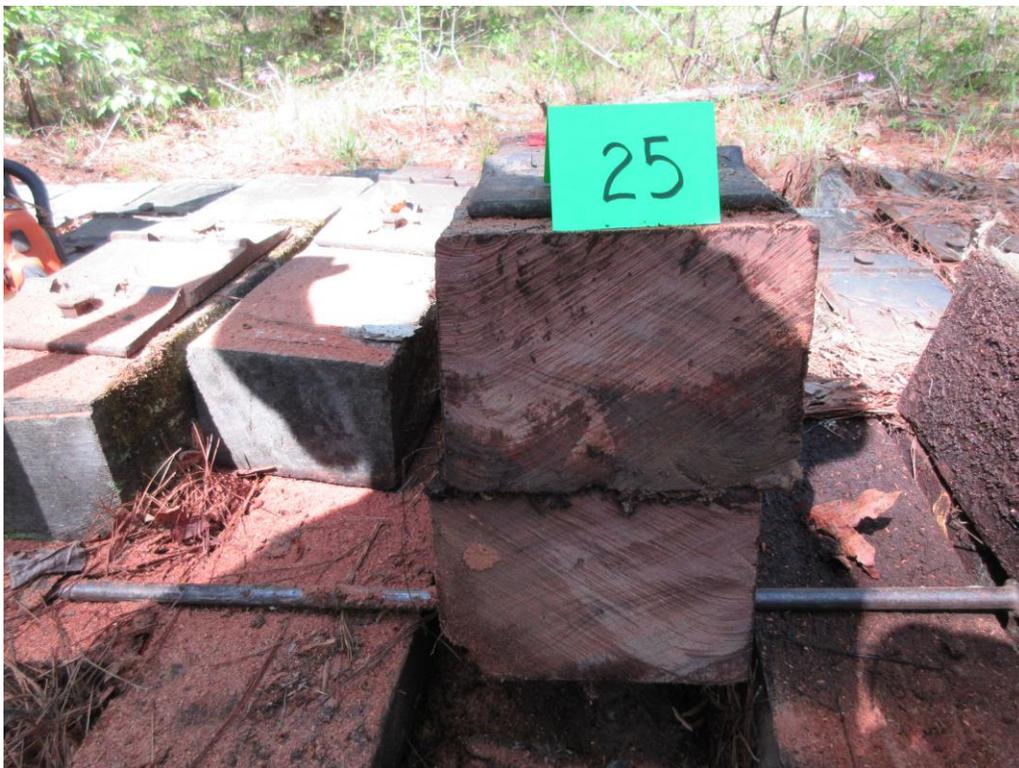
A5 – Tie #25 (Turada) with decay on bottom and side.

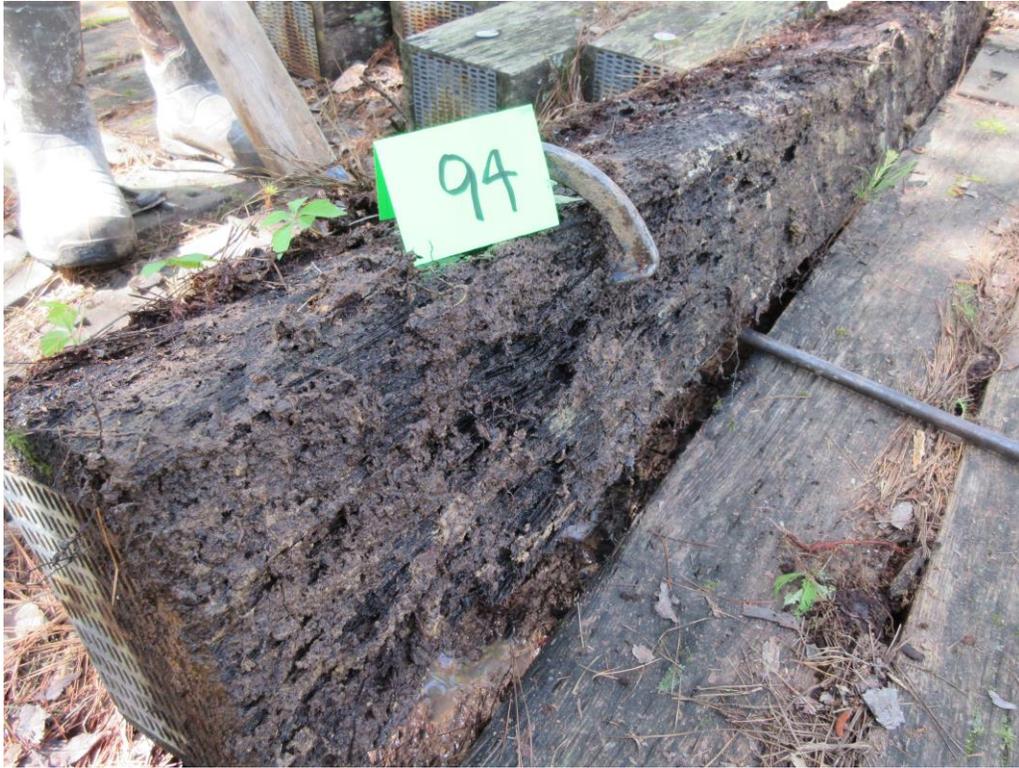
A17 - Tie #94 (Lonza/white oak) decay on bottom.

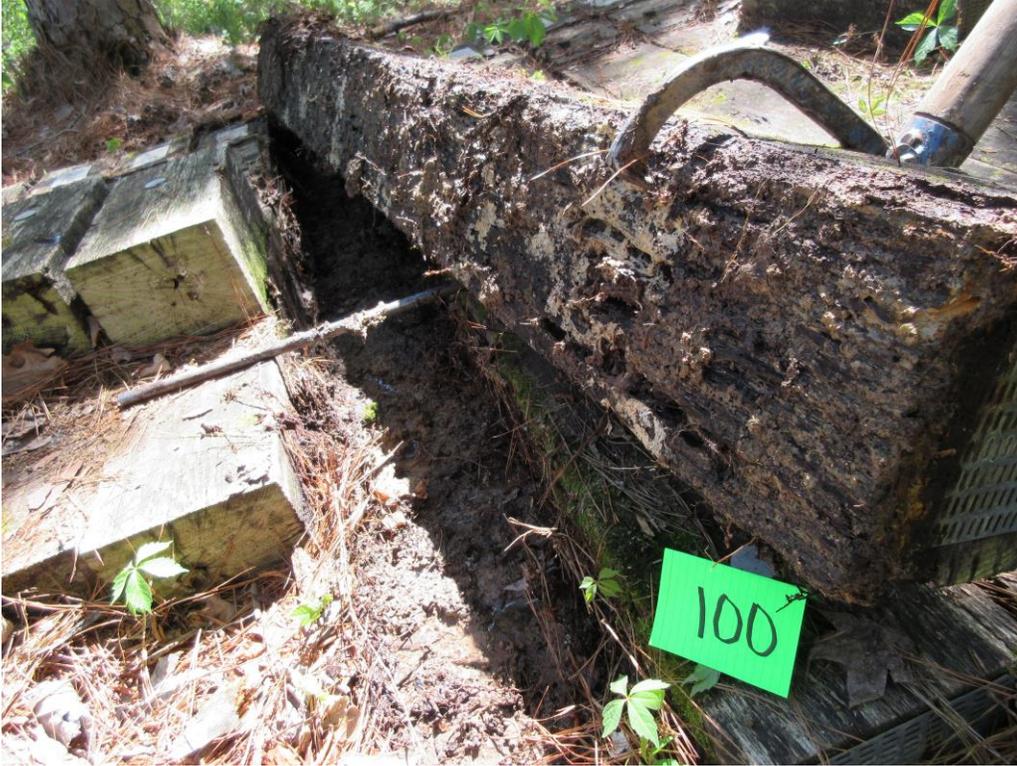
A19 - Tie #100 (Lonza/red oak) with moderate decay on bottom.

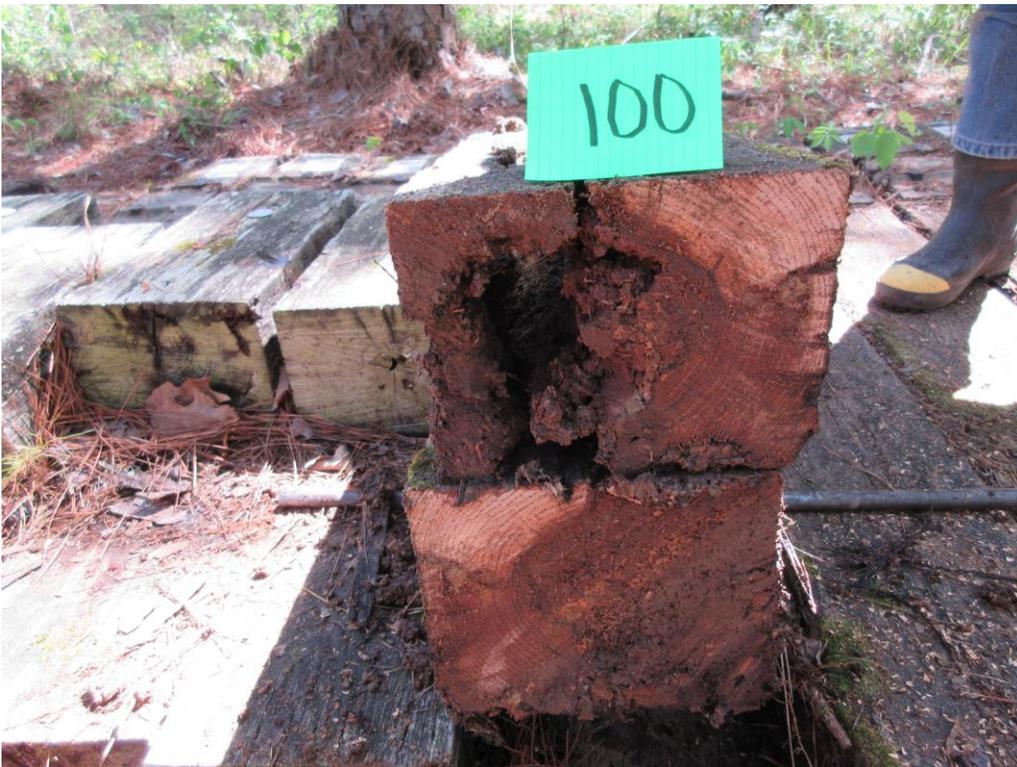
A20 - Tie #100 (Lonza/red oak) significant internal deterioration.

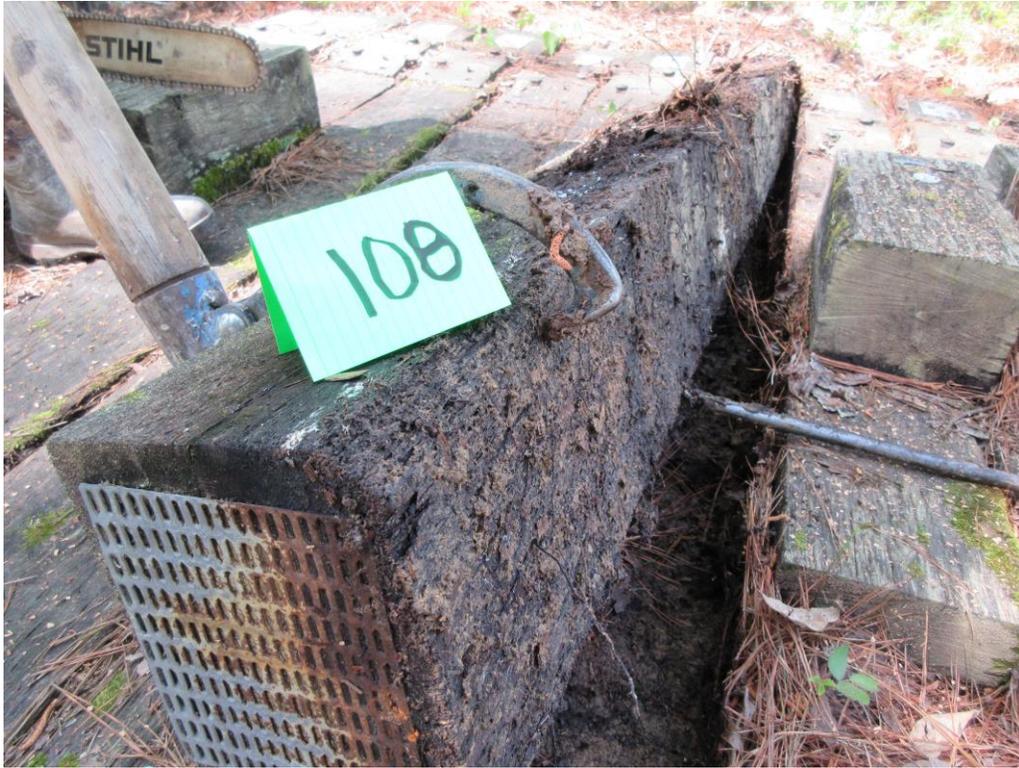
A21 – Tie #108 (Lonza/white oak) with light decay.

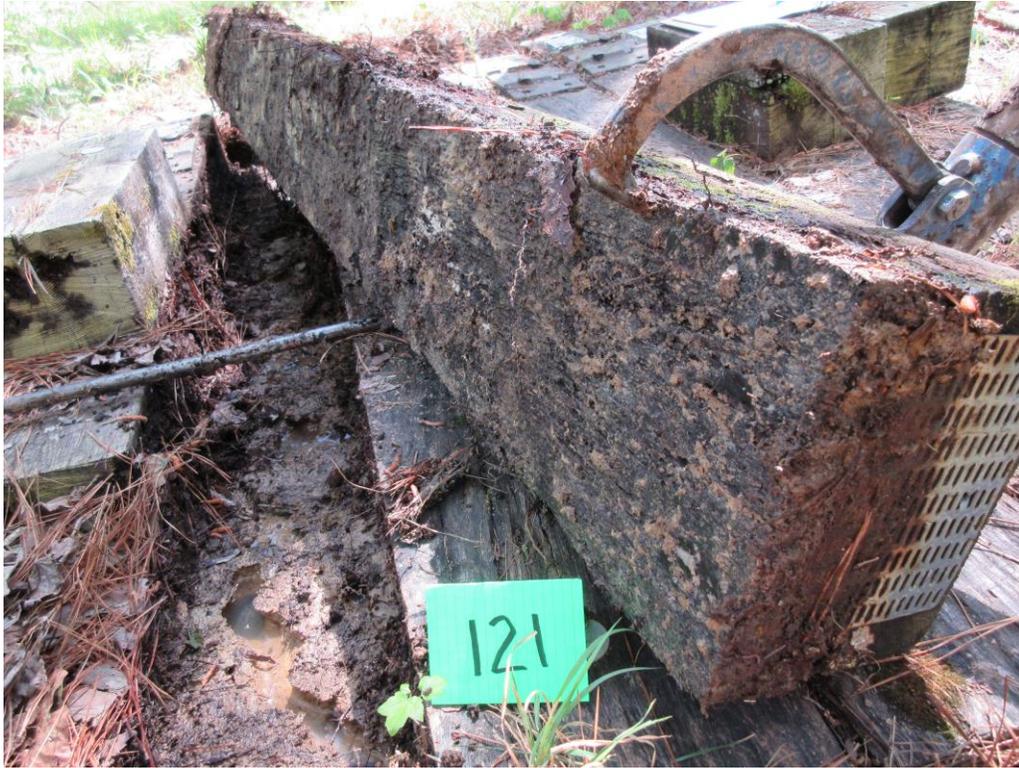
A23 - Tie #121 (Lonza/red oak) with light decay.

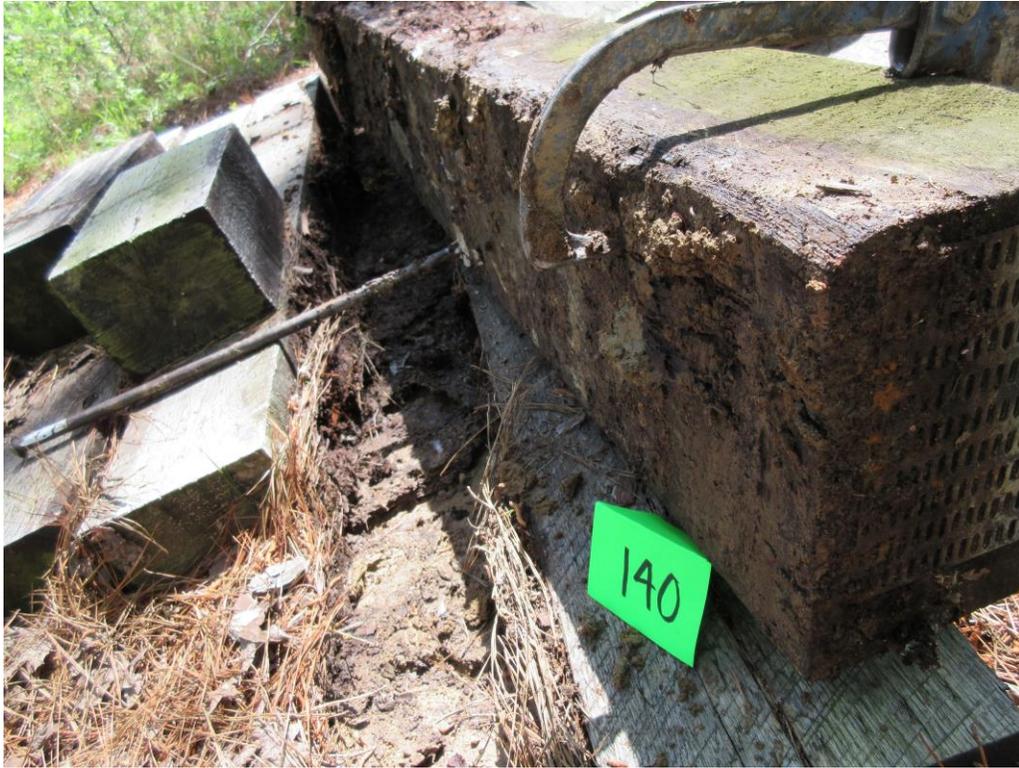
A27 - Tie #140 (KMG/white oak) with trace decay and termite damage.

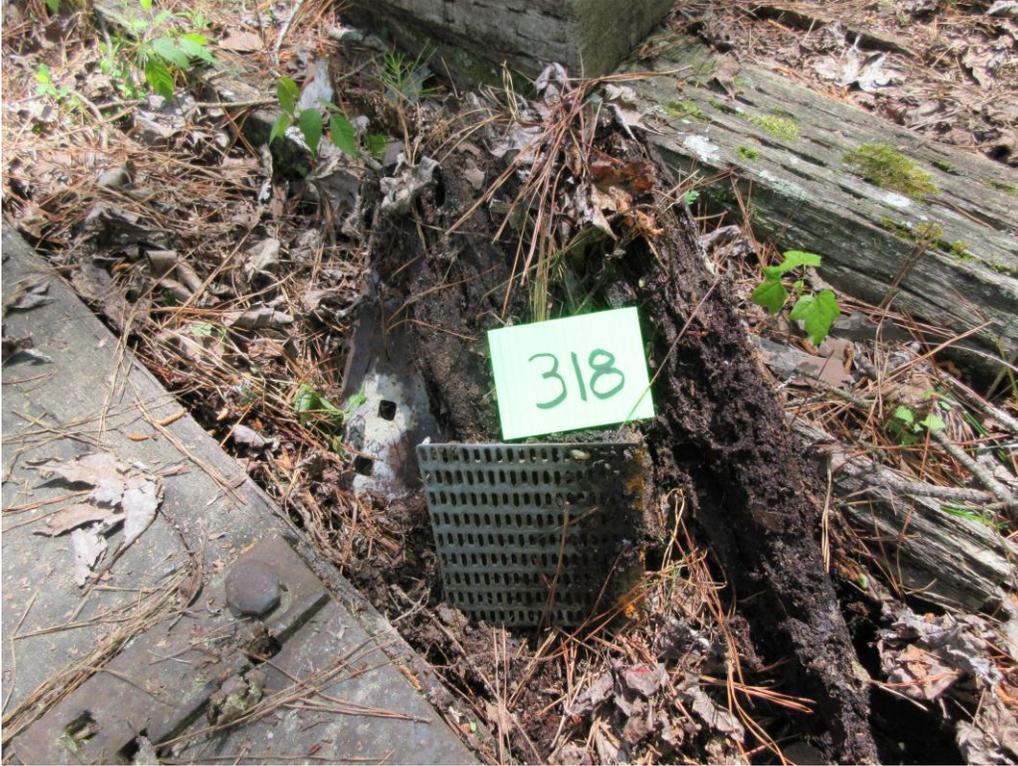
A29 - Tie #318 (untreated/red oak) completely deteriorated.

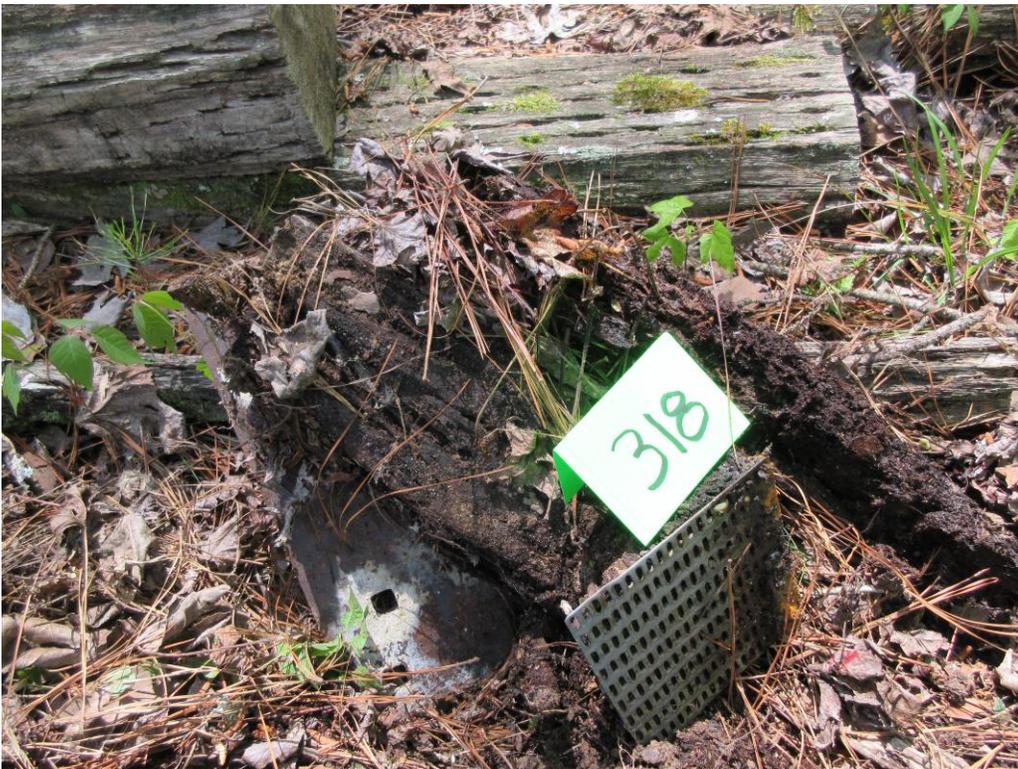
A30 - Tie #318 (untreated/red oak - closer view of failed tie/decay).

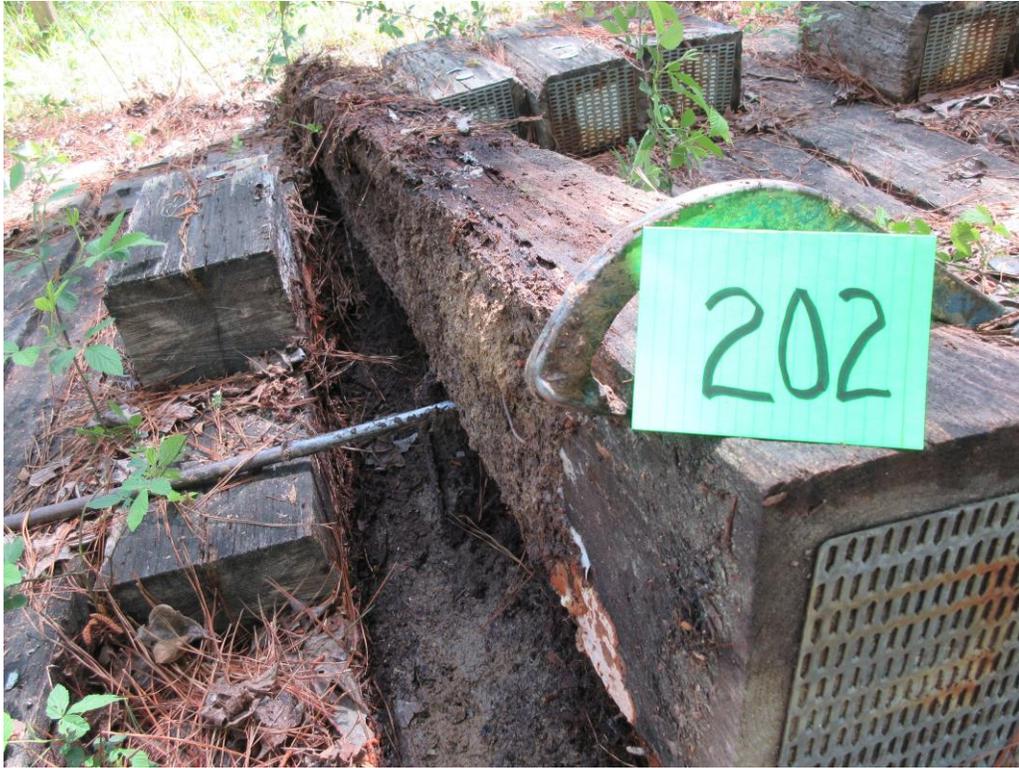
A39 - Tie #202 (Nisus/red oak/borate) decay & trace termite attack on bottom.

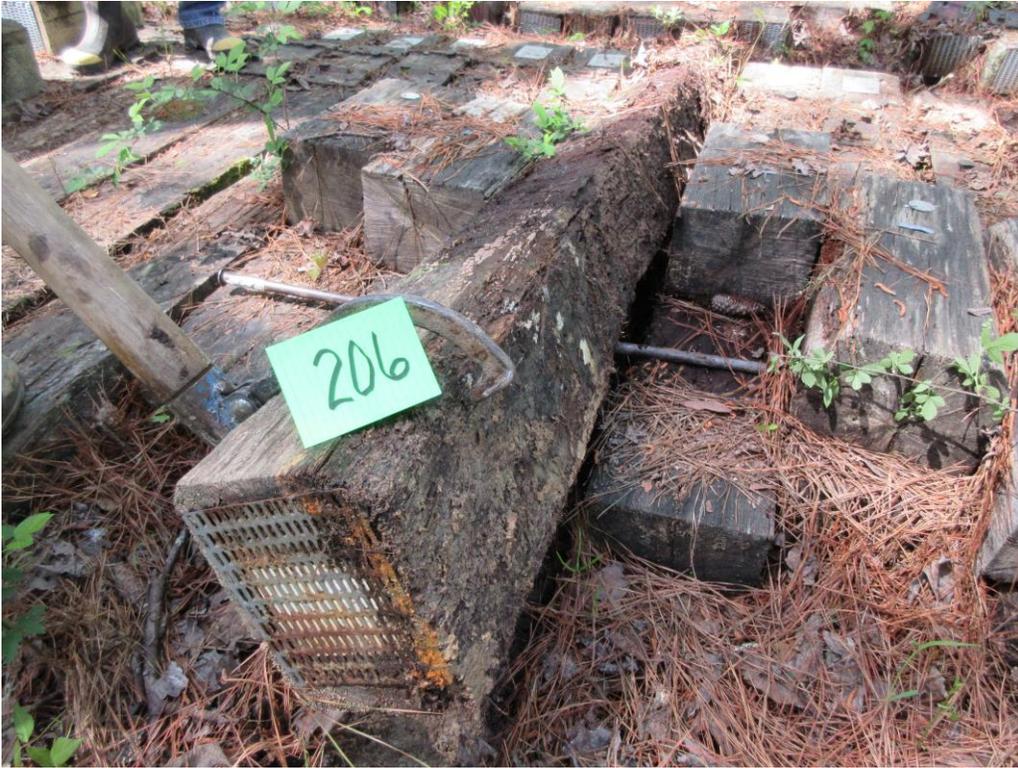
A41 - Tie #206 (Nisus/white oak/borate) with decay on bottom.

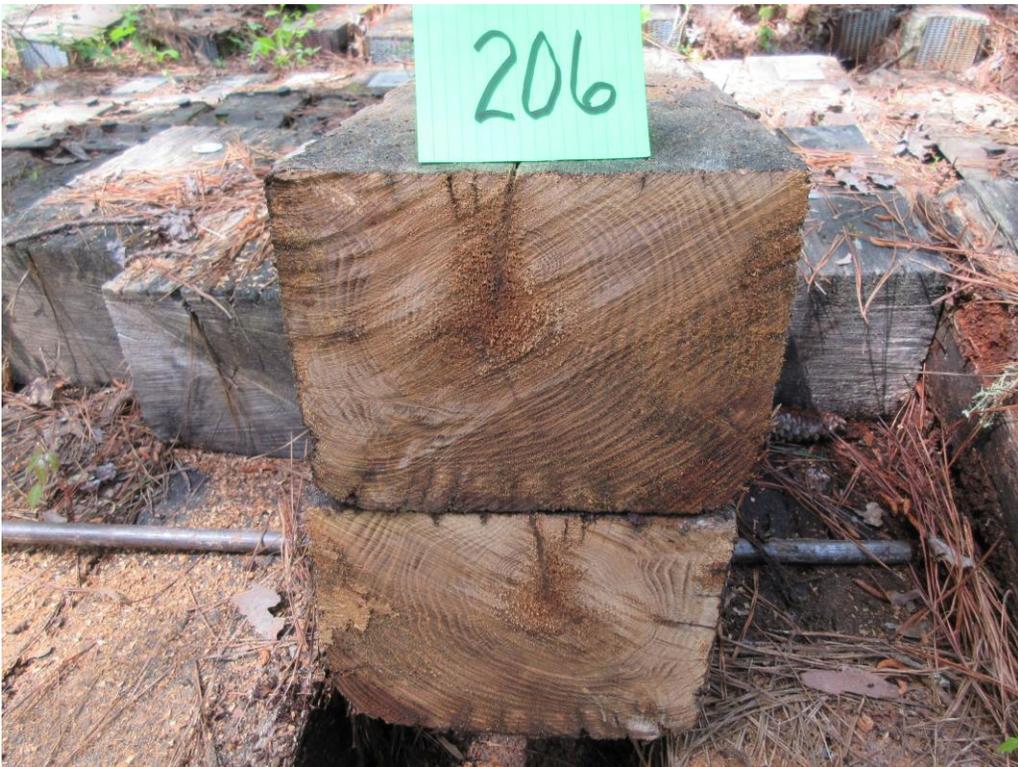
A42 - Tie #206 (Nisus/white oak/borate) with decay near checks & on bottom.

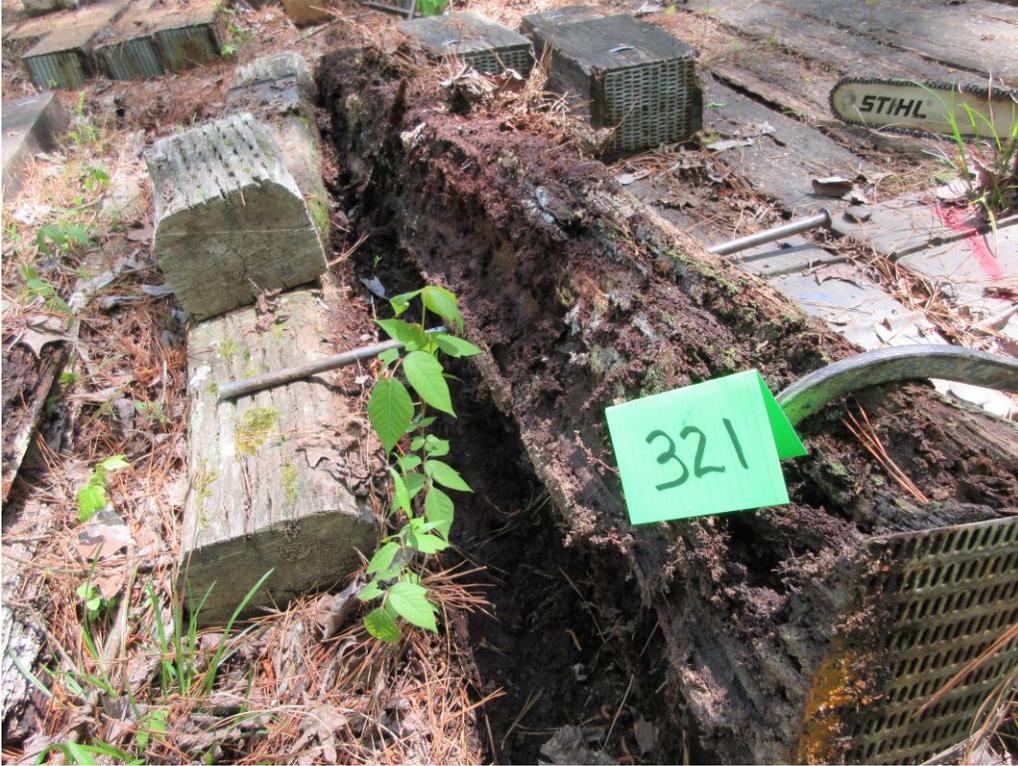
A45 - Tie #321 (untreated/white oak) with extensive decay and moderate termite damage.

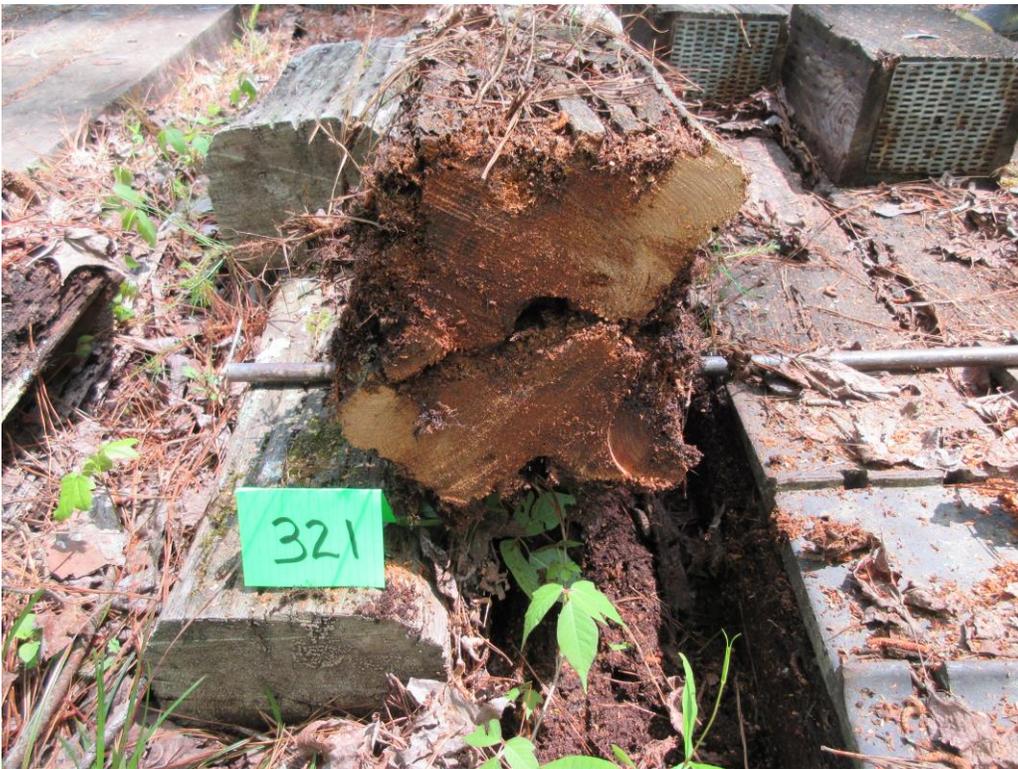
A46 - Tie #321 (untreated/white oak) which failed due to decay.

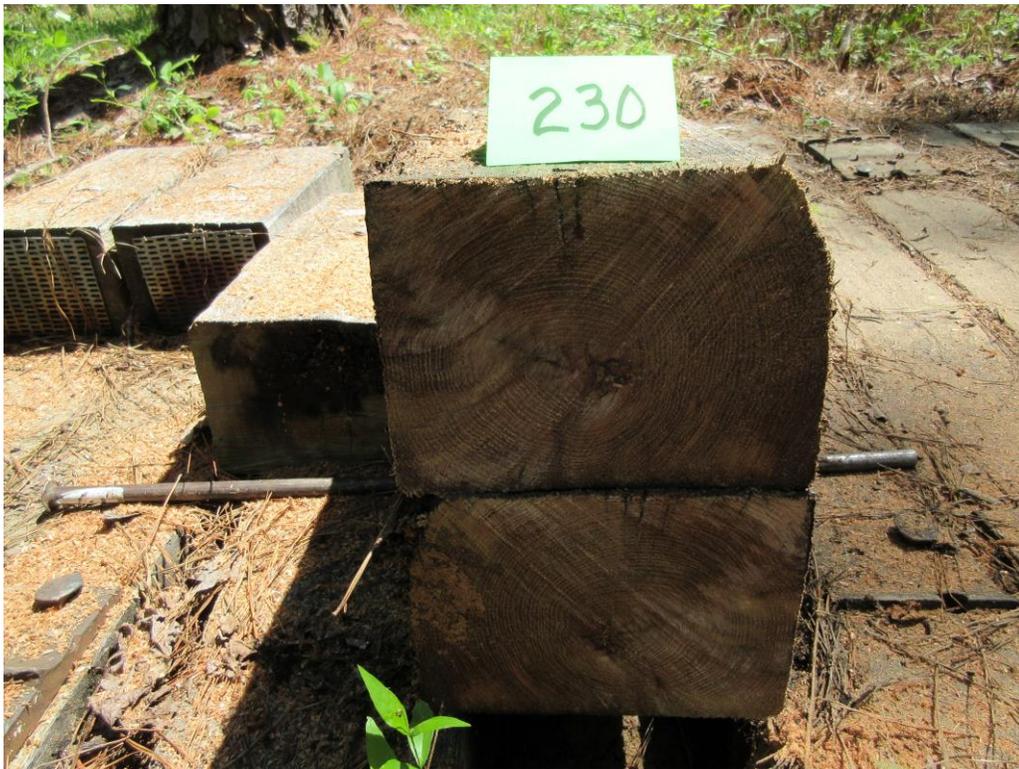
A48 - Tie #230 (Merichem/red oak/CuNap) with light internal decay.

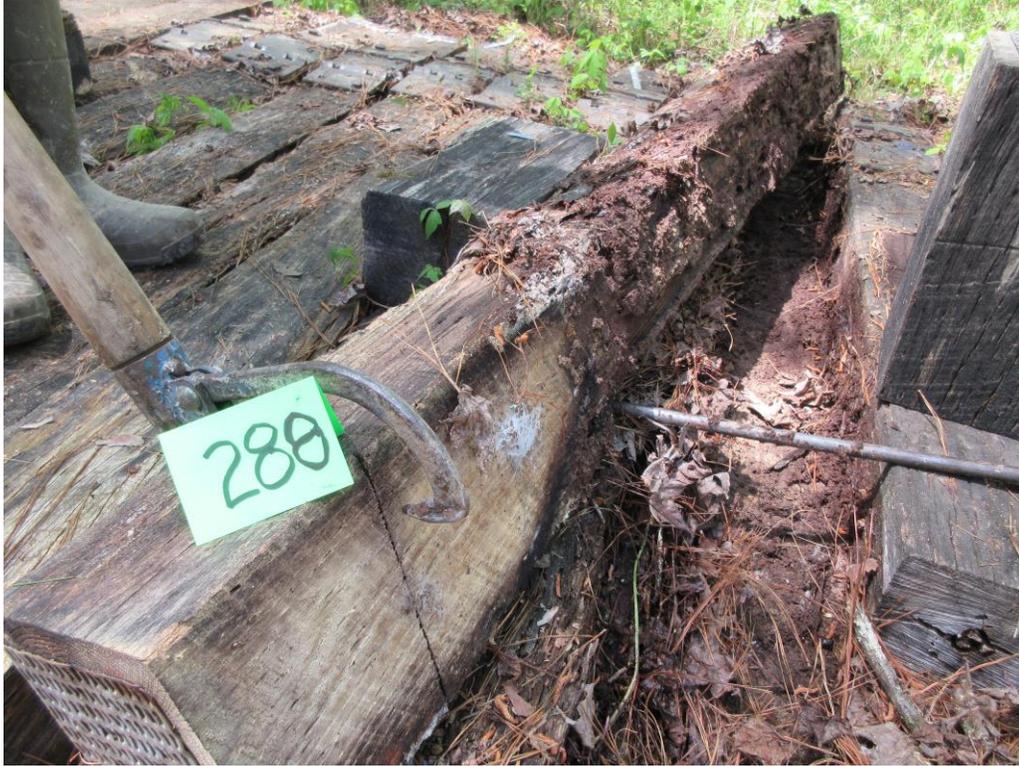
A61 - Tie #288 (Envirosafe/red oak) with moderate decay on bottom.

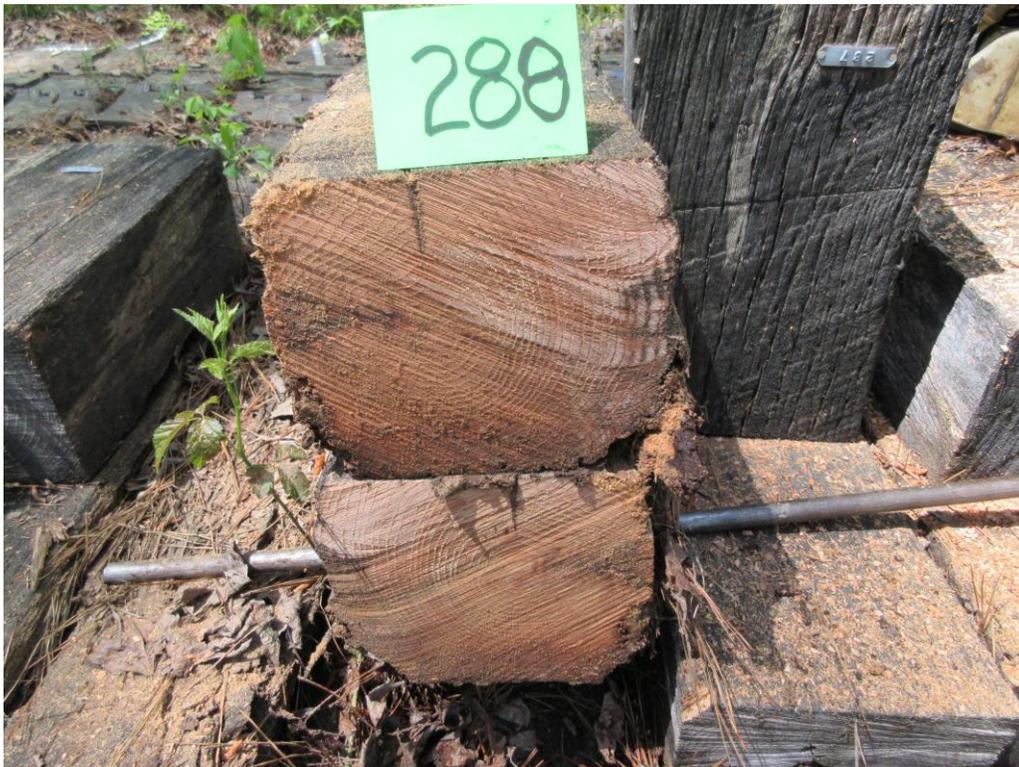
A62 - Tie #288 (Envirosafe/red oak) with decay on bottom & side faces.

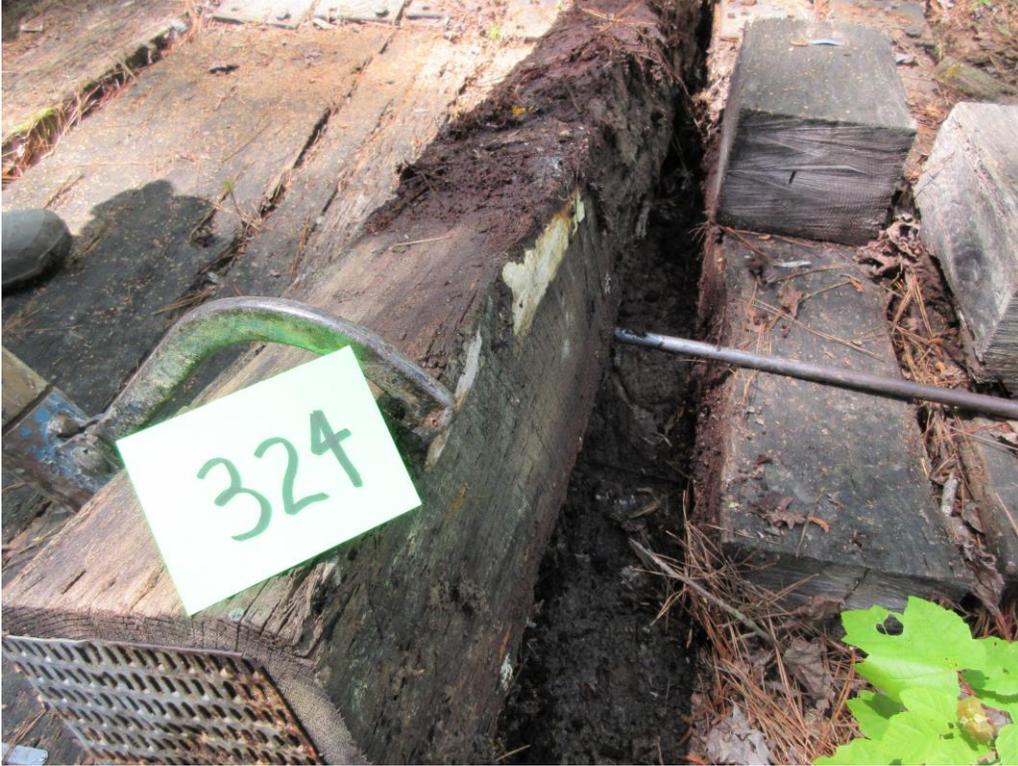
A63 - Tie #324 (Envirosafe/white oak) with decay on bottom.

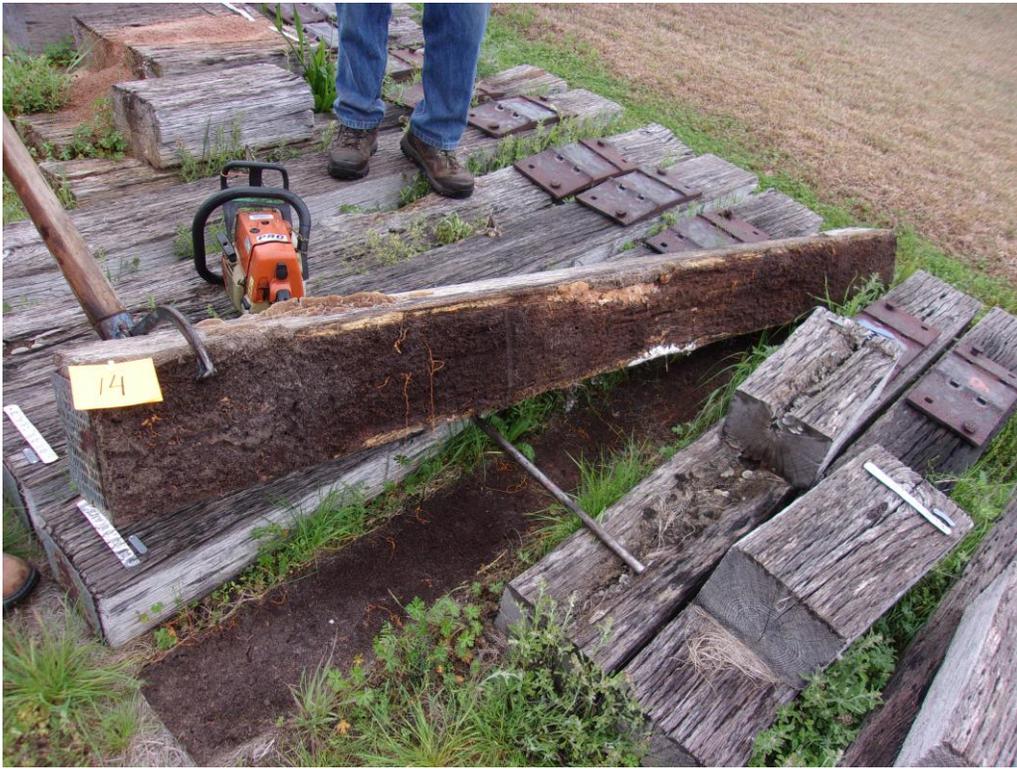
A67 – Tie #14 (Envirosafe/red oak) with decay.

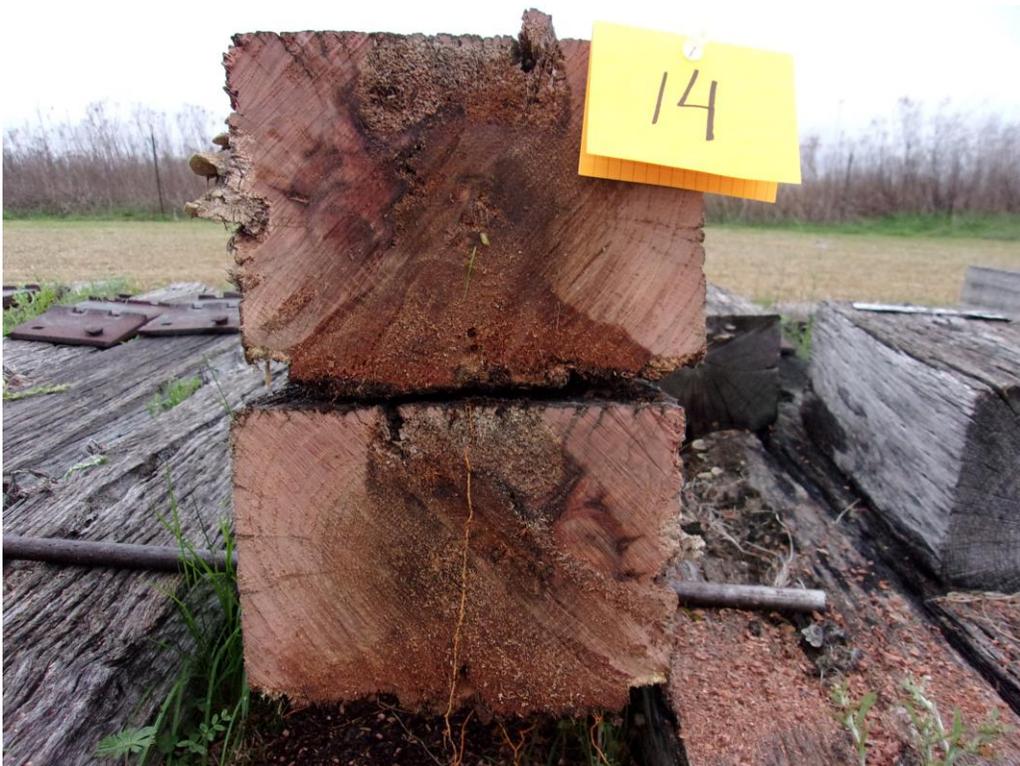
A68 – Tie #14 (Envirosafe/red oak) with decay.

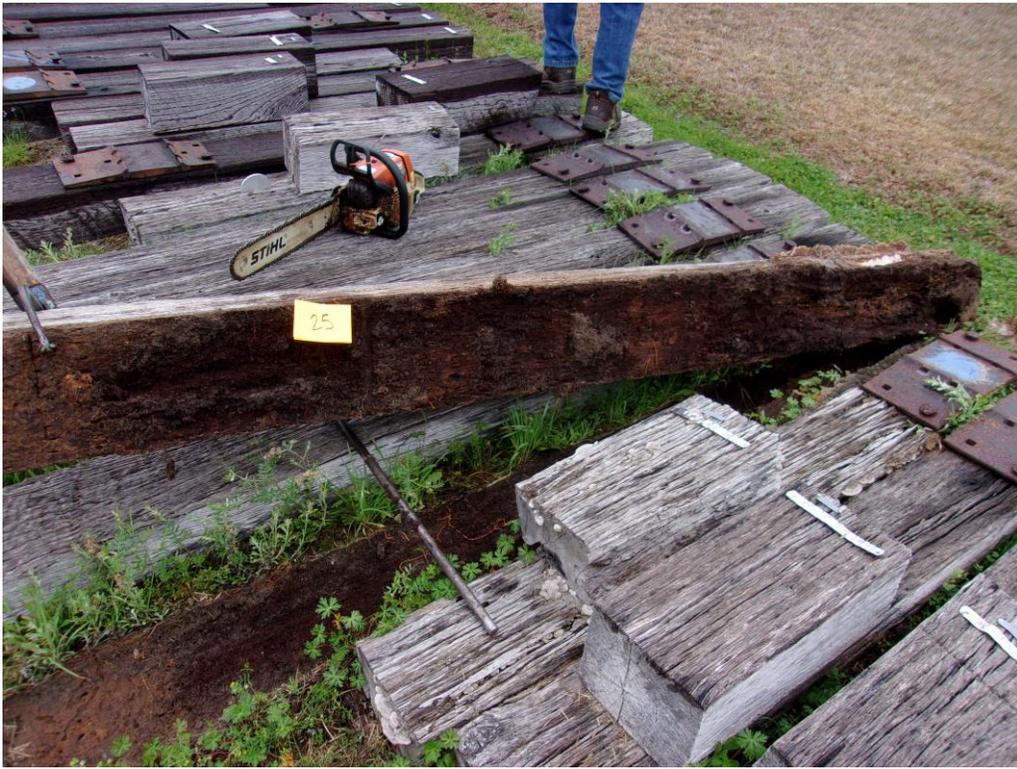
A69 – Tie #25 (Envirosafe/white oak) with decay and live termites.

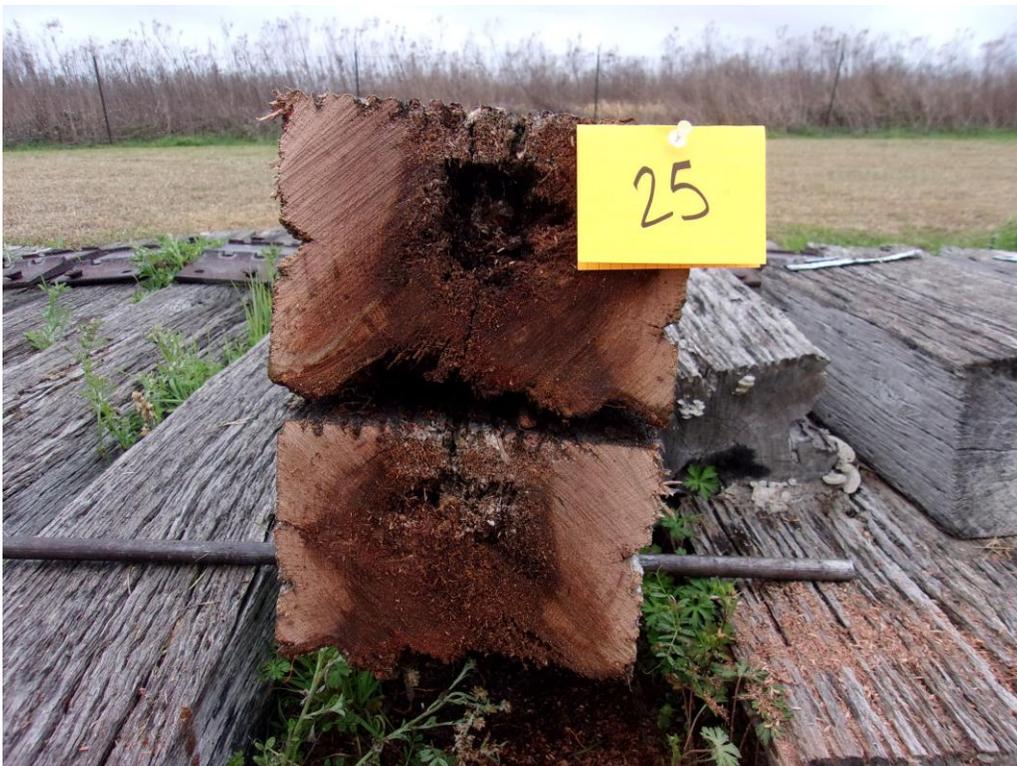
A70 – Tie #25 (Envirosafe/white oak) with extensive decay.

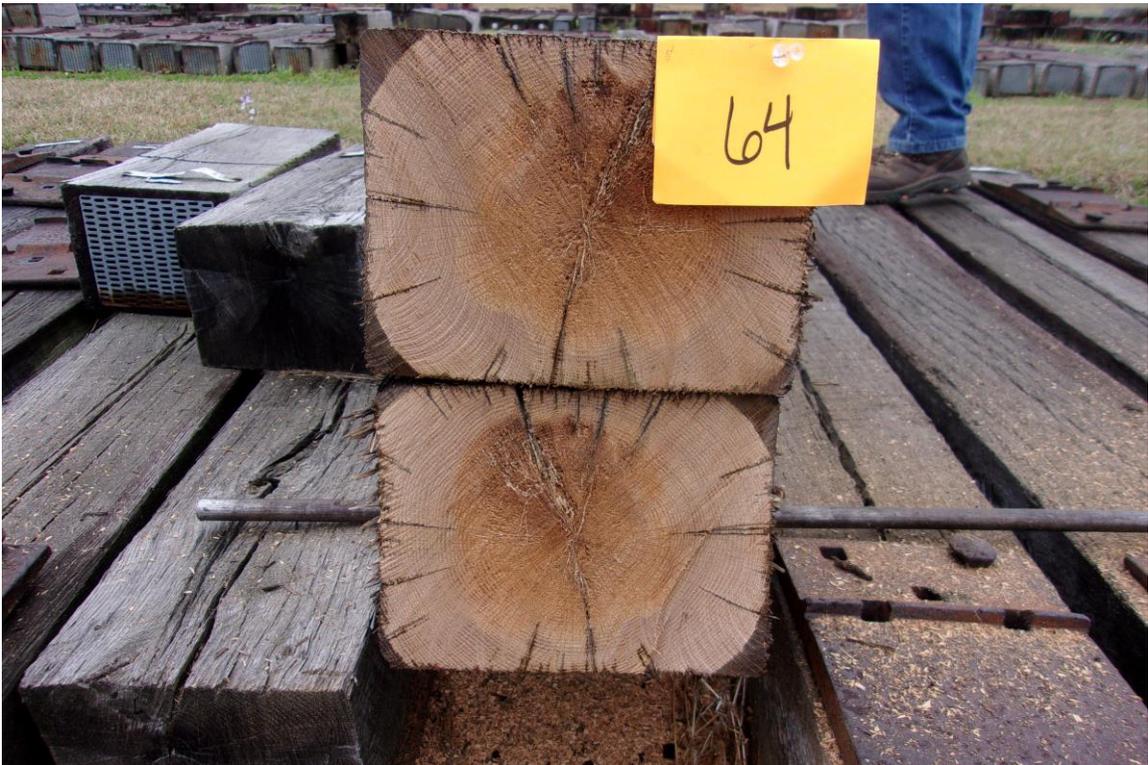
A78 - Tie #64 (Boatright/white oak/borate-creosote to refusal) with trace internal decay.

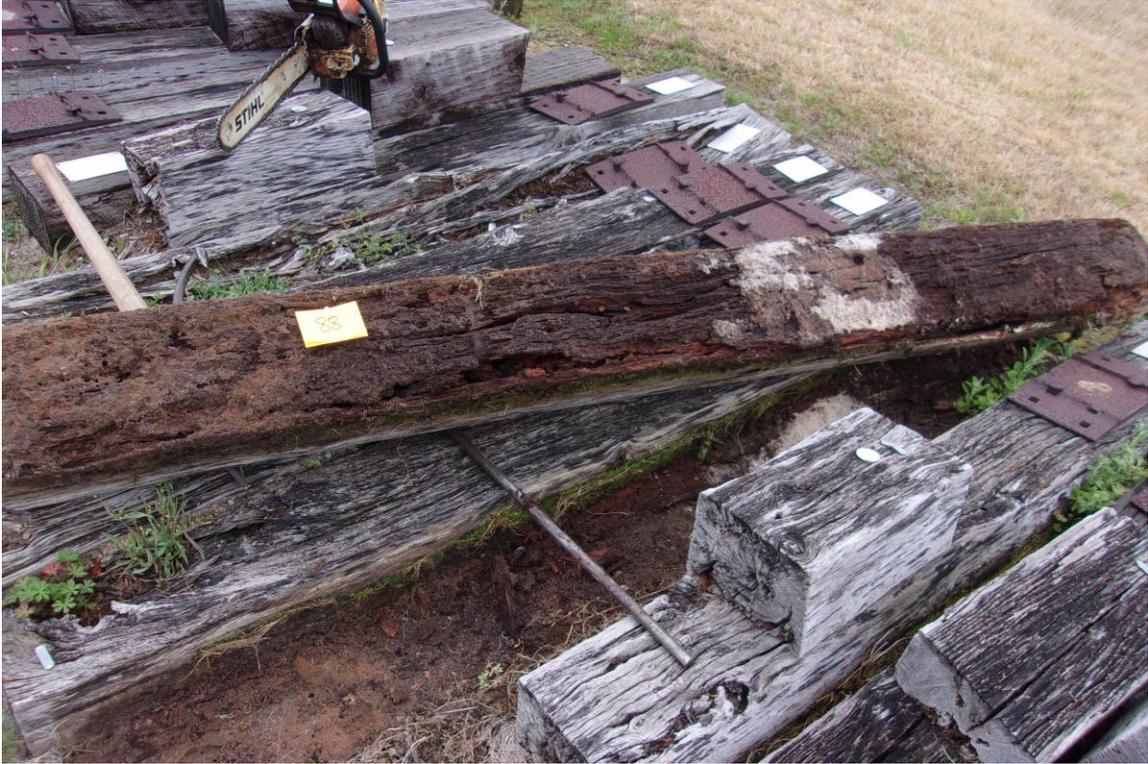
A81 - Tie #88 (Lonza/red oak) decay and termite damage on bottom.

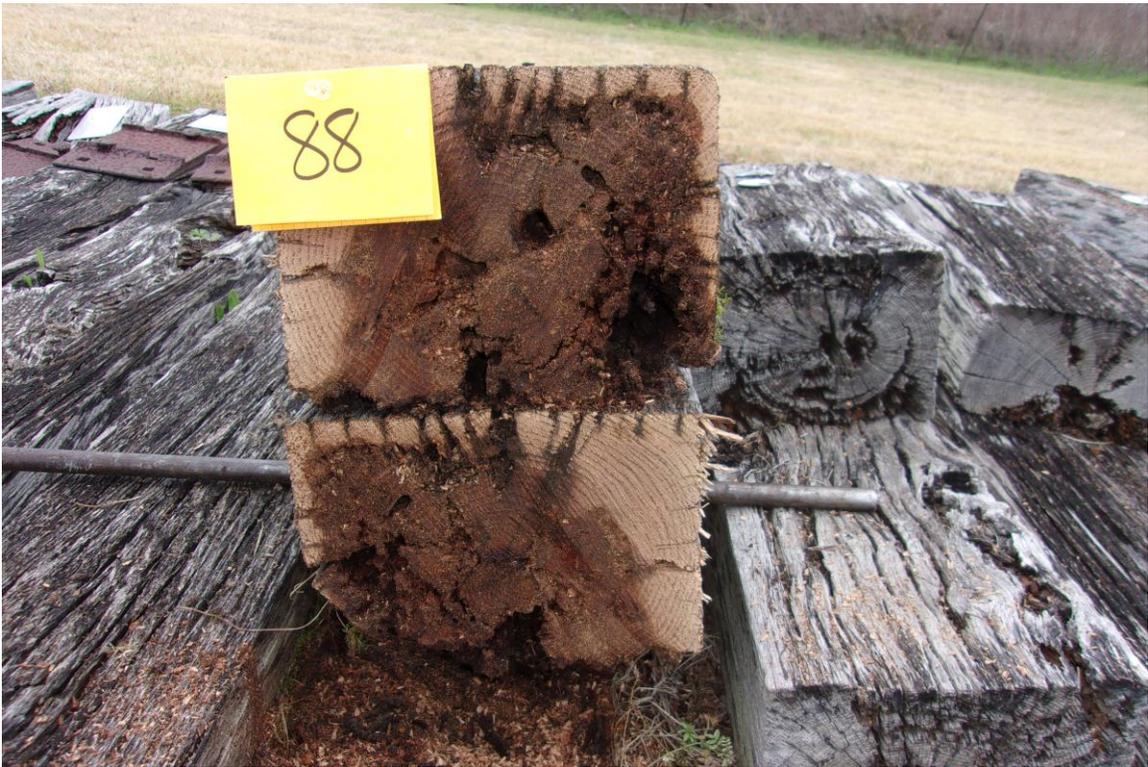
A82 - Tie #88 (Lonza/red oak) heavy decay evident in cross-section.

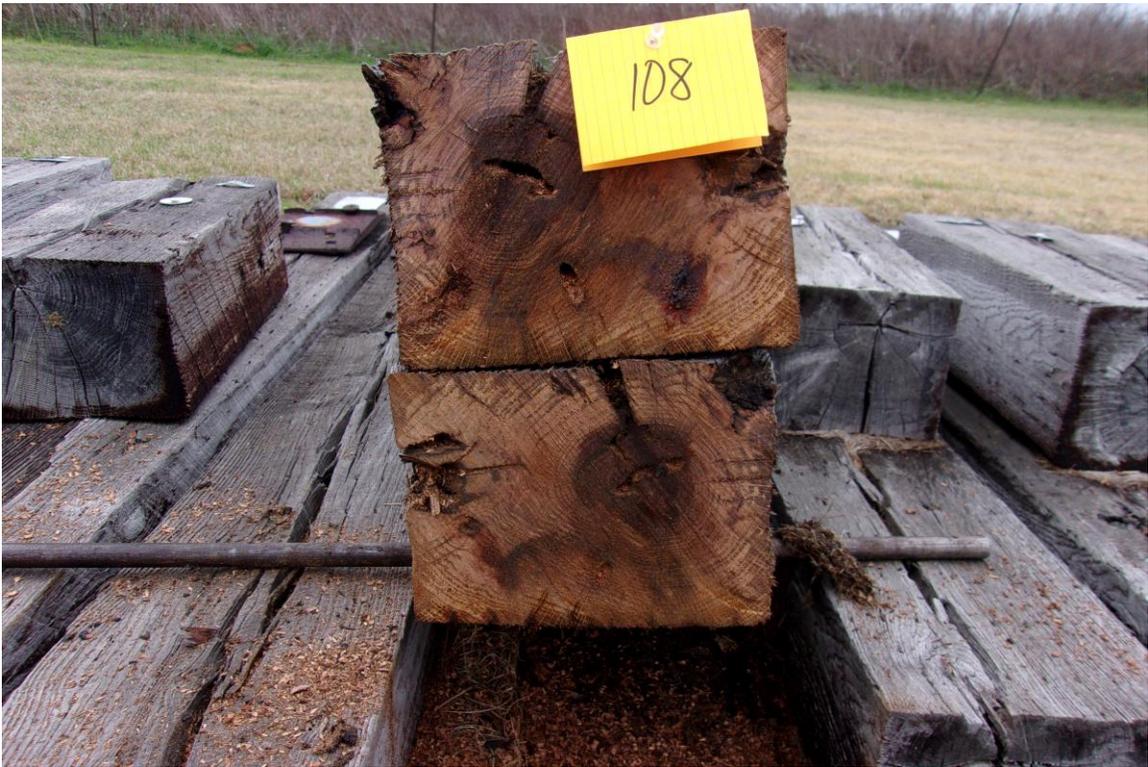
A86 - Tie #108 (Nisus/red oak/borate/oil B) with pretreatment internal damage.
