**MISSISSIPPI STATE
UNIVERSITY™**

**FOREST AND WILDLIFE RESEARCH CENTER
DEPARTMENT of SUSTAINABLE BIOPRODUCTS**

Fourteenth Annual Evaluation of MSU/RTA Alternative Preservative Study

August 22, 2022

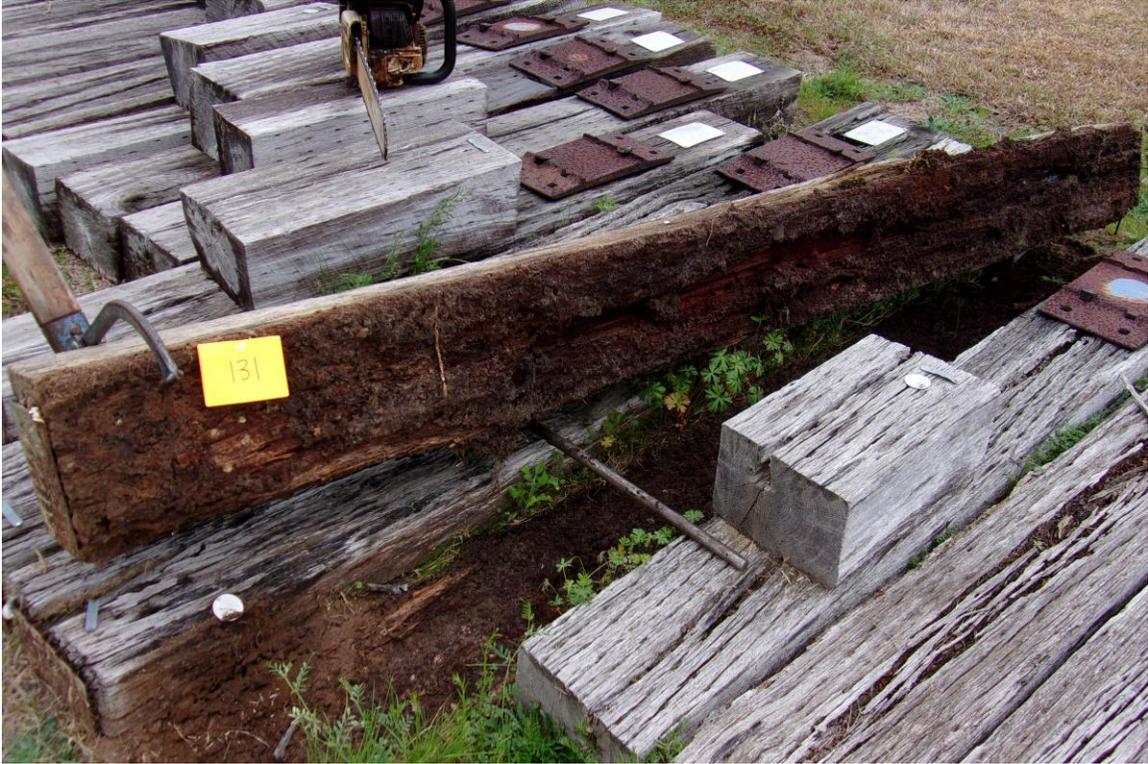
A89 – Tie #131 (Nisus/red oak/borate) with decay on top & bottom.

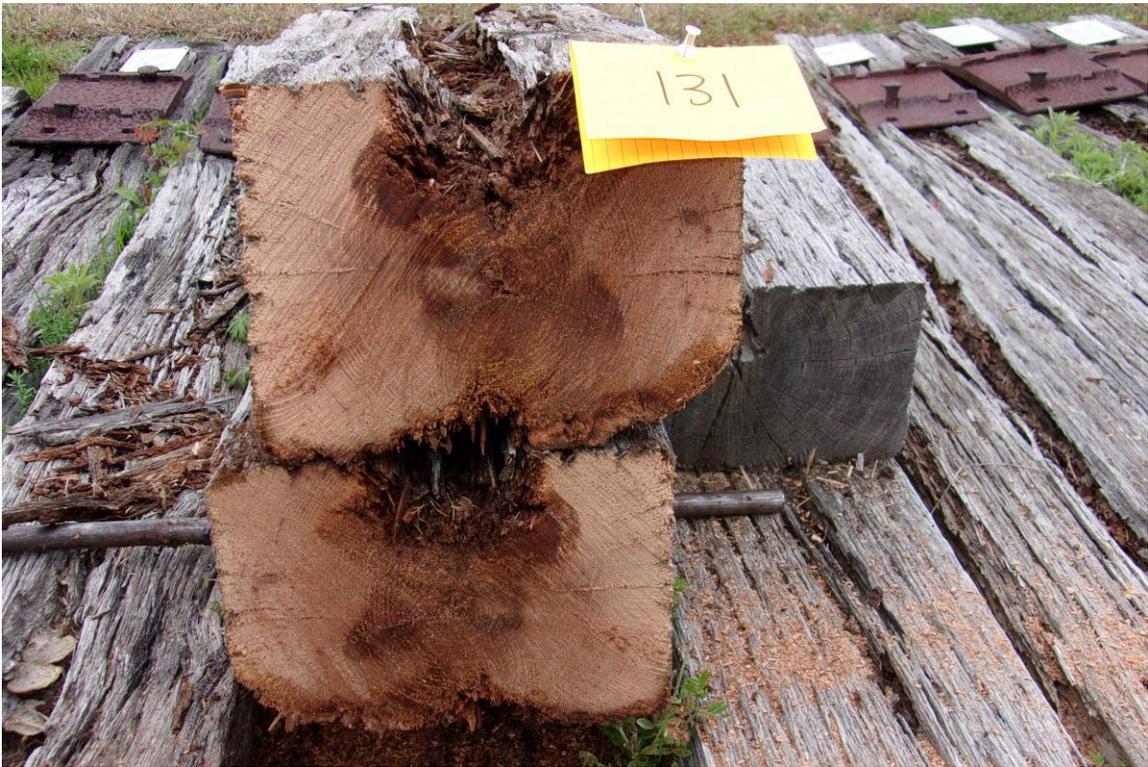
A90 - Tie #131 (Nisus/red oak/borate) with decay.

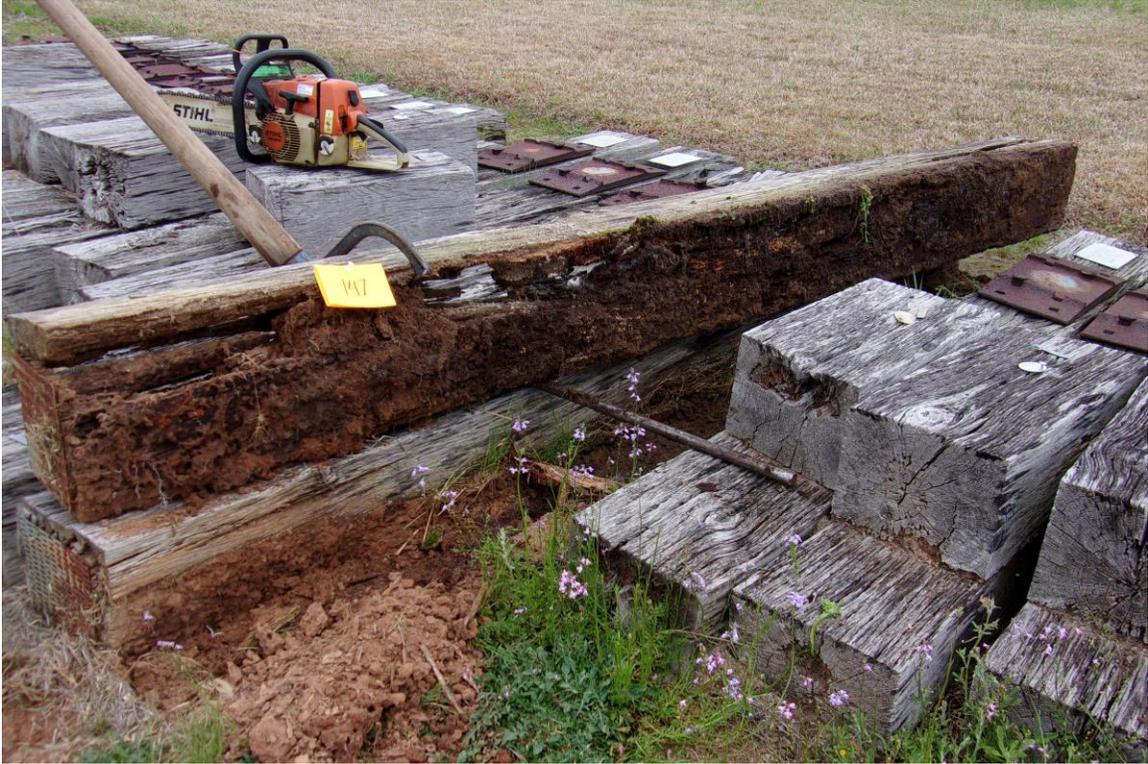
A93 - Tie #147 (Lonza/white oak) with decay and active Formosan termites.

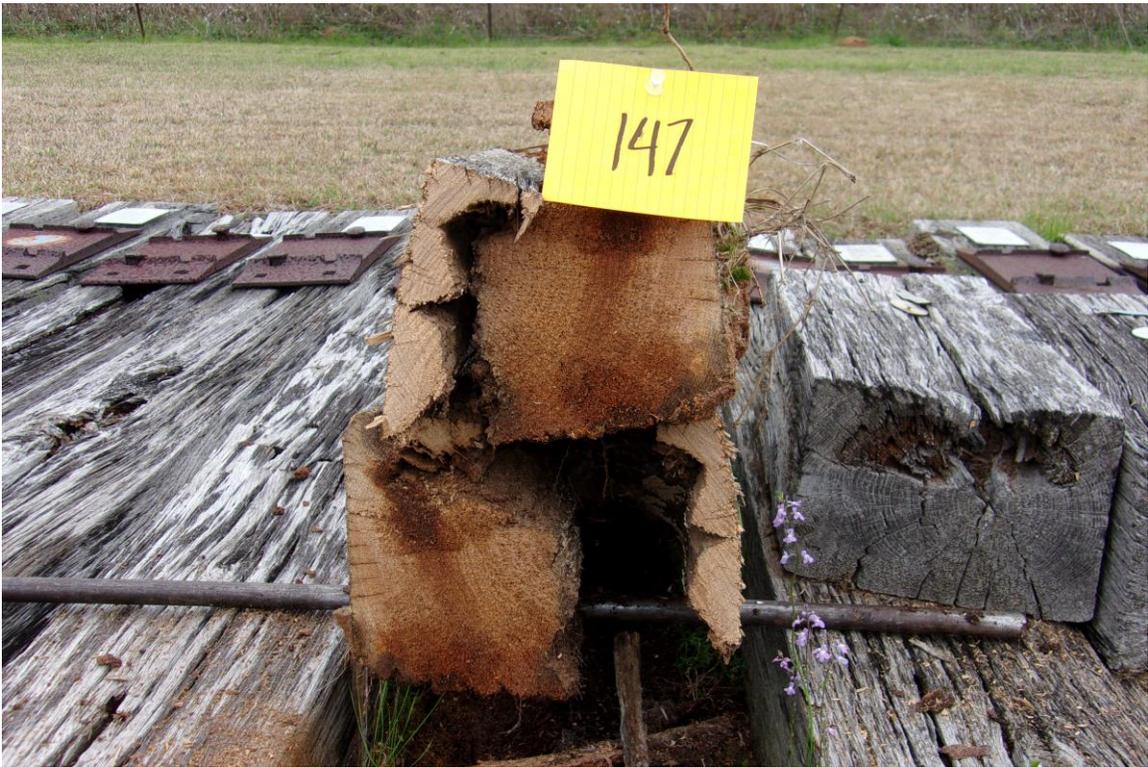
A94 - Tie #147 (Lonza/white oak) which failed due to decay.

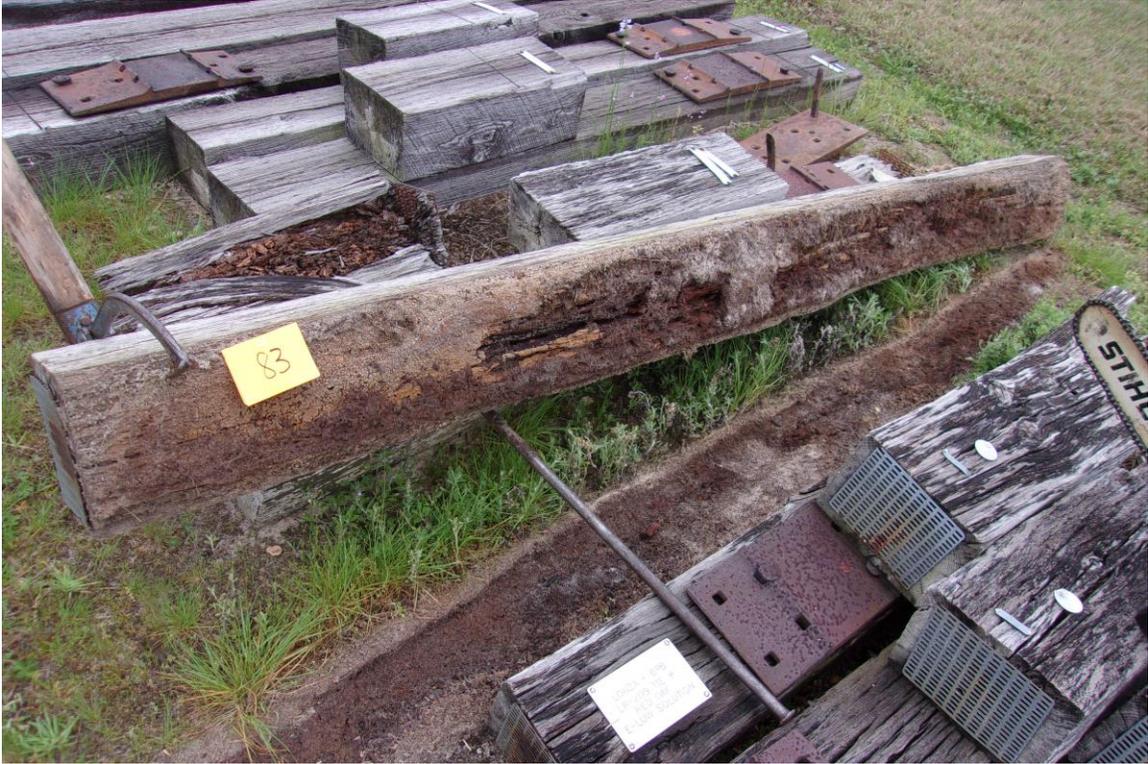
A95 - Tie #83 (untreated/White oak) with heavy decay.

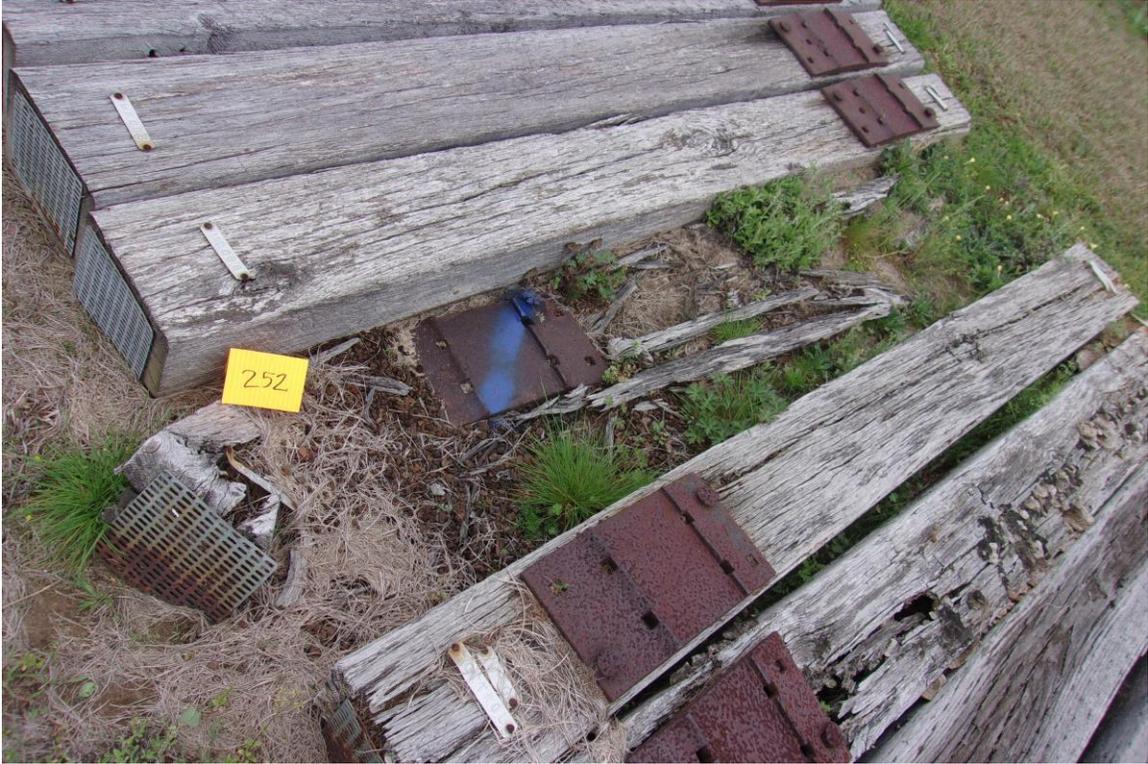
A97 - Tie #252 (untreated/red oak) failed due to decay

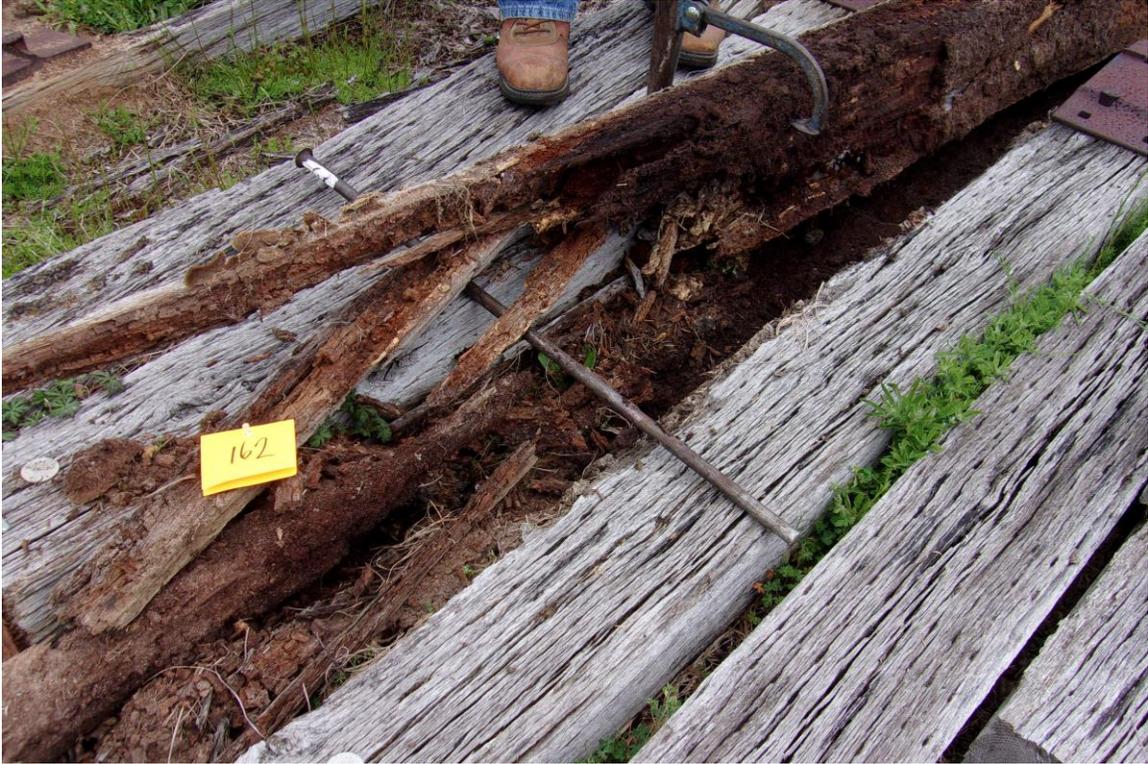
A101 - Tie #162 (Nisus/white oak/boron) failed due to decay.

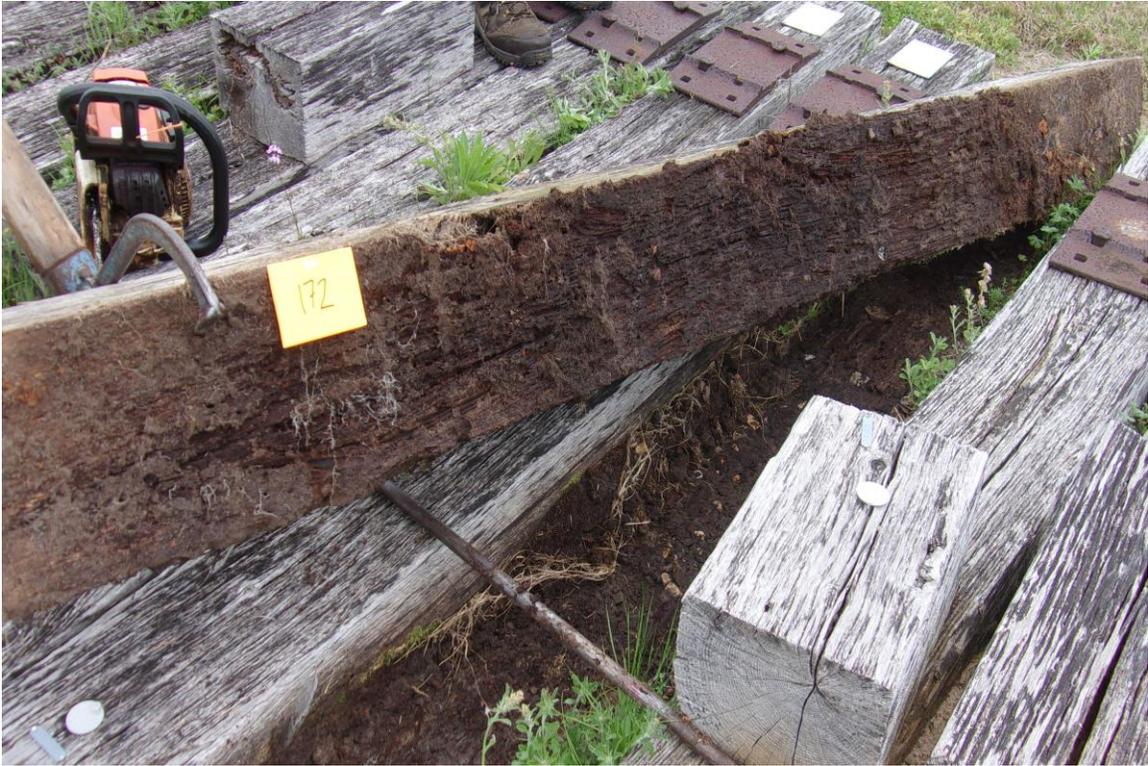
A103 – Tie #172 (Lonza/red oak) with decay and termite damage.

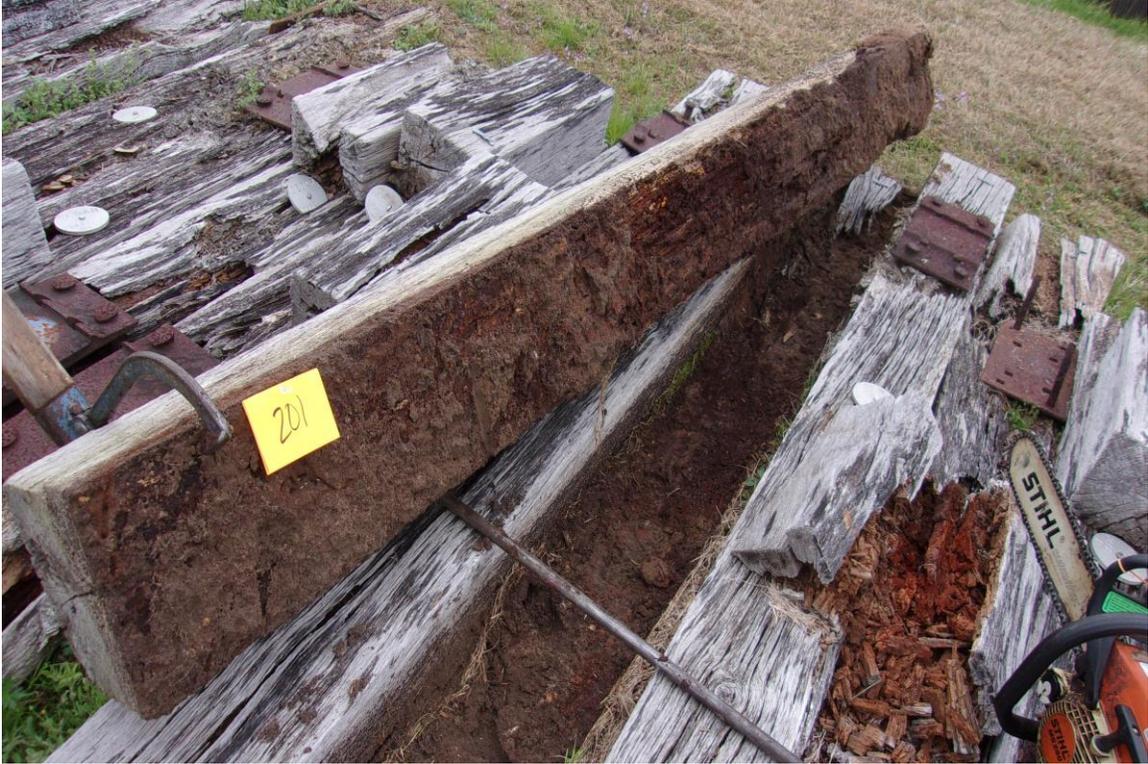
A105 - Tie #201 (Cedarcide/white oak) decay & termite damage.

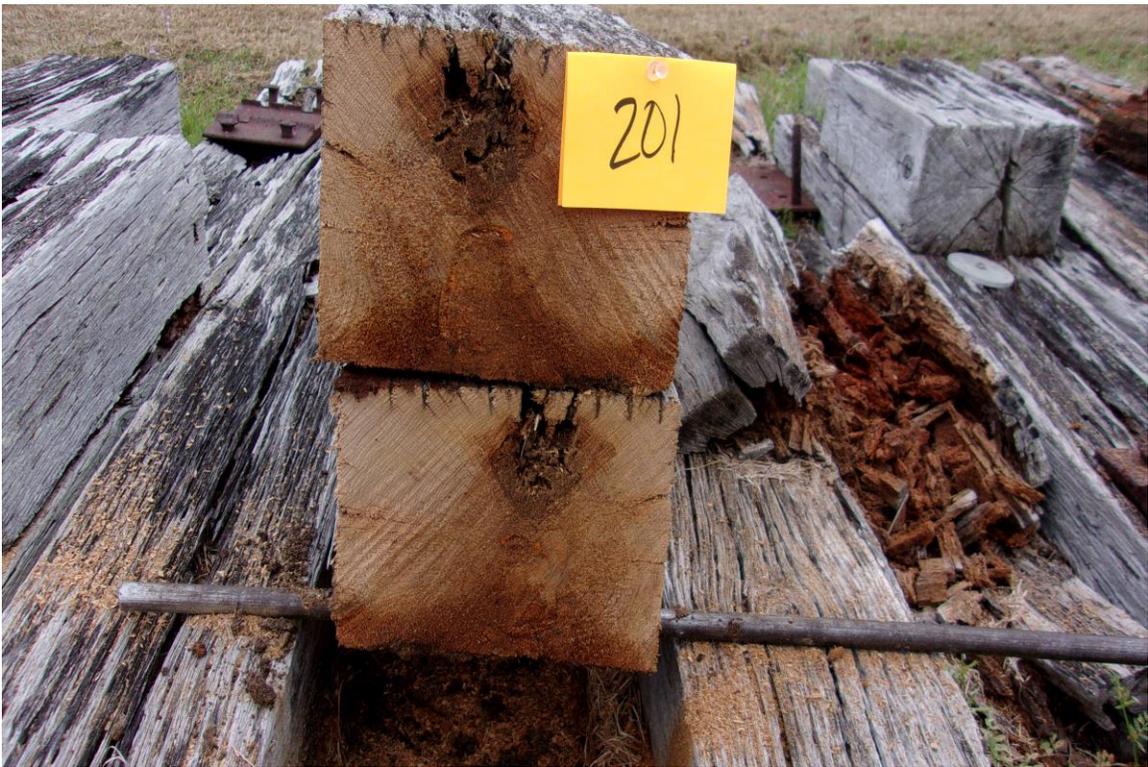
A106 - Tie #201 (Cedarcide/white oak) with internal decay.

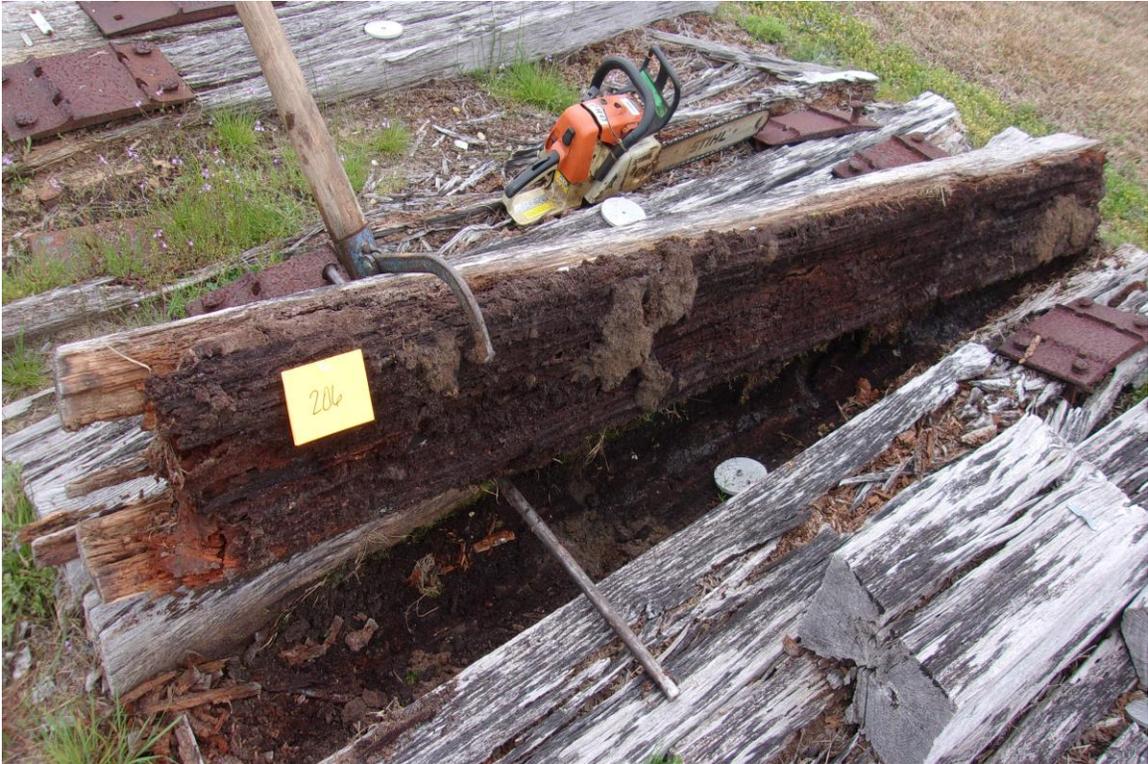
A107 - Tie #206 (Cedarcide/red oak) with extensive decay and moderate termite damage.

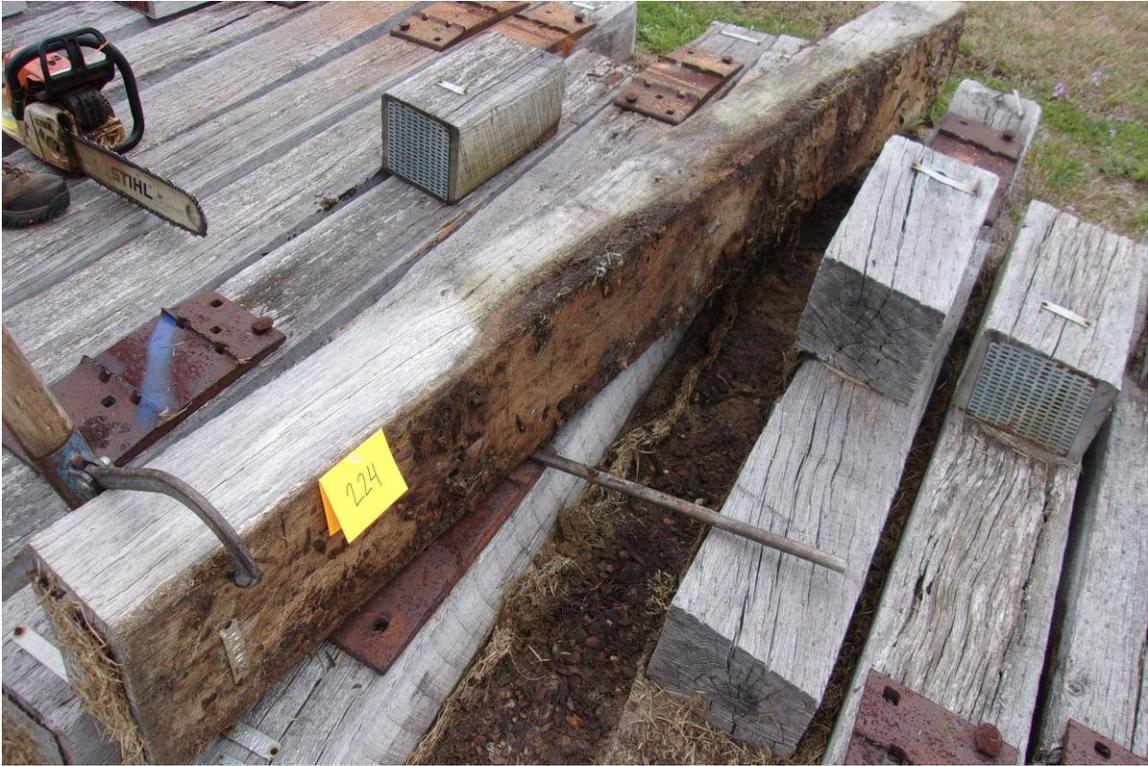
A111 - Tie #224 (Merichem/red oak/CuNap) with trace decay.

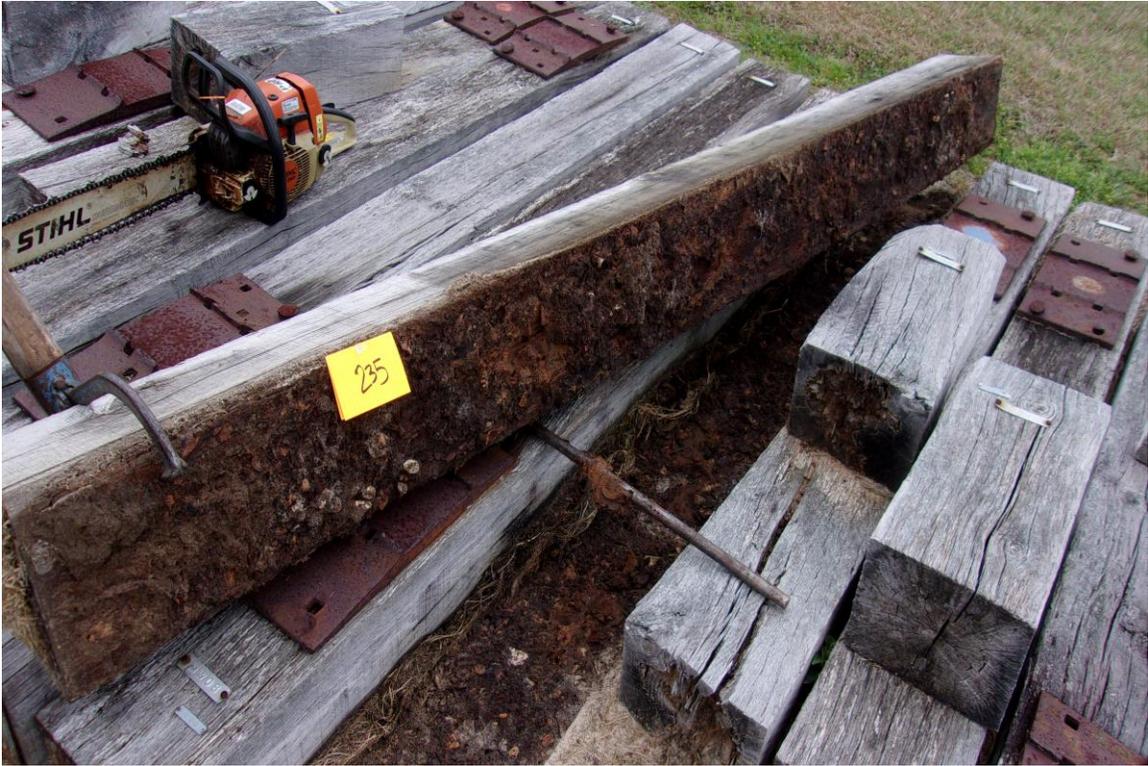
A113 - Tie #235 (Merichem/white oak/CuNap) with trace decay & termite damage.

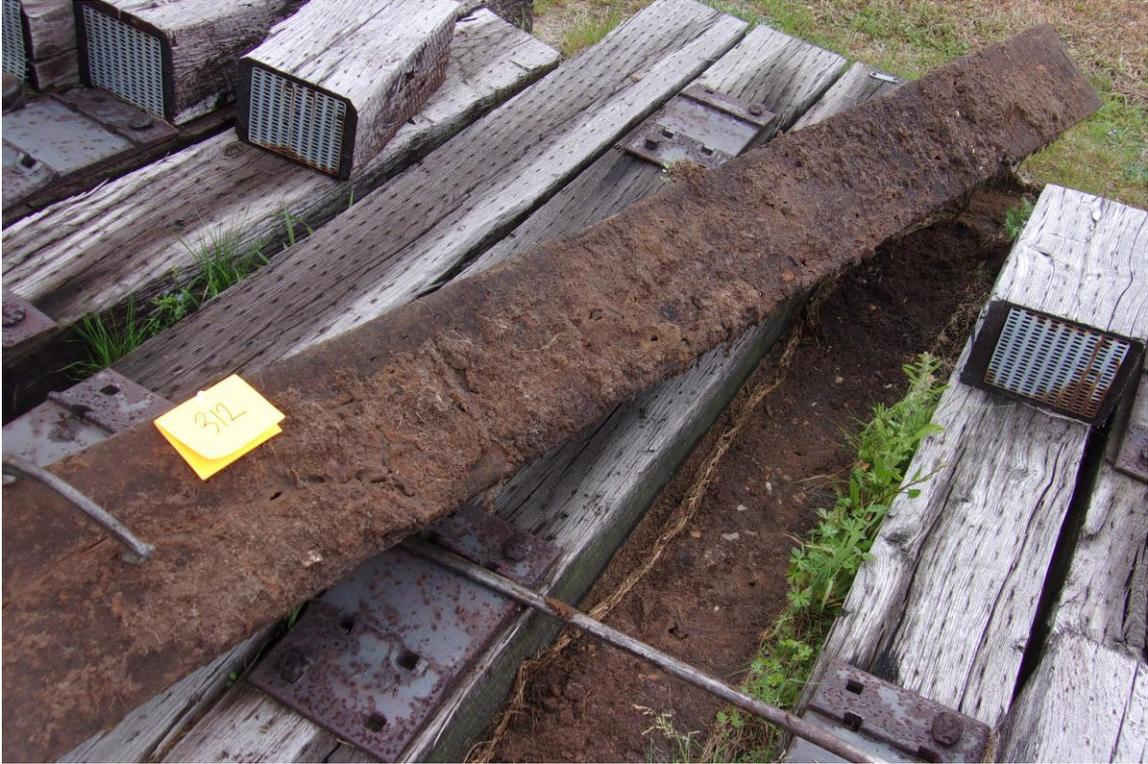
A125 - Tie #312 (Koppers/white oak/creosote petroleum solution) with light decay & Formosan termite damage.

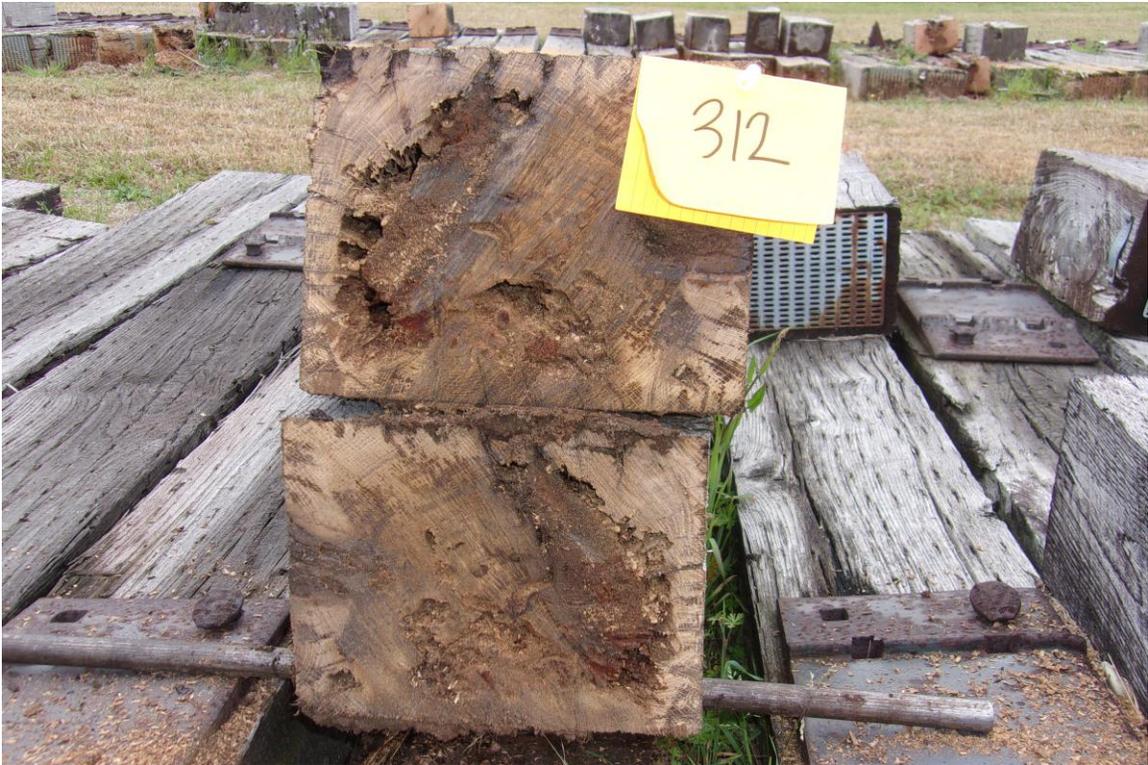
A126 - Tie #312 (Koppers/white oak/creosote petroleum solution) with internal decay.
