**FOREST AND WILDLIFE RESEARCH CENTER**

**DEPARTMENT OF SUSTAINABLE BIOPRODUCTS**

**Third Annual Evaluation of Phase II MSU/RTA Alternative Preservative Study**

**June 30, 2015**

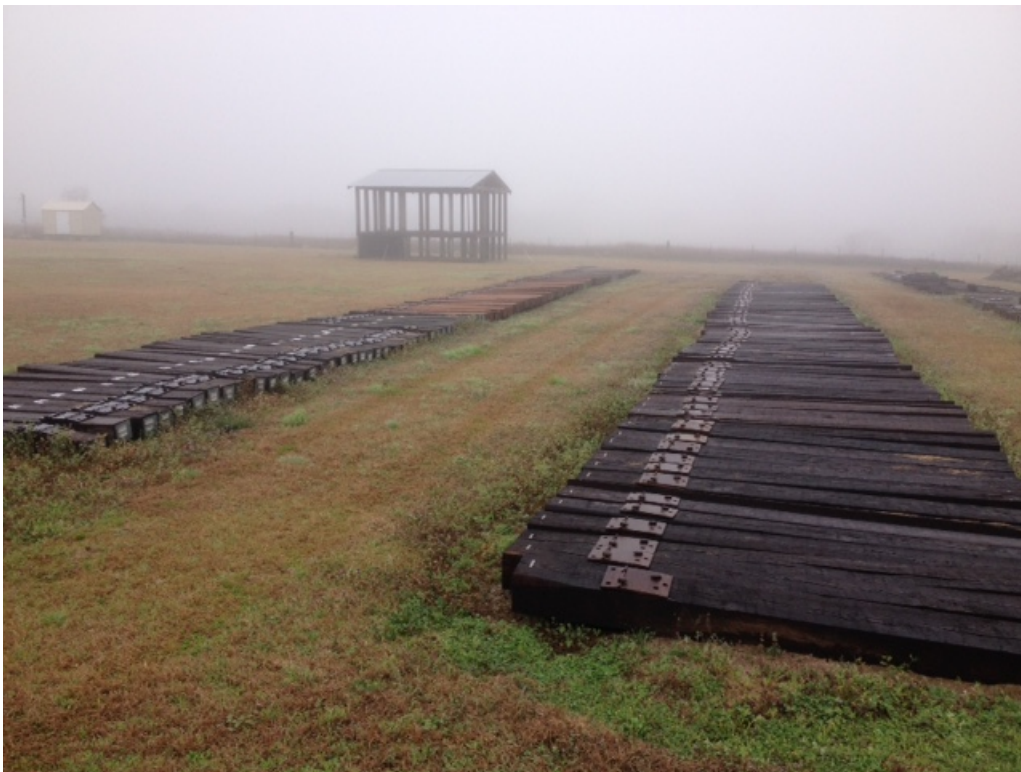
**Figure 1** - An overall view of exposure Site 2 illustrating the conditions at the time of inspection.

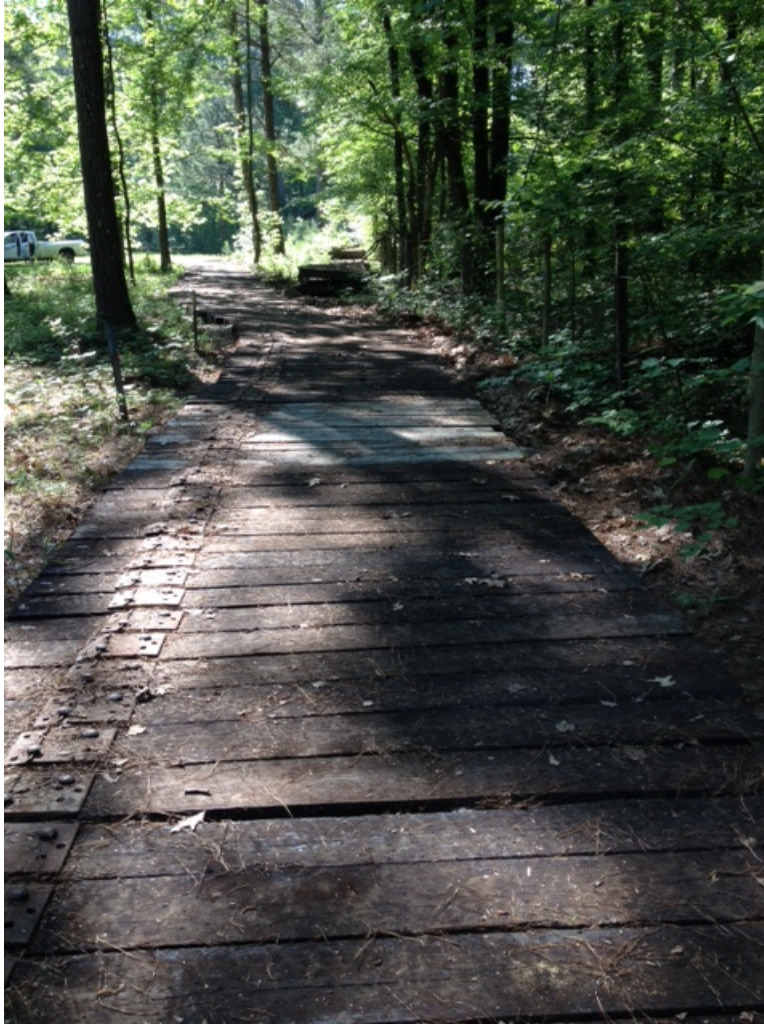
**Figure 2** - A general photograph demonstrating the exposure conditions at Site 1 at the time of inspection.

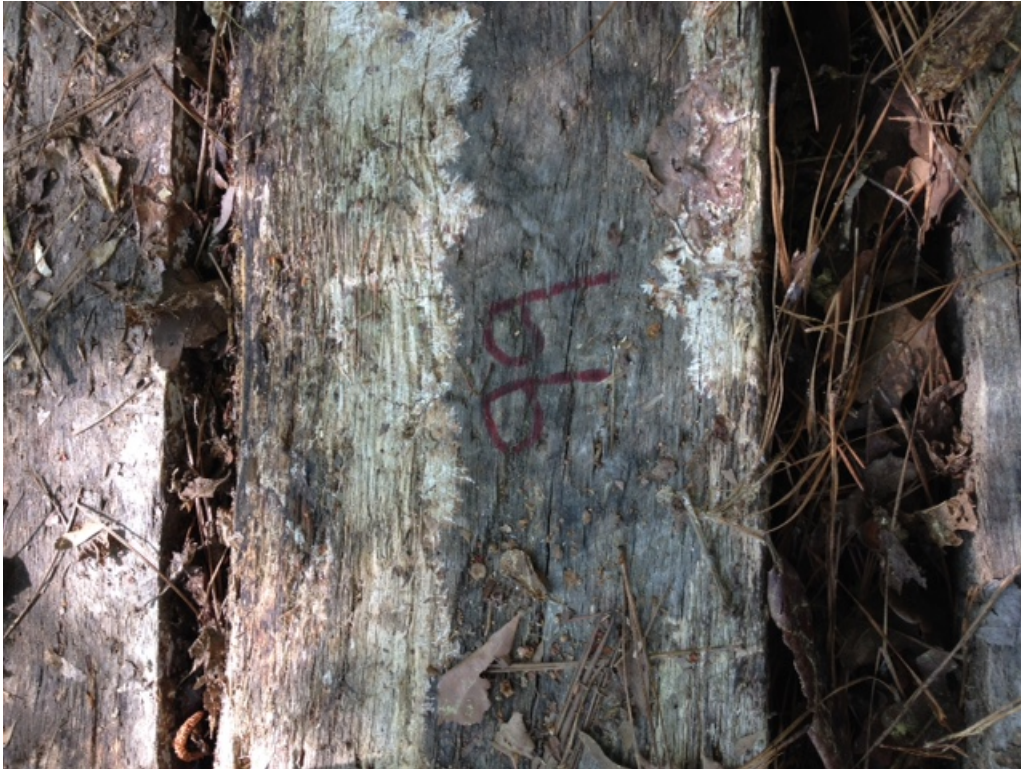
**Figure 3 - Tie #99 (unt. white oak) showing trace amounts of decay.**

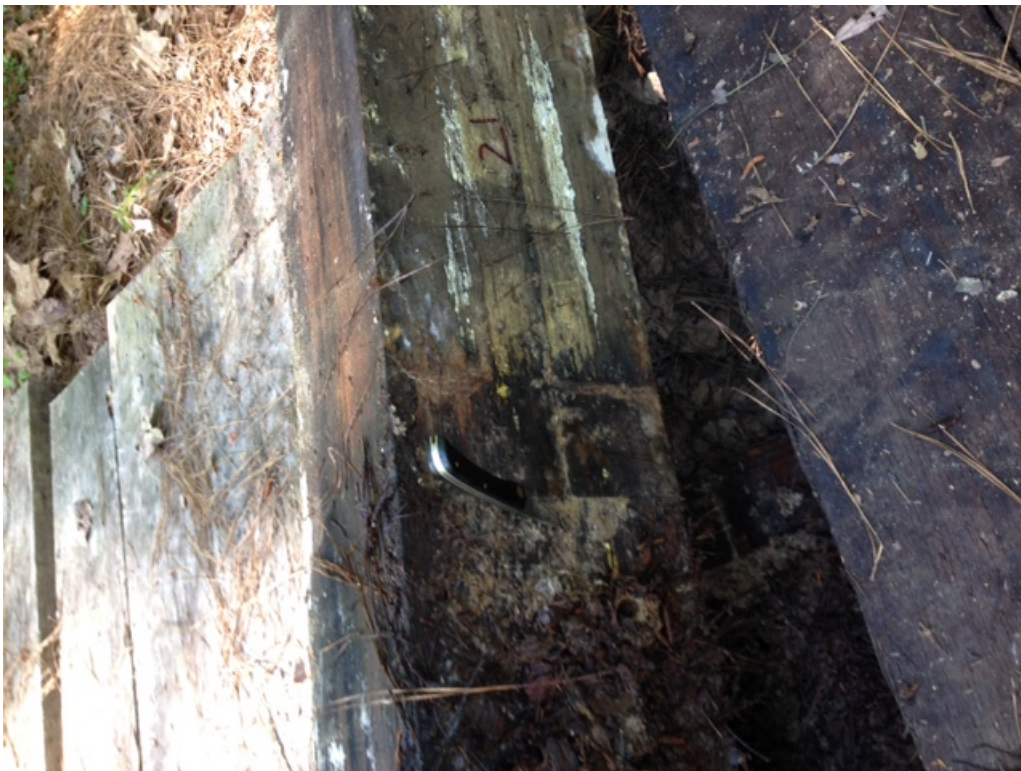
**Figure 4 – Tie #21 (unt. red oak) tie with light decay.**

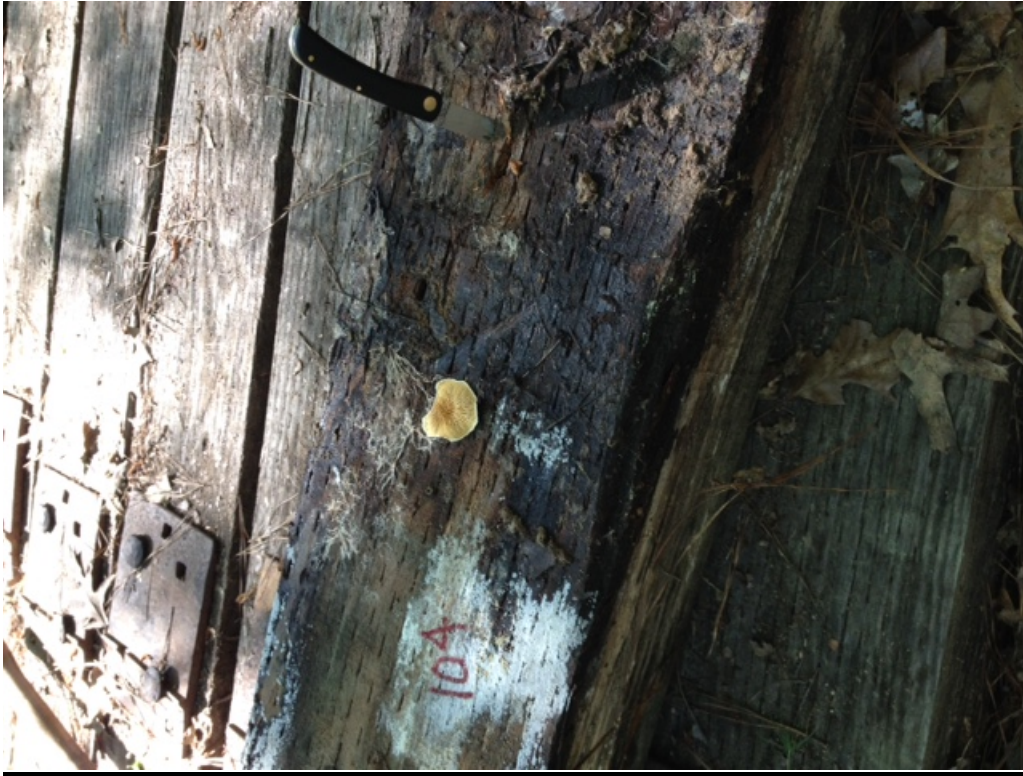
**Figure 5 - Tie #104 (D-fir untreated) with light decay.**

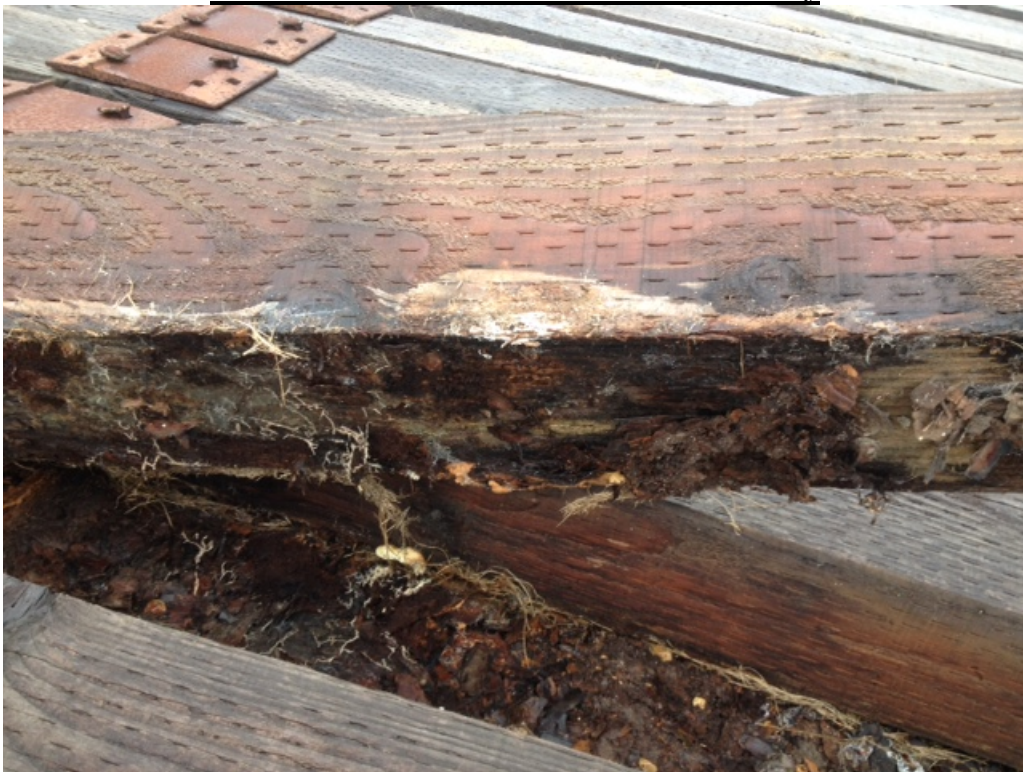
**Figure 6 - Tie #106 (unt. D-fir) with visible decay.**

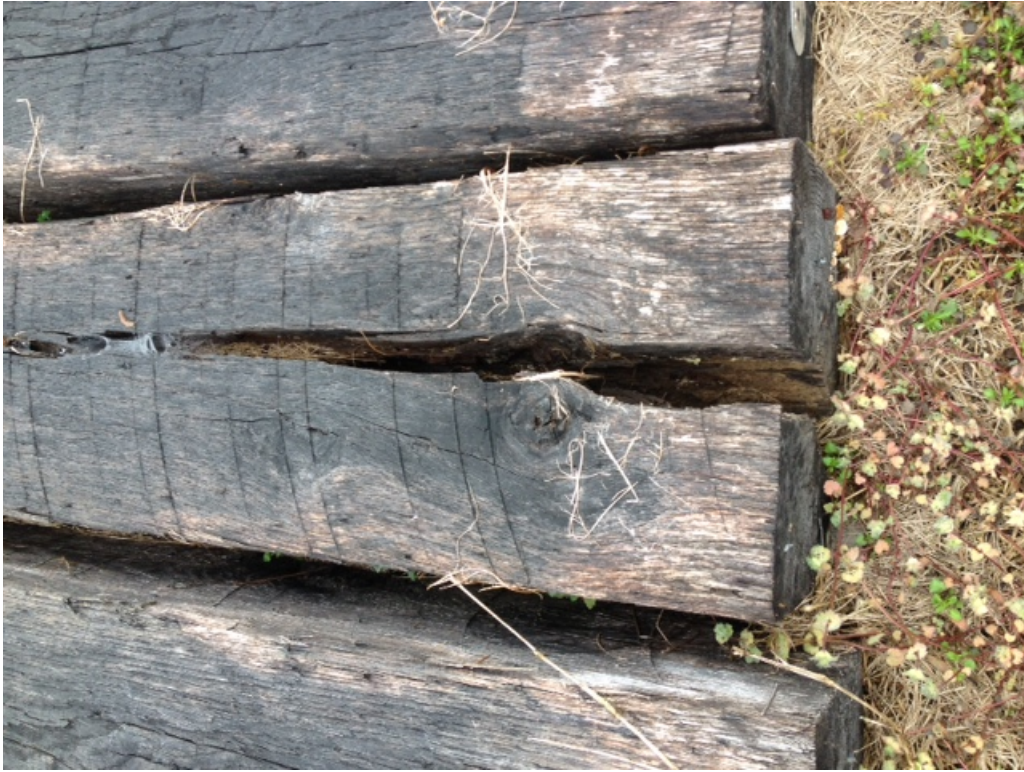
**Figure 7** - Tie #249 (unt. red oak) with severe split and decay fruiting bodies on end grain.

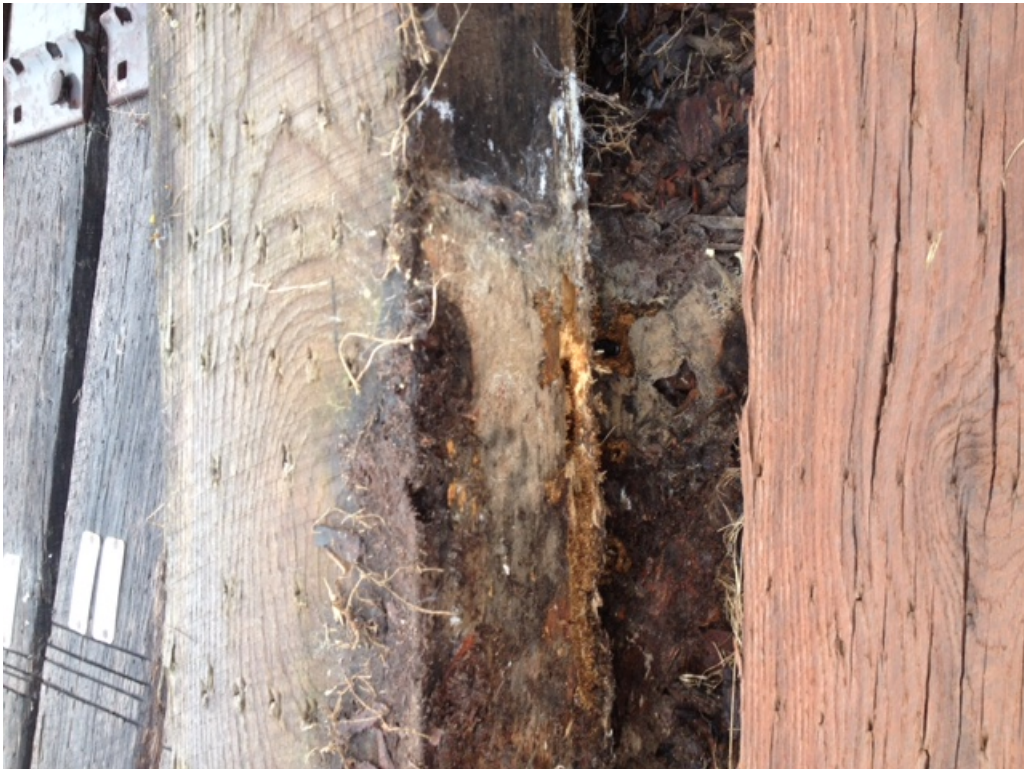
**Figure 8** -Tie #40 (unt. white oak) with decay and beetle damage.
