Separating Shelling or Spalling

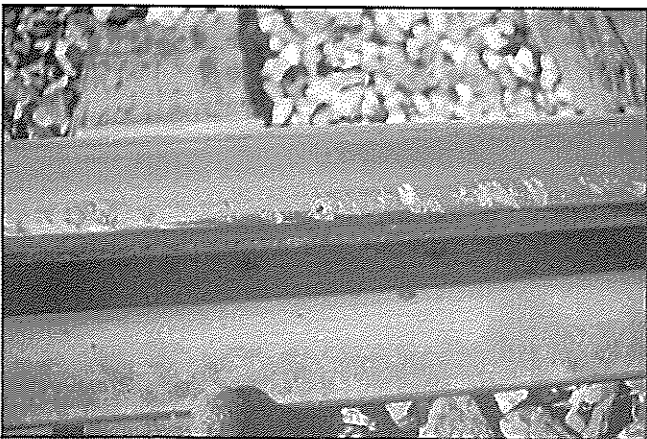
Spalling, or flaking, an example of which is illustrated in Figure 1, is a localized degradation of the running surface of the rail. It is most commonly found at the gage corner of the high rail. This condition often reveals itself initially as head checks (micro-cracks) at the gage corner. Usually these cracks are oriented at an angle of 45 degrees to the axis of the rail, and corresponding to the direction of traffic. The micro-cracks tend to propagate and coalesce into larger cracks or failure areas. In turn, these can break out from the surface of the head of rail. Spalling can also be found on the top surface of the rail head, often on the running surface of the low rail in curves.

Spalling, or flaking, is a surface phenomenon. It is shallow in depth, and is associated with areas of very

high contact stresses. Usually, these defects do not progress deeply below the surface of the rail. Instead, they progress about 0.030 inch below the surface, towards the gage side of the railhead! Spalling appears to be a surface fatigue condition related to high shear stresses as well as normal contact stressing.

Figure 1 – Spalling is a localized degradation commonly found at the gage corner of the high rail.

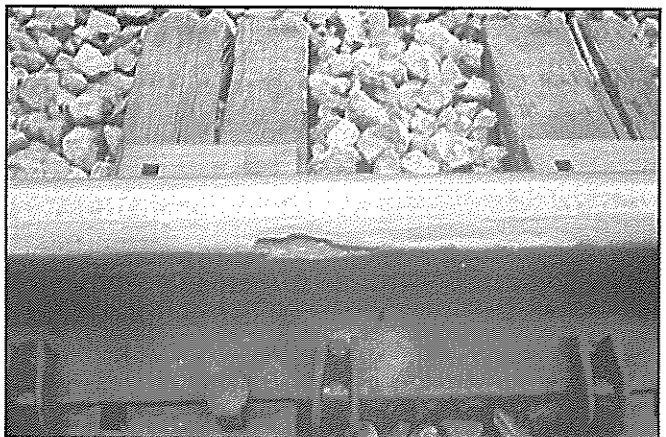
On the other hand, shelling, or more specifically, Gage Corner Shelling (see Figure 2), is a progressive internal separation that develops beneath the cold-worked region at the gage corner of the rail. Such a separation may propagate longitudinally along the rail and ordinarily at an angle to the rail axis. It can crack out at any level, usually near the upper gage corner.

As the shells propagate, they can turn down and in to form a transverse separation, which is often referred to as a detail fracture from shelling. This transverse defect can develop at any stage of the shell's longitudinal propagation. And since transverse defects in general, and the detail fracture in particular, are considered to be causes of rail breakage under load with possible derailment if not detected in time, these defects are particularly dangerous.

Gage-corner shelling is a subsurface fatigue phenomenon associated with high contact stresses at the point of contact between the throat of the wheel and the

Figure 2 – Gage Corner Shelling, on the other hand, is a progressive internal separation that can 'crack out.'

gage corner of the rail. Research studies have linked shelling with the presence of inclusions within the rail steel — particularly non-metallic inclusions.²
