# **Field Demonstration of the Use of Track Strength Data to Optimize Tie Replacement Requirements for High Speed Operations**

**Final Report**

June 2006

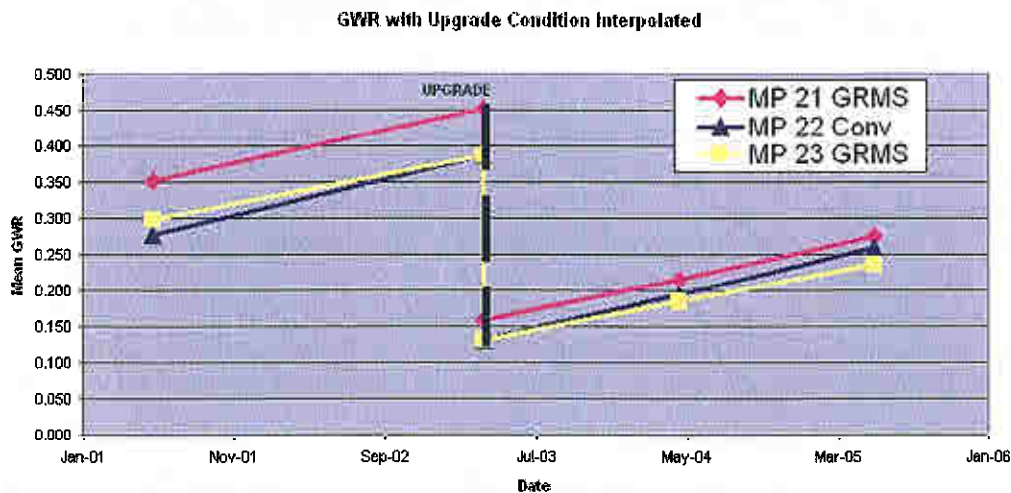
**FIGURE A: Mean GWR as a Function of Traffic and Upgrade**

As shown in Table B, the GRMS miles outperformed the conventional mile in the effectiveness of the tie replacement/upgrade as defined by the corresponding mean GWR

degradation rate. As can be seen, the lowest degradation rate corresponds to the GRMS upgrade mile (Mile 23) with the lowest number of ties installed; 356 vs. 838 for the conventional mile. In addition, examination of the GWR standard deviation show that the GRMS miles had higher pre-upgrade standard deviations, which indicates a wider scatter of tie condition, but ended up with lower standard deviations (less scatter) after the upgrade. This highlights the ability of the GRMS upgrade approach to provide a more uniform, stronger condition, based on the gage strength of the track.

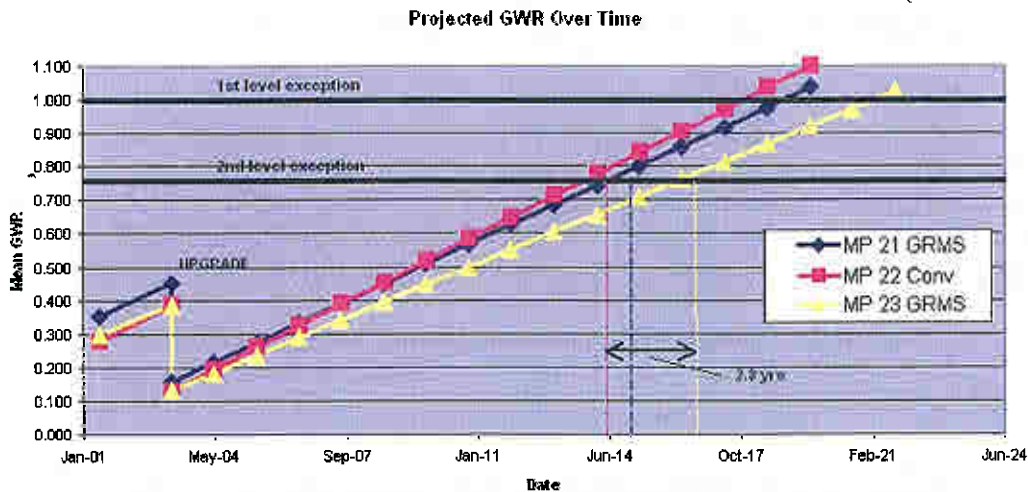
FIGURE B: Projected GWR Over Time

The effects of these relative degradation rates on the time it takes for the track to reach the GWR threshold levels<sup>2</sup> was calculated and presented in the Figure B below. Note, the 2<sup>nd</sup> or maintenance level used is 0.75 inches. A GWR value between 0.75 and 1 inch represents a second level exception and track speed must be set at the maximum for class 3 track (*FRA Track Safety Standards Part 213 pg 38*). A GWR reading of 1 inch or more represents a first level exception and track speed is to be reduced to 10 mph (*FRA Track Safety Standards Part 213 pg 37*). Noting the above, the conventional mile on average reaches a second level exception 2.8 years earlier than the best performing GRMS mile. This is a direct function of the higher degradation rate shown above. By averaging the two GRMS mile degradation rates and using the second level exception threshold, it can be shown that the GRMS upgrade approach provides an additional 2.1

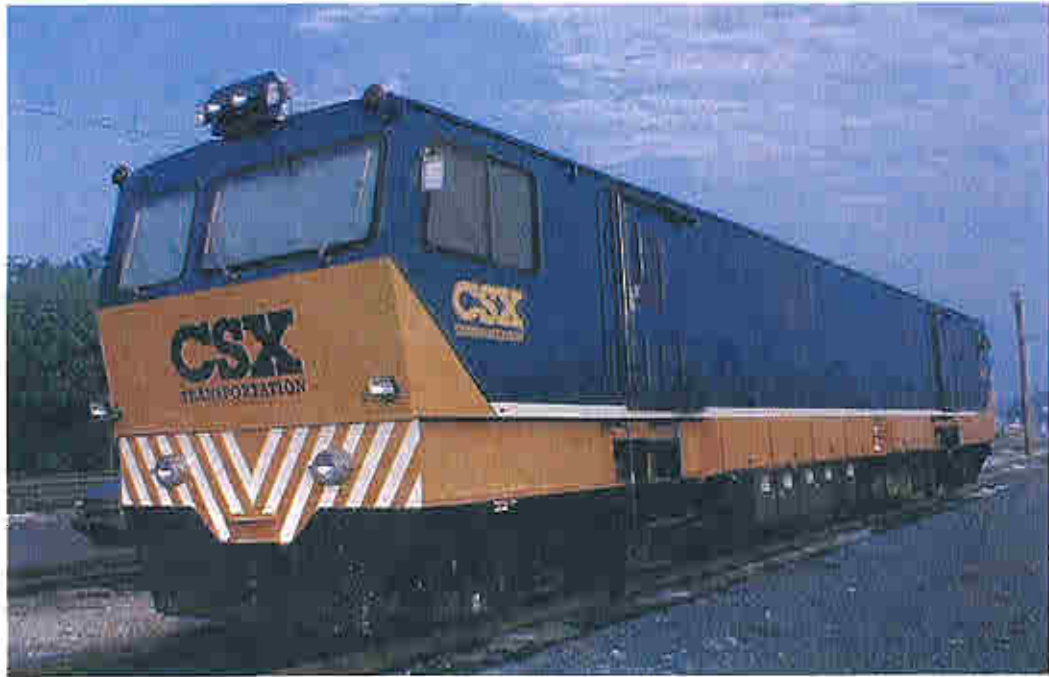
**Figure 1A: CSX's GRMS Track Inspection Vehicle.**

where *LTG* is the loaded track gage, *UTG* is the unloaded track gage, and *L* is the laterally applied GRMS load. Projected Loaded Gage (PLG24) is not used for tie replacement, as it is sensitive to rail gage face wear, wide gage, and weakened track strength.

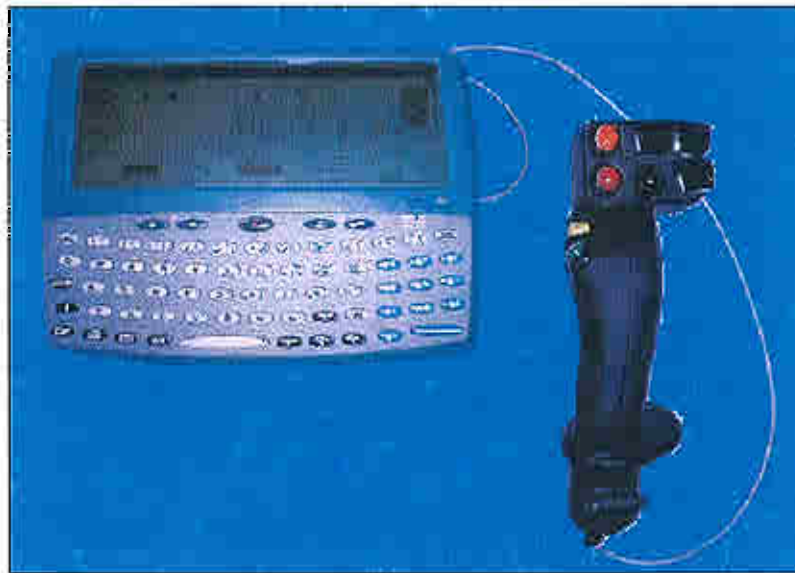
Figure 1B. ZETA-TECH's *TieInspect™* unit.

The *TieInspect™* upgrade is based on ZETA-TECH's *TieInspect™* replacement logic, which is dependent upon track class and curvature. Each test mile will have a tie-by-tie condition report, which is collected using ZETA-TECH's *TieInspect™* unit shown in Figure 1B. This logic utilizes the collected data and strategically breaks up bad clusters while assuring adequate replacement in the vicinity of bridges, crossings, and turnouts (See Figure 2). Thus, not all bad ties are replaced, but only those ties required to maintain track integrity.

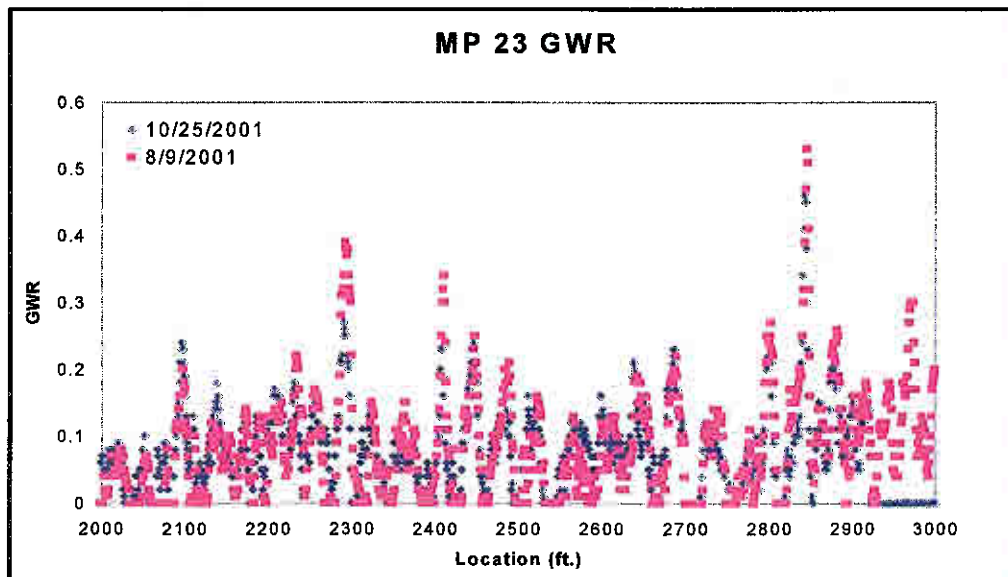
Figure 4. Two consistent GRMS runs.

Several GRMS vehicle runs were also analyzed for GWR data consistency and relative rates of degradation as shown in Figures 4 and 5. Figure 4 shows a foot-by-foot record of two GWR runs over a potential test mile with excellent correlation.

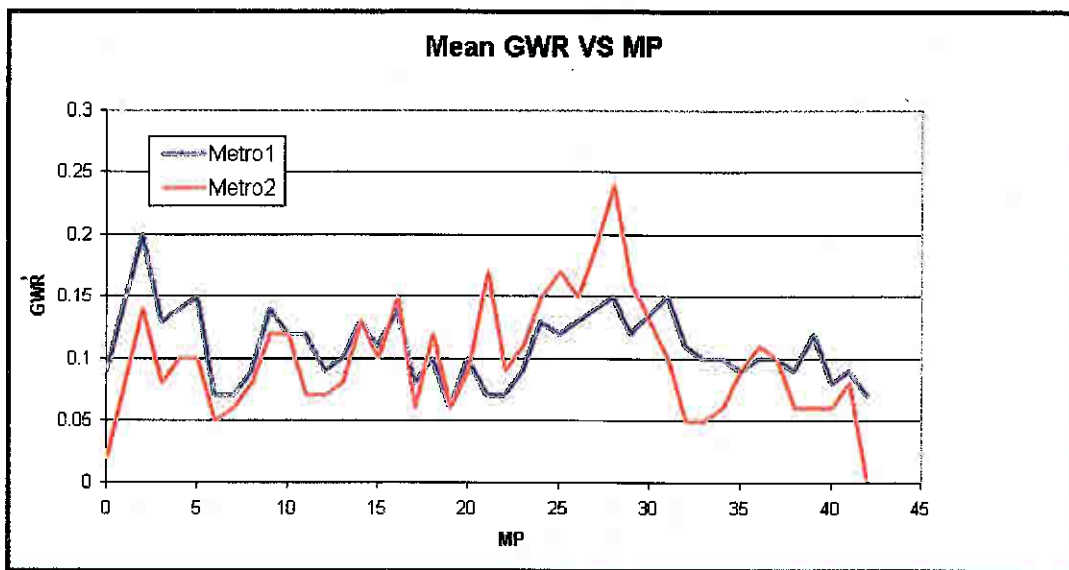
Figure 5. Mean GWR by mile.

Figure 5 plots mean GWR (for the mile) for two runs over all potential test miles. This was useful in determining both consistency and relative degradation between runs.

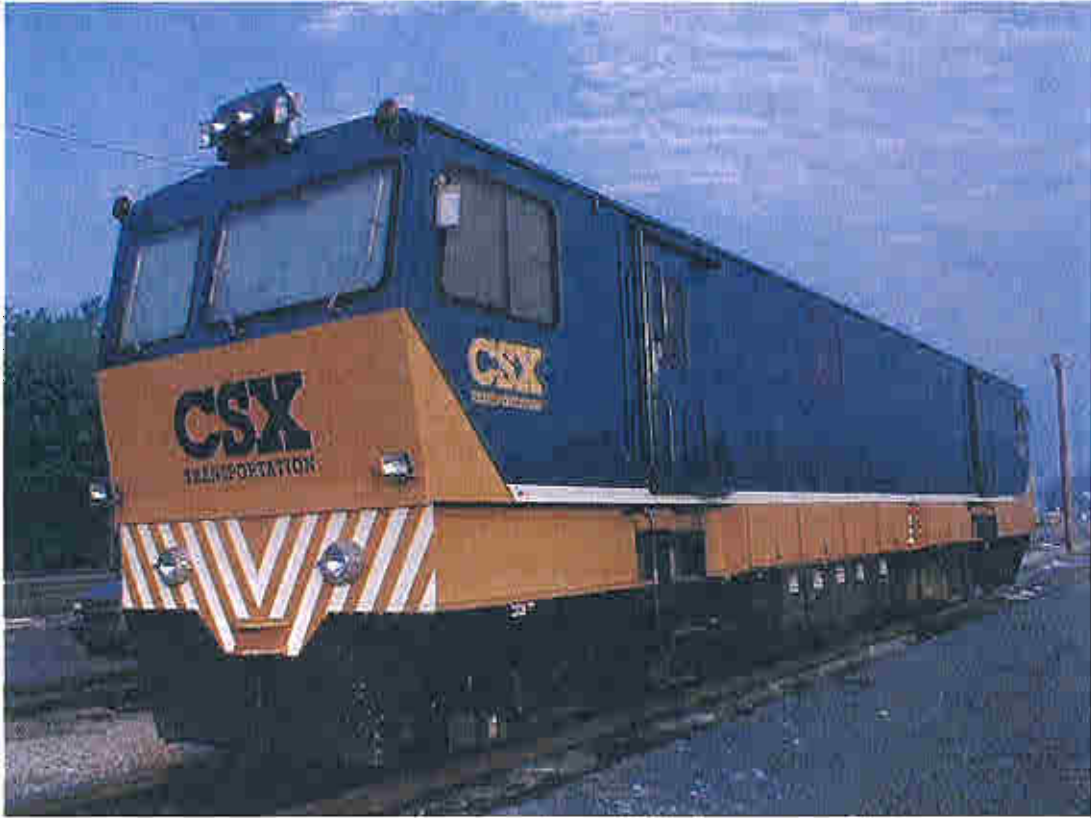
**Figure 10.** CSX's GRMS-1 vehicle.

GRMS-1, as a single vehicle, travels at a max speed of 35 mph to allow for time for the mechanical gage widening system to perform. A picture of the vehicle is shown in Figure 10, as it awaits orders to begin testing in Brunswick, MD. Several other pictures documenting the GRMS-1 run over the test miles are included in Appendix B.

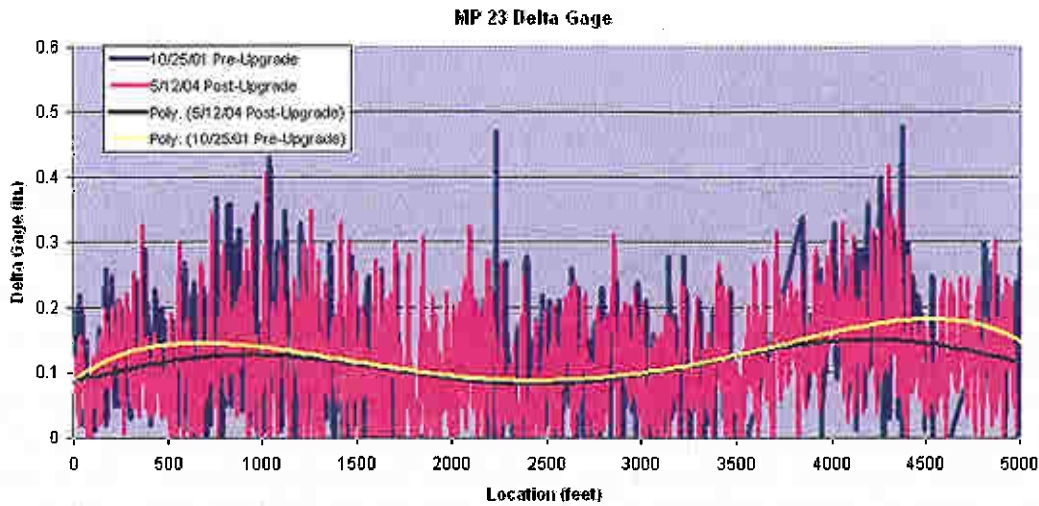
**Figure 13. MP 23 Pre- vs. Post-Upgrade Delta Gage**

MP 23 also utilized a GRMS upgrade designed to improve the lateral track strength of the mile with only a limited number of ties. The upgrade consisted of 356 ties targeting locations exhibiting weak lateral track strength. Examination of Figure 13 shows the average lateral track strength to be at or better than the pre-upgrade track condition with only a limited number of ties installed 15 months previously.. Thus, the integrity of the mile has been maintained with a limited upgrade. Successful reductions of some of the highest delta gage peaks are also seen throughout the mile. This mile will undergo a conventional maintenance cycle.

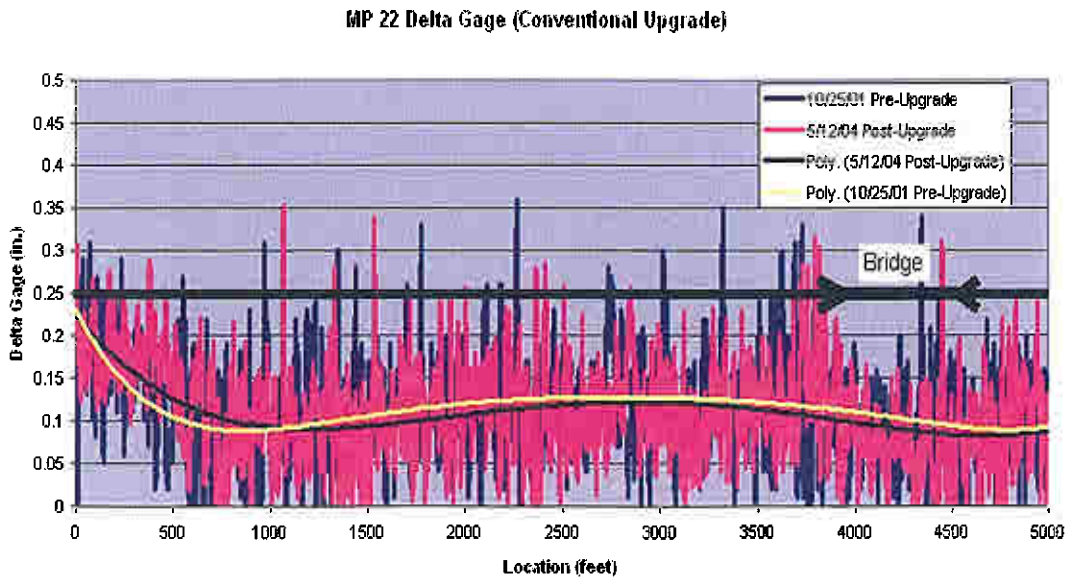
**Figure 14. MP 22 Pre- vs. Post-Upgrade Delta Gage**

MP 22 was conventionally spotted and upgraded by CSX personnel. The upgrade consisted of 838 ties, with the majority of the mile being a long tangent stretch. Although still in relatively good condition, Figure 14 shows a slight increase in delta gage in the first 750 feet (a 2.25-degree curve). Throughout the rest of the mile however, slight improvement in delta gage can be seen. It should be noted that this mile contains a bridge spanning from locations 4060 ft to 4500 ft, where the ties were in good condition at the time of the upgrade. Otherwise requirements could have increased to that of adjacent mile conventional CSX tie gang upgrades (1000-tie range). This test mile will undergo a conventional maintenance cycle.

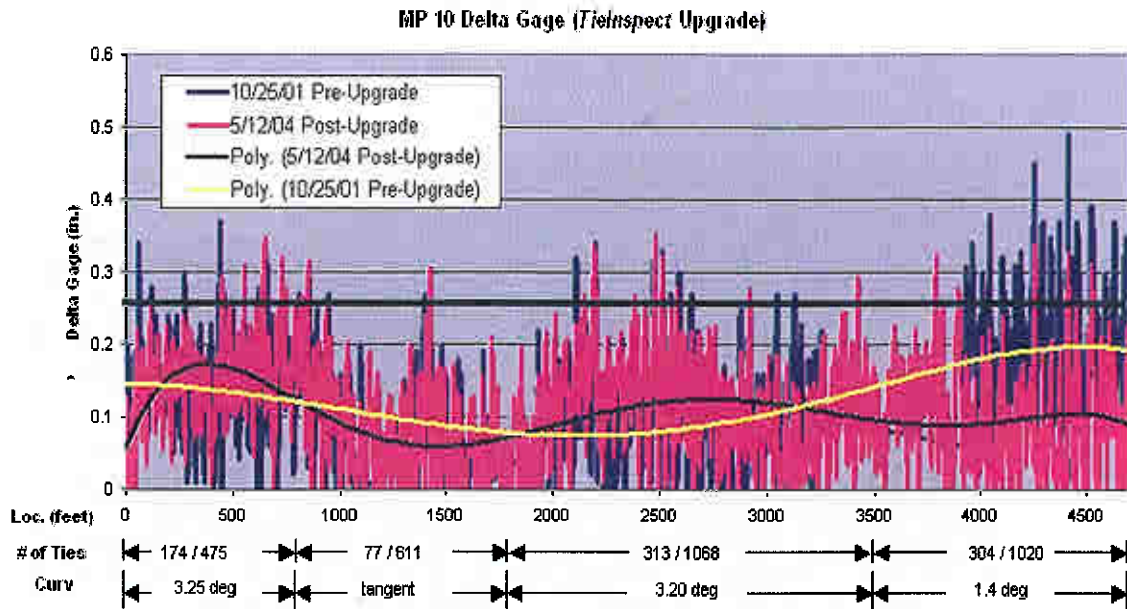
**Figure 15. MP 10 Pre- vs. Post-Upgrade Delta Gage**

track curvature, and running the *TieInspect* replacement logic, the tie replacement requirements for the mile was reduced to an **888** tie upgrade (9.8% reduction in ties). The *TieInspect* logic, based on track class and curvature, will leave spotted ties with limited life remaining in track if an adequate number of “good” ties surround them. This logic utilizes the collected data and strategically breaks up bad clusters while assuring adequate replacement in the vicinity of bridges, crossings, and turnouts. Thus, not all bad ties are replaced, but only those ties required to maintain track integrity. The spotted ties left in track were located in the mile’s only tangent stretch (located between 800 and 1800 feet) between two 3-degree curves. A reduction in delta gage is seen in this tangent stretch, where 97 spotted ties were left in track. Also the last 1500 feet of the mile saw a significant decrease in delta gage, which was within a 1.5-degree curve.

The two locations where the post-upgrade polynomial is above the pre-upgrade polynomial were within the 3-degree curves. Since rate of track degradation increases in curves and no single bad ties were left in these curves, the data suggests more ties needed to be spotted by CSX personnel. This test mile will undergo a *TieInspect* maintenance cycle.

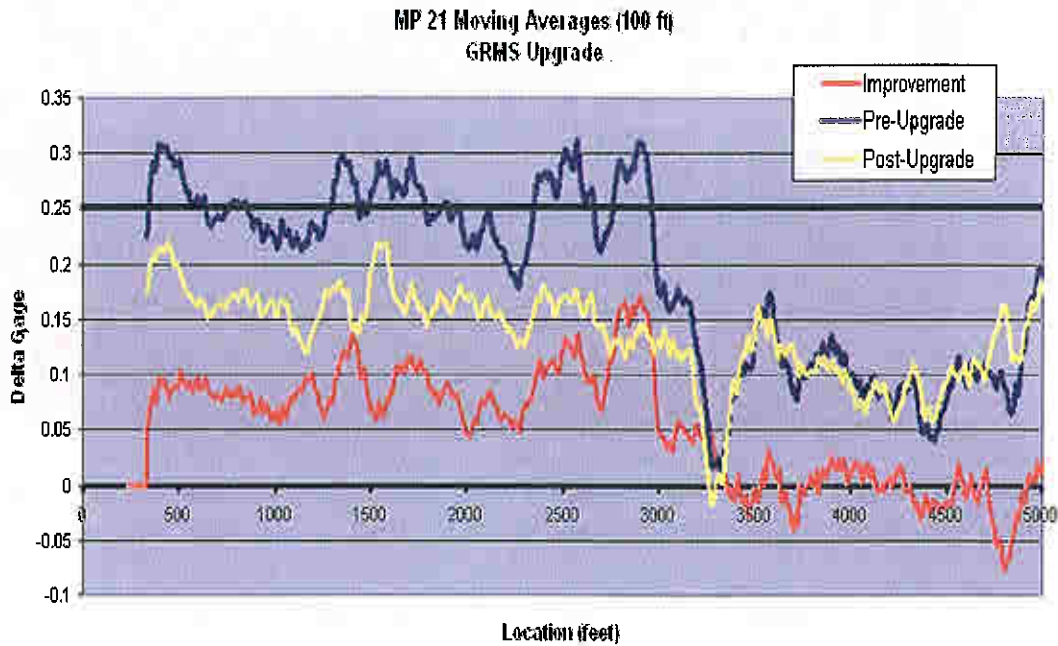
**Figure 16.** MP 21 Overall improvement.

To determine relative effectiveness of the upgrades, the Pre- and Post-upgrade delta gage 100-ft moving averages were compared. An improvement curve for each mile was created which represents the difference between the Pre- and Post-upgrade average delta gage curves, where data points above zero represent reduction in delta gage attributed to the upgrades. The overall effectiveness index is defined as the area under the improvement curve, which was used for relative comparison of upgrade success. Figure 16 shows the improvement curve for the GRMS upgrade mile at MP 21. Note that the post-upgrade curve is now completely below the dark horizontal line which represents the upgrade threshold of 0.25 delta gage. The improvement curve shows a significant improvement in delta gage over the first 3500 feet of the mile where the upgrade was concentrated. Since the last 1500 feet of the mile was in good condition to begin with, the upgrade was limited and the condition was maintained. Summing the area under the improvement curve produced by far the highest effectiveness index with a value of 243.4. It was anticipated that the GRMS upgrade, which targeted weak spots in lateral track strength, would show the greatest improvement in delta gage.

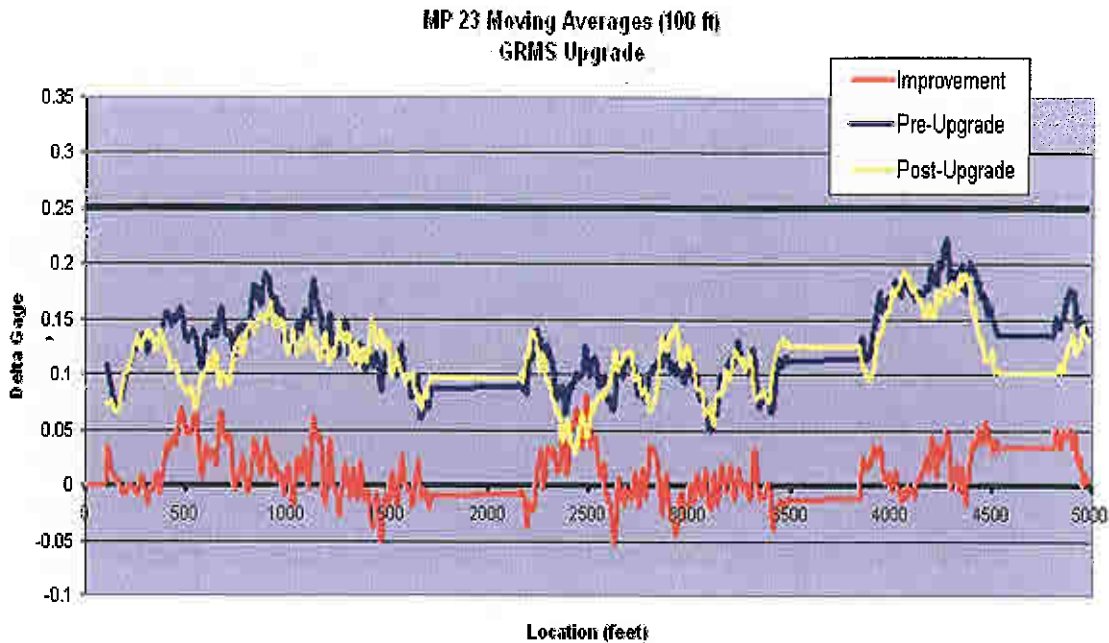
**Figure 17.** MP 23 Overall improvement.

The overall upgrade effectiveness for MP 23, a GRMS upgrade with limited ties, is shown in Figure 17. This mile displayed a much better initial condition than MP 21, and targeted locations with weak lateral track strength with 356 strategically located ties. As can be seen by the improvement curve, slight reductions in delta gage can be seen for the majority of the mile. Summing the area under the improvement curve produced an effectiveness index of 43.9<sup>10</sup>, signifying slight improvement in a mile with good starting condition.

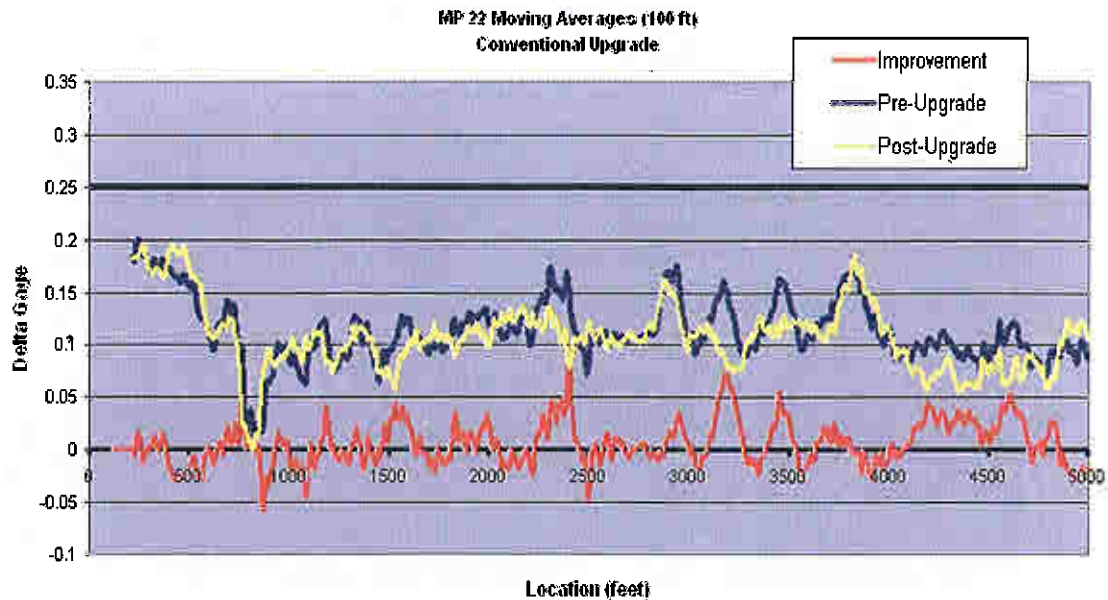
**Figure 18.** MP 22 Overall improvement.

The improvement in delta gage from the CSX conventional upgrade is shown in Figure 18 for MP 22. This mile had the best initial condition (average pre-upgrade delta gage of 0.114), and the post-upgrade data shows this condition to be essentially maintained, with slight improvement in some areas. Summing the area under the improvement curve produced an effectiveness index of 42.2, which is similar to the track strength improvement seen in MP 23 (GRMS upgrade) where only 42% of the ties used in this conventional mile were installed.

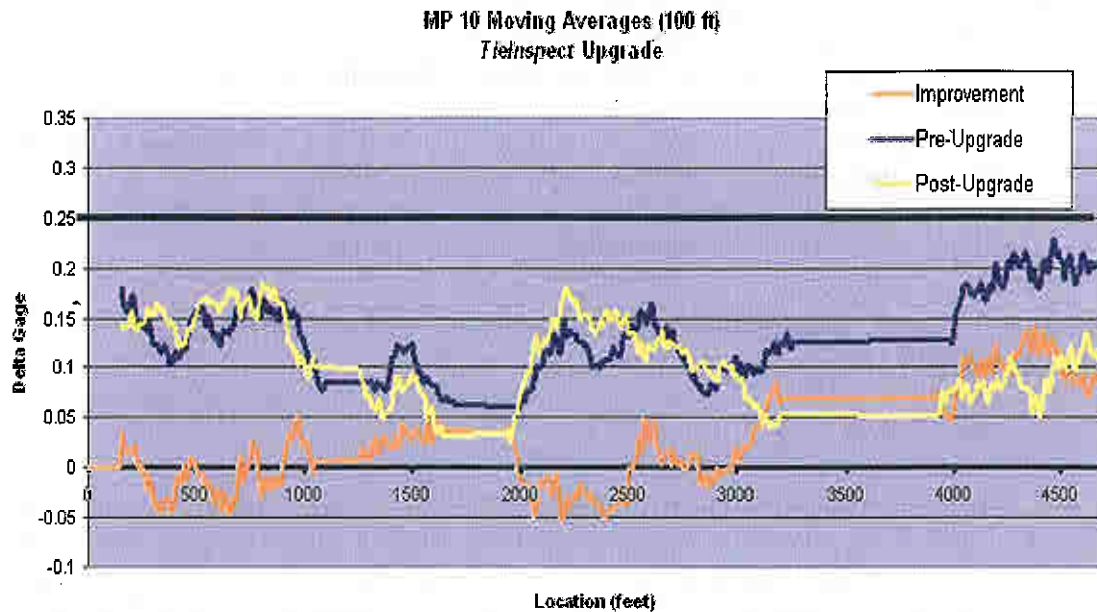
**Figure 19.** MP 10 Overall improvement.

Investigation into the improvement for the *TieInspect* upgrade, MP 10, once again shows slight increases in delta gage in portions of the two 3-degree curves (located from 250 ft to 750 ft and 2000 ft to 2500 ft). These average delta gage values are still well below the 0.25 in threshold used in the GRMS miles, and reflect track that is in good condition. Improvement is seen in the tangent stretch (located from 900 ft to 1750 ft) where 97 ties were strategically left in track according to *TieInspect* logic. Significant improvement in delta gage is seen at the end of the mile. Summing the area under the improvement curve produced an effectiveness index of 86.9<sup>11</sup>, which represents the second most effective upgrade.

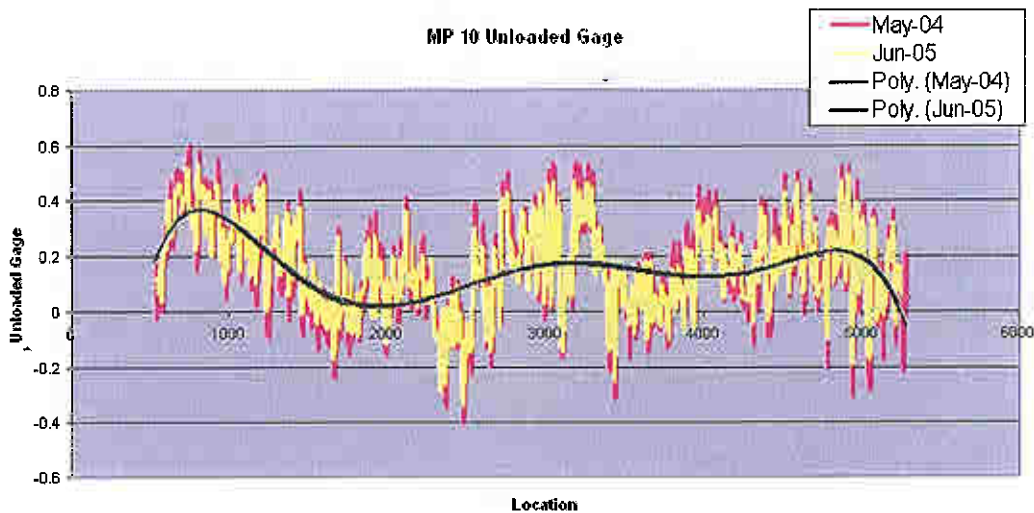
**Figure 22. Unloaded gage channel horizontally and vertically aligned.**

For comparison purposes it was necessary to recalibrate and align these channels vertically. Figure 22 shows the calibrated unloaded gage channel for these two runs. This vertical alignment process was employed on both the unloaded gage and loaded gage channels with offsets calibrated to the June 2005 run.

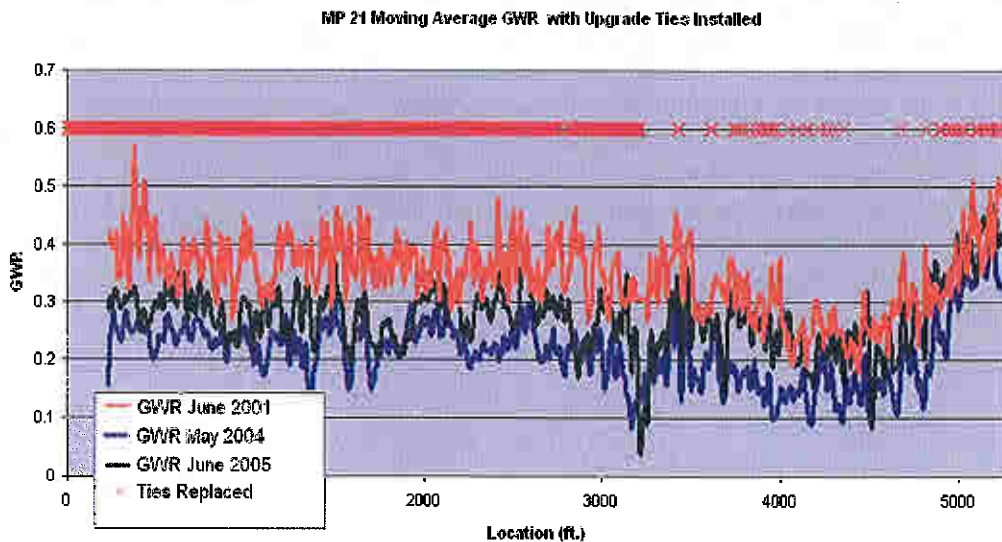
**Figure 23. 25 ft Moving Average GWR for Three Runs.**

MP 21 underwent a GRMS upgrade, in which delta gage peaks over 0.25 were targeted. Since passenger trains hit 79 mph through these miles it was the goal to invoke a tight upgrade standard. Of the 878 ties installed, 828 were located in the first 3000 feet where most of the exceedance locations were found. Figure 23 shows the 25-ft moving average GWR for the June 2001, May 2004, and June 2005 runs, noting the locations of the installed ties. Upgrade success is seen in the shift from the orange curve (June 2001) to the blue curve (May 2004). As expected a larger improvement is seen in the first 3000 feet. Overall lateral degradation for the mile is shown by the shift from the blue curve (May 2004) to the black curve (June 2005).

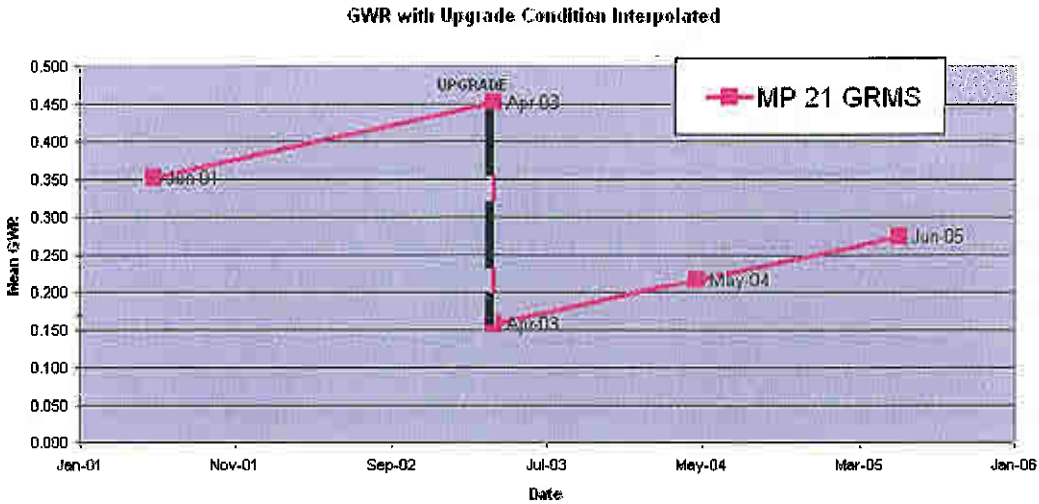
**Figure 24. GWR Degradation Over Time.**

Using this calculated degradation rate and the assumption that the degradation is linear, both Pre-Upgrade and Post-Upgrade condition can be interpolated as shown in Figure 24. This provides a more realistic improvement in mean GWR since the pre- and post-upgrade GRMS runs were almost 2 years before and approximately 1.1 years after the upgrade respectively. This still only represents an approximation in overall upgrade success as it would be expected that the pre-upgrade degradation rate would be more aggressive for two reasons: (1) the mile was certainly starting from a worse condition than the post-upgrade condition, and (2) the upgrade targeted “weak performing areas” so these areas would now degrade more slowly, and the good performing areas would at least initially continue as such. However, this analysis improves on the accuracy of the evaluation of the upgrade success. As shown in Figure 24, MP 21 registered an approximated 0.294 improvement in mean GWR.

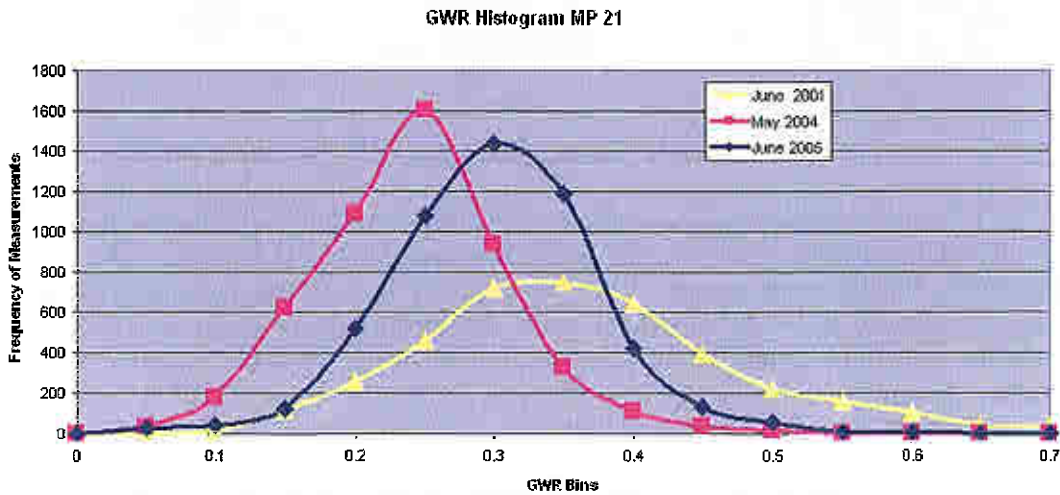
**Figure 25. GWR Histogram for MP 21.**

Another measure of upgrade success would be the statistical distribution of GWR measurements for each of the GRMS runs. According to Figure 25, the June 2001 histogram (using 0.05 GWR increments) shows the widest scatter of measured GWR, with the curve shifted furthest to the right due to the higher mean value<sup>14</sup>. The effects of the upgrade are evident as the histogram shows a much narrower distribution (lower standard deviation from the mean), and the curve is shifted furthest to the left. The degradation experienced at the June 2005 run is represented by the rightward shift of the curve and widening of the histogram.

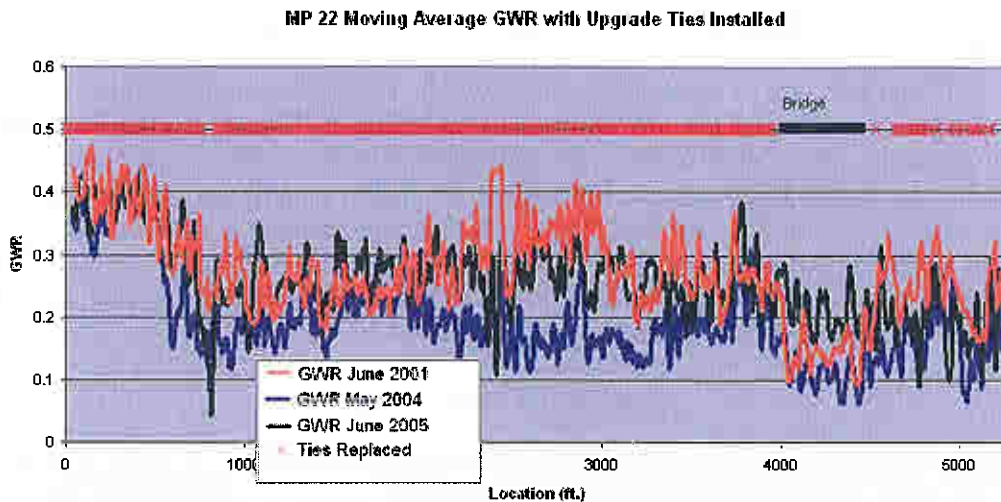
**Figure 26. 25 ft Moving Average GWR for Three Runs.**

MP 22 was spotted and subsequently upgraded according to CSX’s current (conventional) practices based on visual inspection and marking by CSX tie inspectors. The upgrade consisted of 838 ties, with the majority of the mile being a long tangent stretch. It should be noted that this mile contains a bridge spanning from locations 4060 ft to 4500 ft, where the ties were in good condition at the time of the upgrade. Otherwise requirements could have increased to that of adjacent mile conventional CSX tie gang upgrades (1000-tie range). Figure 26 shows the 25-ft moving average GWR for the June 2001, May 2004, and June 2005 runs, noting the locations of the installed ties. Upgrade success is seen in the shift from the orange curve (June 2001) to the blue curve (May 2004). Moderate improvement is seen through the mile. The current calculated degradation rate is shown by the shift from the blue curve (May 2004) to the black curve (June 2005).

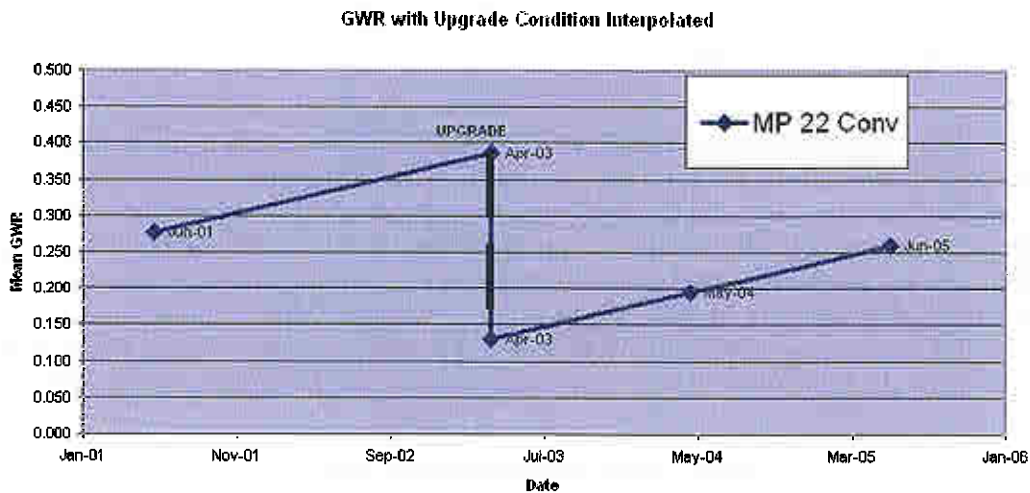
**Figure 26. GWR Degradation Over Time.**

As shown previously, using this calculated degradation rate and the assumption that the degradation is linear, both Pre-Upgrade and Post-Upgrade condition can be interpolated as shown in Figure 26. This provides a more realistic improvement in mean GWR since the pre- and post-upgrade GRMS runs were almost 2 years before and approximately 1.1 years after the upgrade respectively. As shown in Figure 26, MP 22 registered an approximated 0.255 improvement in mean GWR.

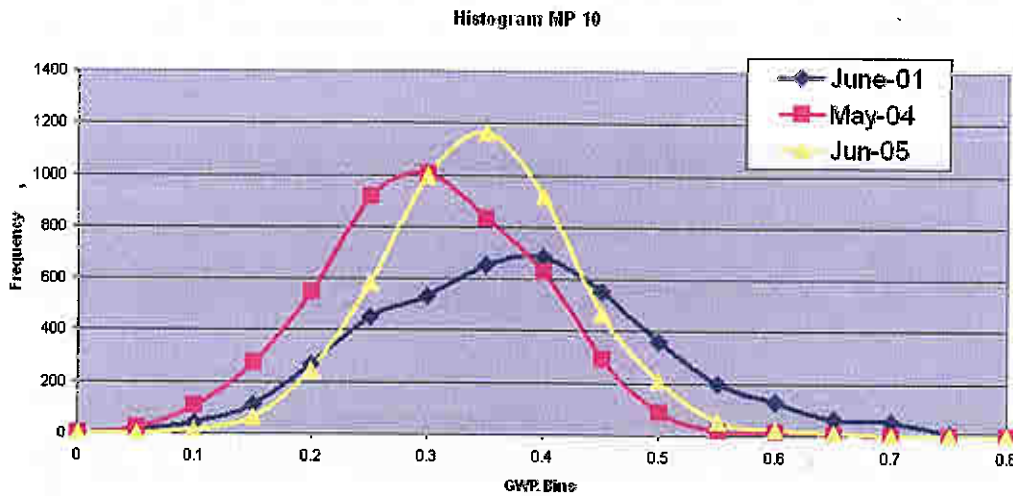
Figure 34. GWR Histogram for MP 10.

The statistical distributions of TieInspect measurements for each run are given in Figure 34. Similar trends hold true as the June 2001 histogram shows the highest mean condition (right-most shift), and a wide scatter due to large variations in pre-upgrade condition.

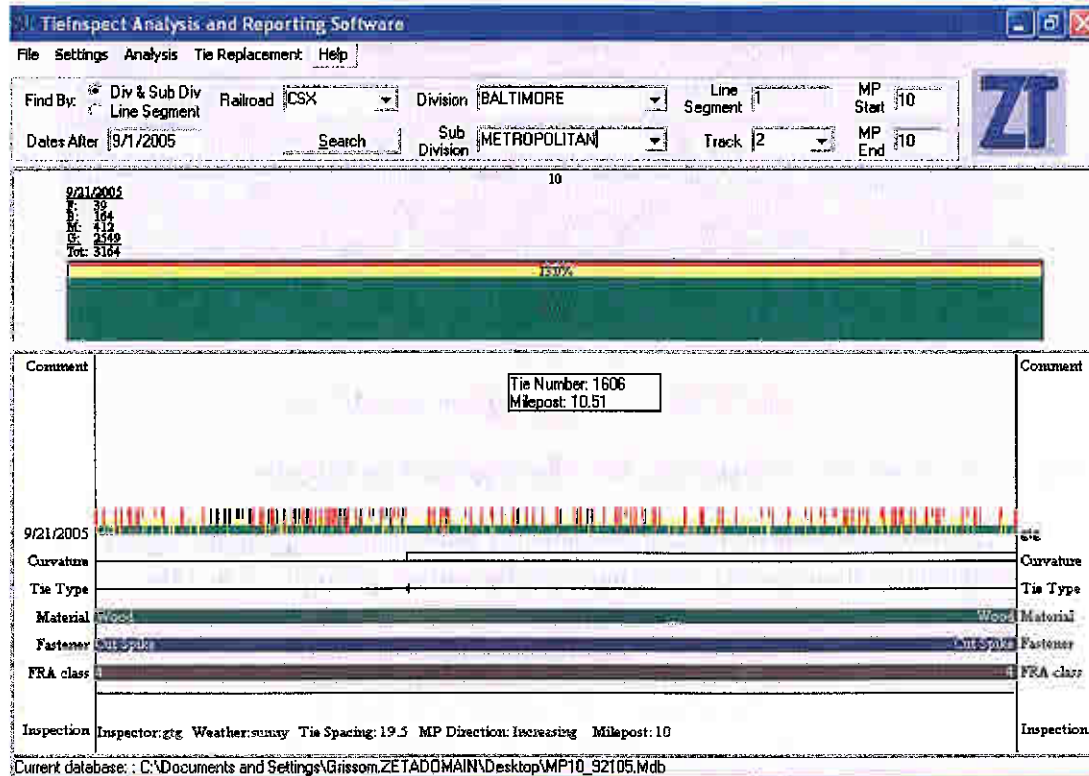
Figure 35. *TieInspect* Condition Map for MP 10.

After tie condition data was collected, the *TieInspect* replacement logic was then employed and specific ties were identified for removal. By analyzing the stored tie condition and location data, the software strategically broke up bad clusters. Although 203 ties in bad condition were identified, surrounding condition dictated that only 184 ties be replaced. The *TieInspect* logic reduced the requirements by 9.4% as 19 bad ties (not failed), which had excellent surrounding tie condition were left in the tangent stretch of track.

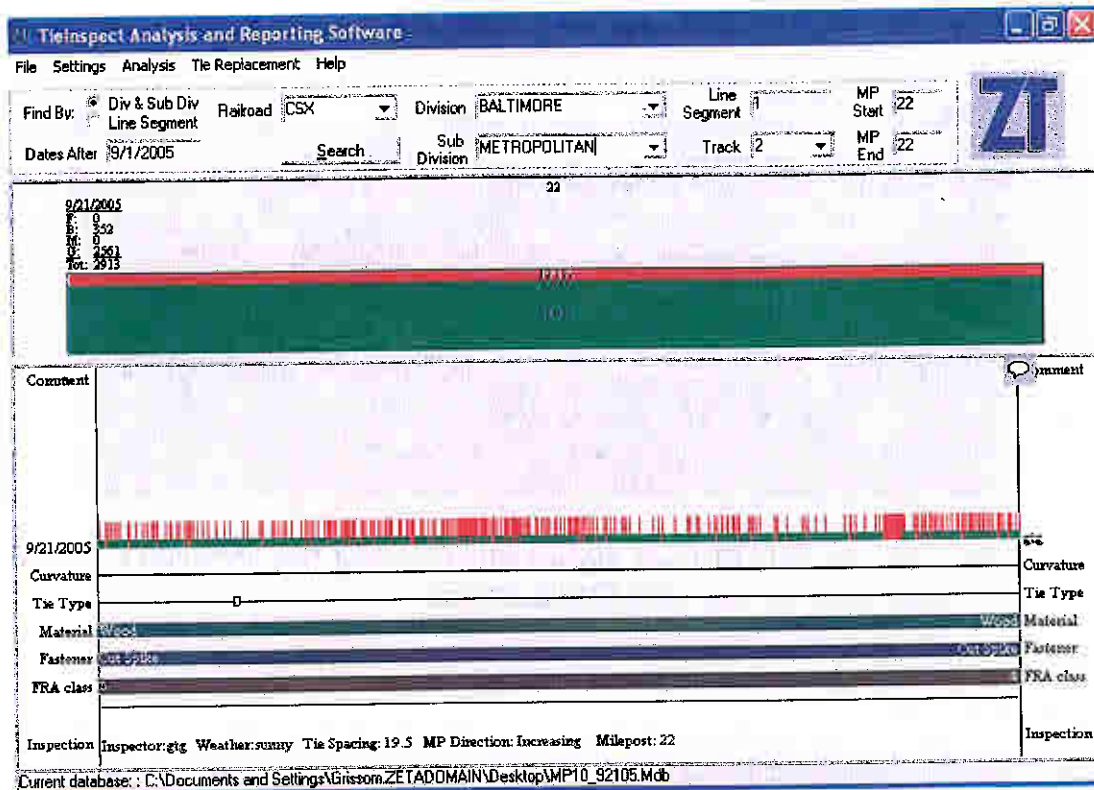
**Figure 38. Tielnspect Condition Map for MP 22.**

**MP 22 (Conventional Maintenance Cycle):** This mile was conventionally spotted by the CSX Roadmaster, who identified 352 ties for replacement. Figure 38 shows locations of the spotted ties that were collected with the TieInspect Unit and marked as “Bad.”

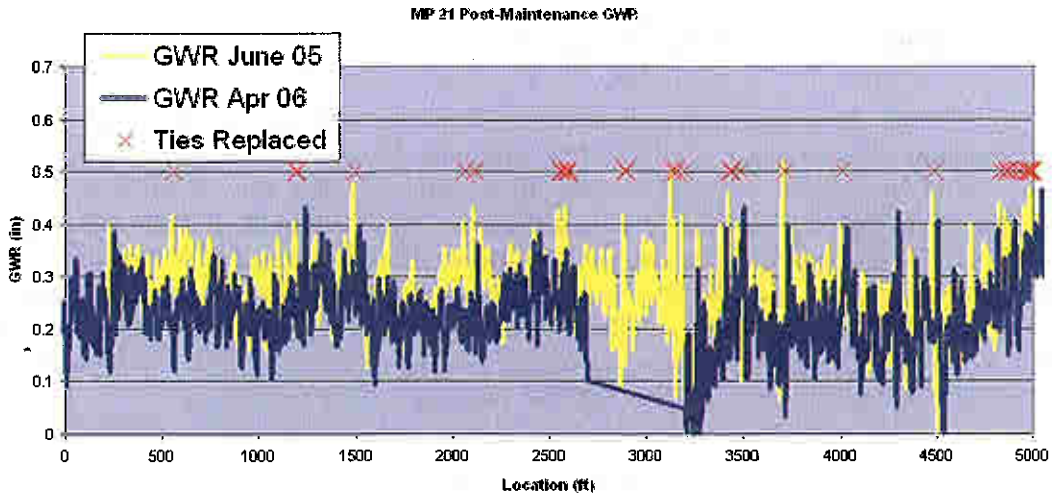
**Figure 18. MP 21 Post-Maintenance GRMS run.**

MP 21 was the only mile to undergo a GRMS based maintenance cycle. Figure 18 shows the pre- and post-maintenance GRMS runs along with the locations of the ties installed. It is evident that GWR peaks exceeding 0.4 were successfully targeted using the June 2005 run by the reduction in the highest GWR peaks. MP 21 outperformed both conventional maintenance cycles (MP 22, 23), by reducing average GWR by 0.046 inches with significantly less ties.

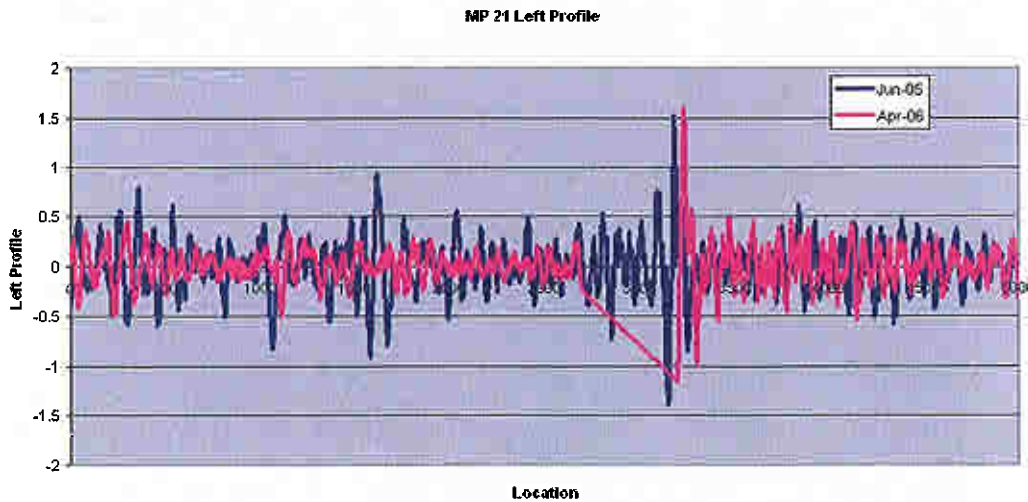
**Figure 19. Left Profile for MP 21**

One issue with GRMS maintenance is the effect on track profile, as tie replacement is based on lateral track performance. To investigate this, Figure 19 plots the 62 ft chord left profile<sup>17</sup> for MP 21. For most of the mile, a smaller deviation from zero profile can be seen in the April 2006 run, despite tie replacement focusing on lateral performance. The spike seen in this plot occurs at a grade crossing with an abrupt change in profile.

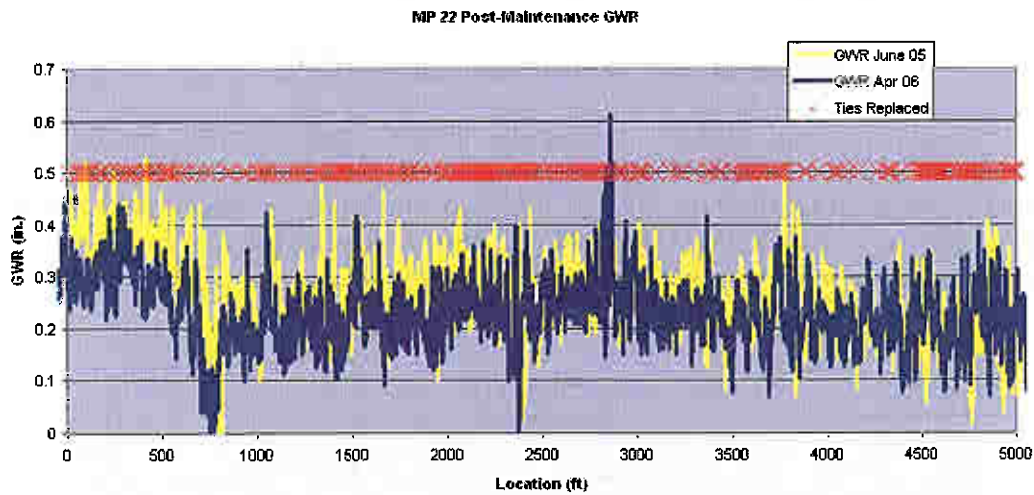
Figure 20. MP 22 Post-Maintenance GRMS run

MP 22, the control mile, underwent a conventional upgrade in which 352 ties were spotted and installed. Replaced ties were identified visually without using lateral track performance data. As can be seen from Figure 20, the conventional philosophy resulted in increased maintenance tie requirements while showing a slight reduction in GWR. The average GWR was reduced 0.03 inches from the pre-upgrade condition using twice as many ties as the GRMS mile. As shown in Figures 20 and 21, a GWR peak of over 0.6 inches was measured, although this was not identified by the June 2005 run. This represents abnormal deterioration and may be a data anomaly. This location is well within FRA compliance for GWR but should undergo further monitoring.

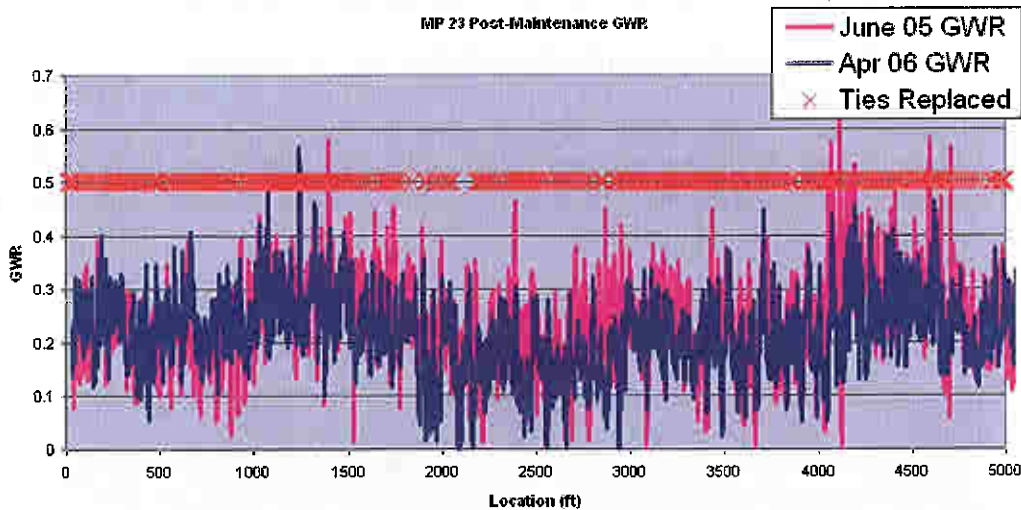
**Figure 22. MP 23 Post-Maintenance GRMS Run.**

MP 23 received a 356 tie GRMS-based upgrade by the production tie gang in April 2003. As a result, a conventional maintenance philosophy generated a higher maintenance tie count. Although this mile was successful at targeting lateral weak spots with minimal ties during the upgrade, conventional spotting targeted all bad ties regardless of surrounding condition and lateral performance. This mile was conventionally spotted by the CSX Roadmaster, who identified 551 ties for replacement. Figure 22 shows the distribution of ties installed along with the effect on GWR. GWR actually increased the first 1000 ft of the mile despite the tie installations. Even with the highest tie count, this mile showed only a 0.019 inch improvement in average GWR. Figure 23 demonstrates that tie maintenance that does not utilize lateral track strength data leaves behind GWR peaks above the maintenance threshold. The selected ties for replacement missed this peak, and as such lateral deterioration will continue for several years to come.

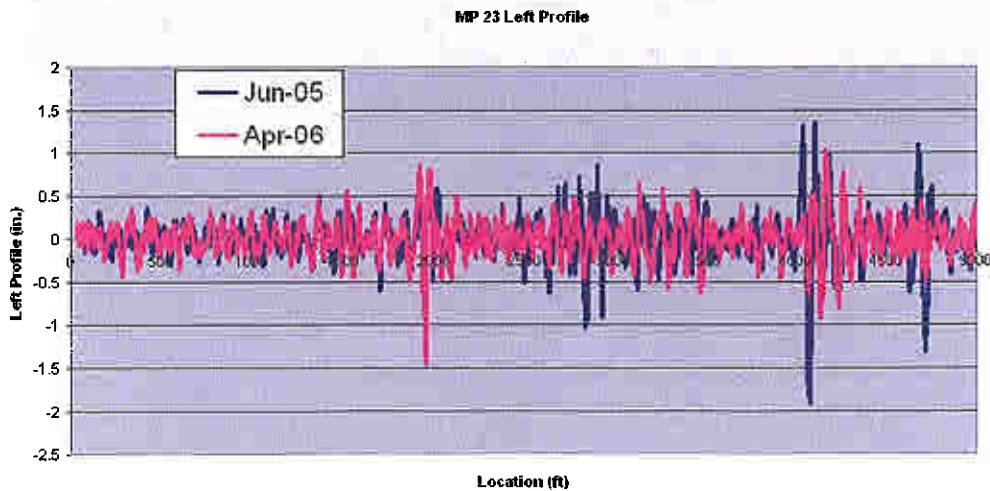
**Figure 24. Left Profile Data for MP 23.**

Figure 24 examines the left profile for MP 23 noting the strategic 356-tie upgrade performed in April 2003. The June 2005 run shows three areas of surface variations at the middle to end of the mile, which were alleviated by the conventional maintenance cycle. This highlights the need to analyze track profile when performing limited GRMS based upgrades. By overlaying GWR and profile data, a targeted complete tie replacement strategy can be implemented.
