**FOREST AND WILDLIFE RESEARCH CENTER**

**Seventh Annual Evaluation of Phase II MSU/RTA Alternative Preservative Study**

**June 5, 2019**

## **Seventh Annual Evaluation of Phase II MSU/RTA Alternative Preservative Study**

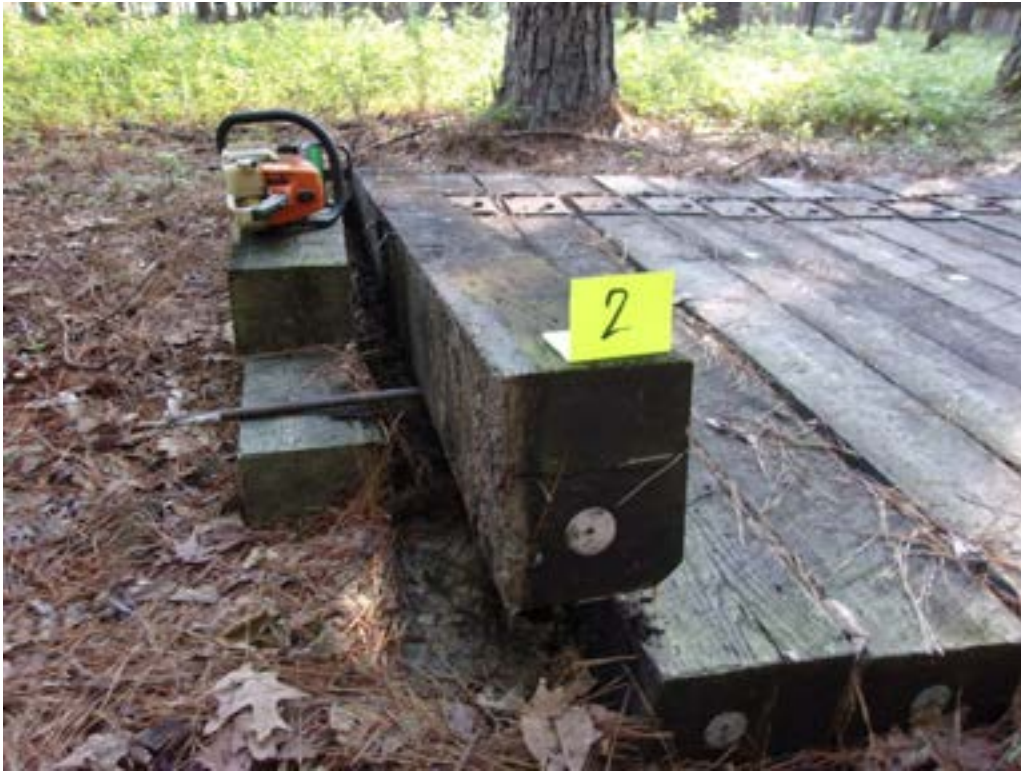
**Figure 1 - Tie #2 white oak/borate/creosote 6# (Koppers).**

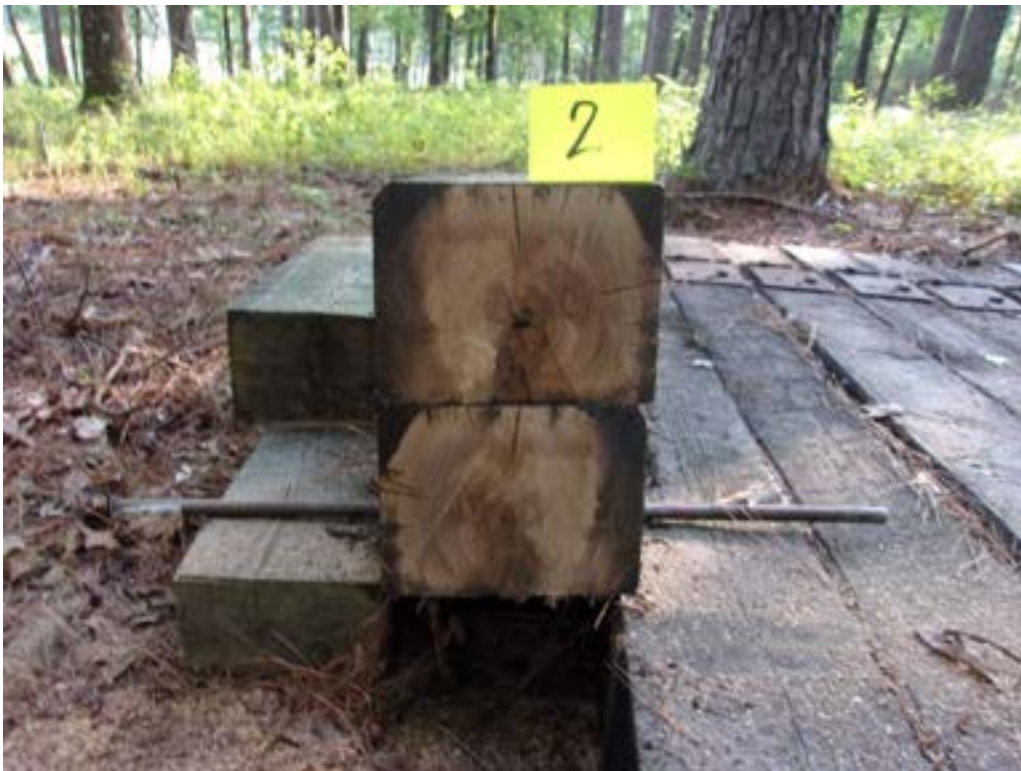
**Figure 2 - Tie #2 white oak/borate/creosote 6# (Koppers).**

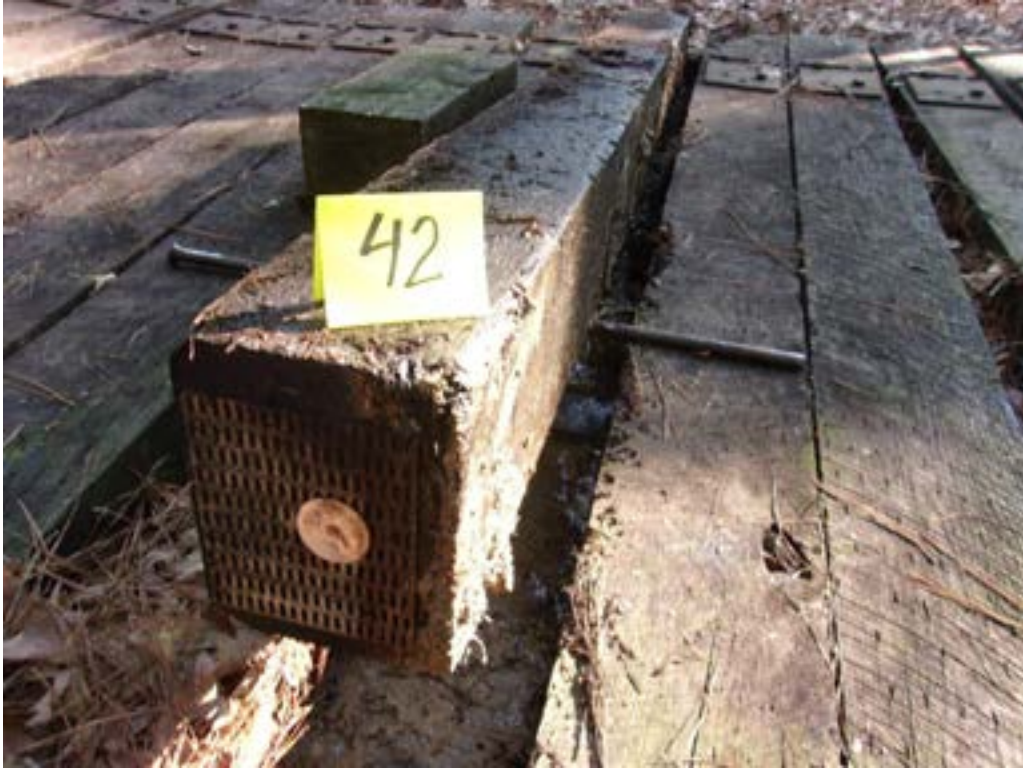
**Figure 9** - Tie #42 white oak/borate/creosote 7lbs (Koppers).

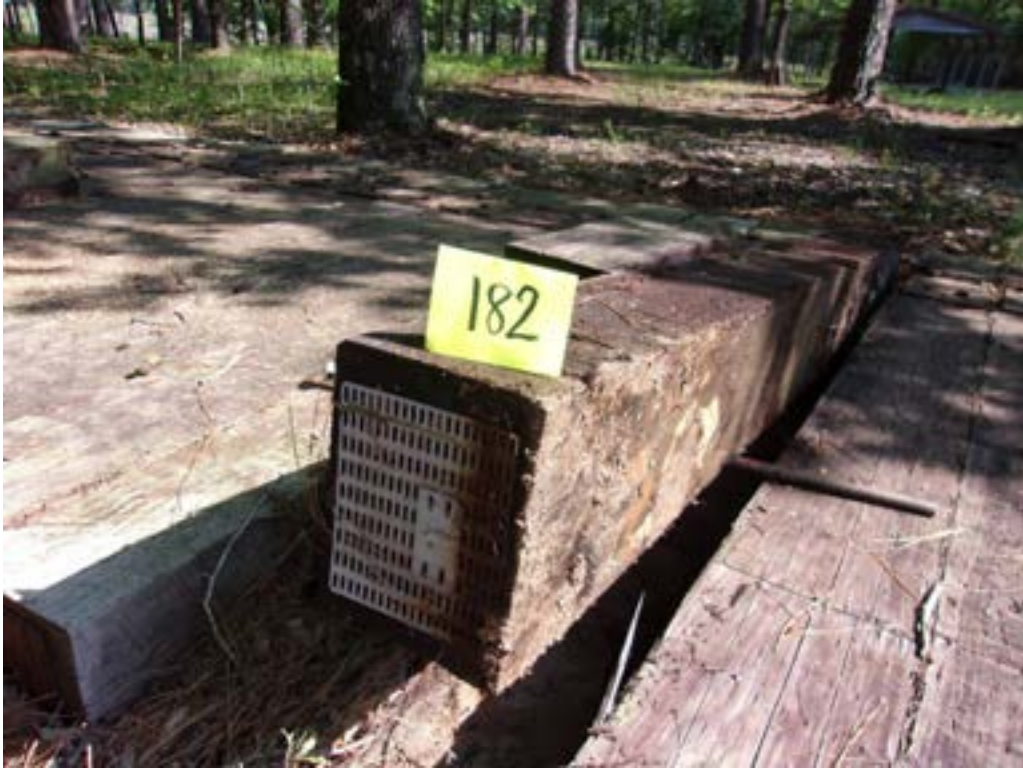
**Figure 39** – Tie #182 Douglas fir/P2 creosote (Lonza).

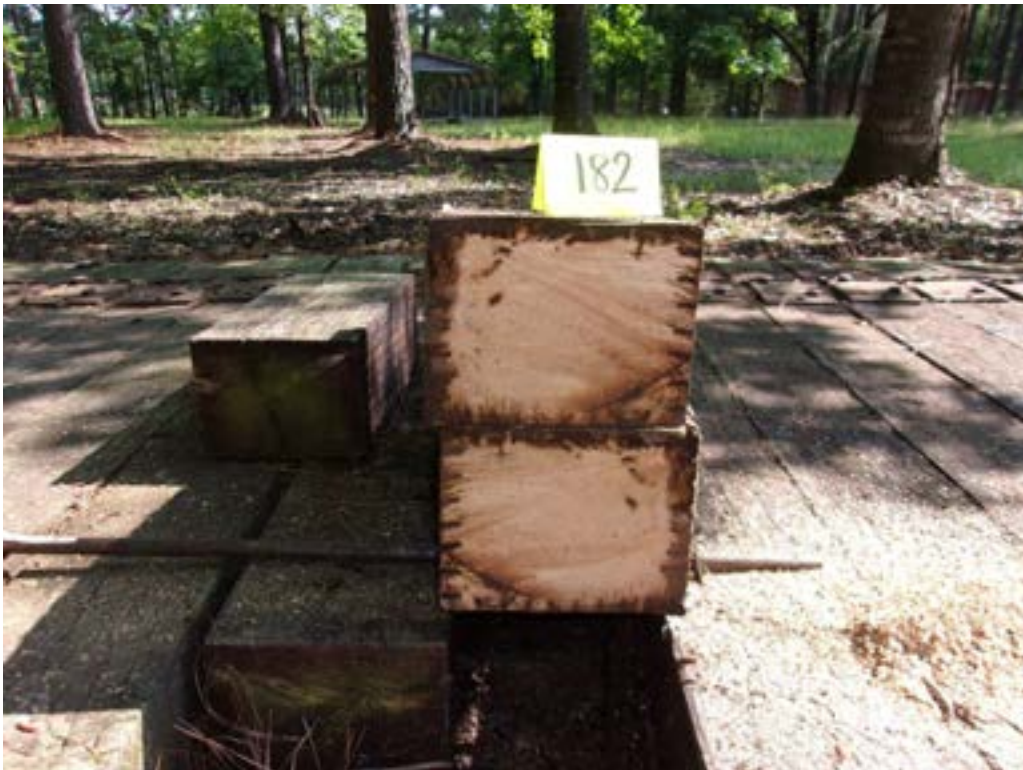
**Figure 40** - Tie #182 Douglas fir/P2 creosote (Lonza).

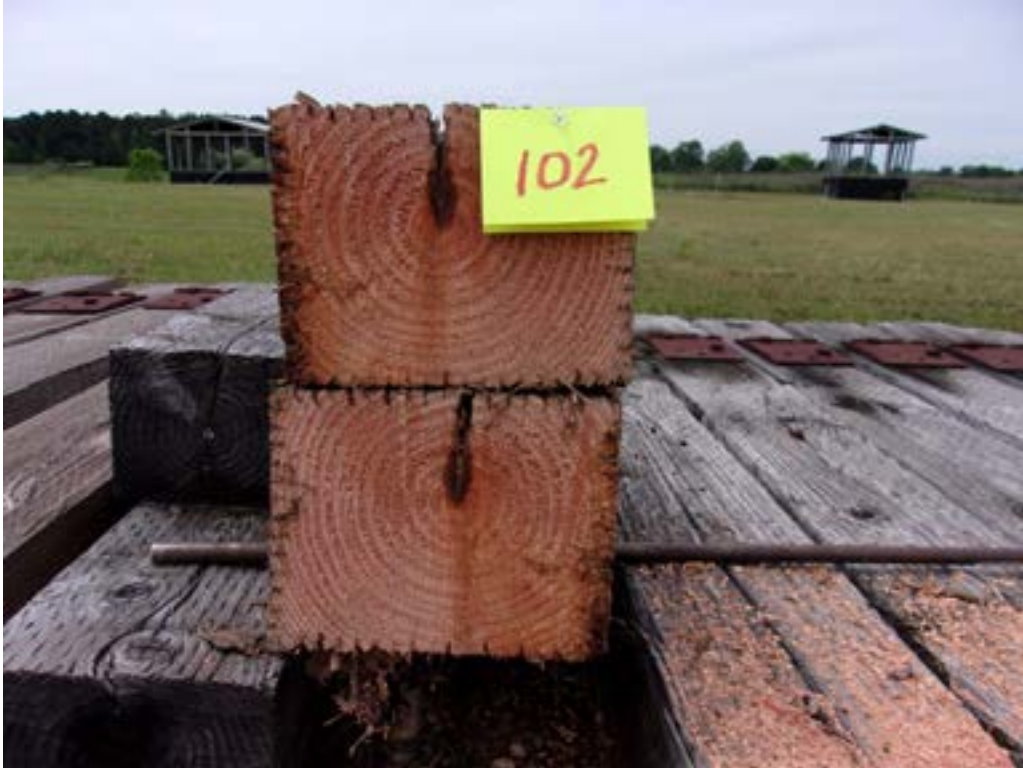
Figure 74 - Tie #102 untreated Douglas fir.

99	696			10	10			end plate corroded
100	700			10	10			end plate corroded
101	795	DF-Unt.	x		x	x	x	cut 2016
102	794			7	10	x	x	cut 2019
103	793			9.5	10			check/IS/FB
104	792			8	10			check/IS
105	791			10	10			check/IS
106	800			9	10			FB/IS
107	799			10	10			check/IS
108	798			10	10			FB/check/IS
109	797			9	10			check/IS
110	796			8	9.5			check/LP
111	755	WO-ACZA	x		x	x	x	cut 2016
112	754			10	10	x	x	cut 2019
113	753			10	10			end plate corroded
114	752			10	10			end plate corroded/check/LP
115	751			10	10			end plate corroded
116	760			10	10			Knot/burl under plate area N end
117	759			10	10			end plate corroded
118	758			10	10			check/end plat corroded
119	757			10	10			check/end plat corroded
120	756			10	10			end plate corroded
121	712	RO-ACZA	x		x	x	x	cut 2016
122	713			10	10	x	x	cut 2019
123	714			10	10			end plate corroded/check
124	715			10	10			end plate corroded
125	717			10	10			end plate corroded/check
