**FOREST AND WILDLIFE RESEARCH CENTER**

**Seventh Annual Evaluation of Phase II MSU/RTA Alternative Preservative Study**

**June 5, 2019**

## **Seventh Annual Evaluation of Phase II MSU/RTA Alternative Preservative Study**

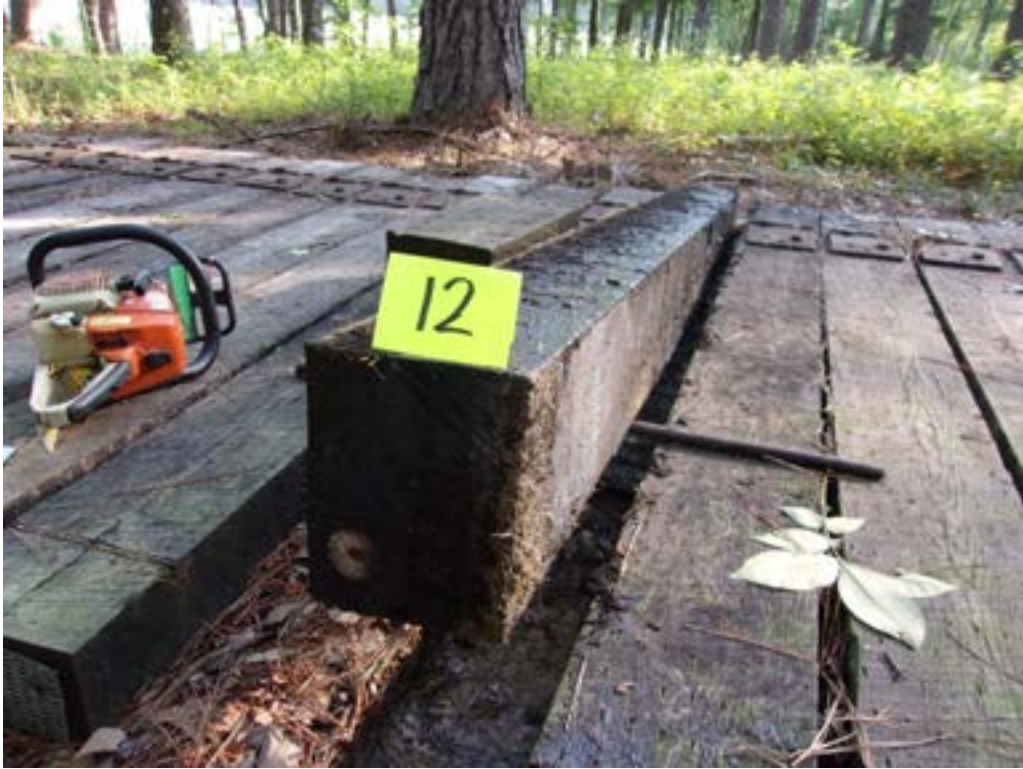
**Figure 3** - Tie #12 red oak/borate/creosote 7lbs (Koppers).

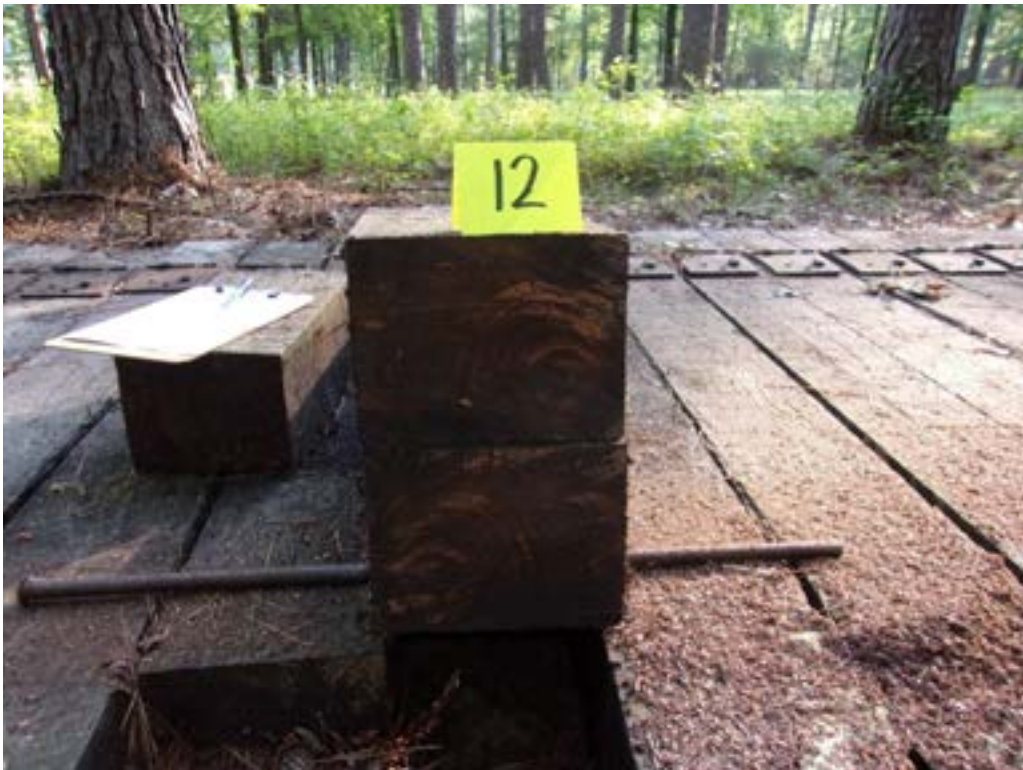
**Figure 4** - Tie #12 red oak/borate/creosote 7lbs (Koppers).

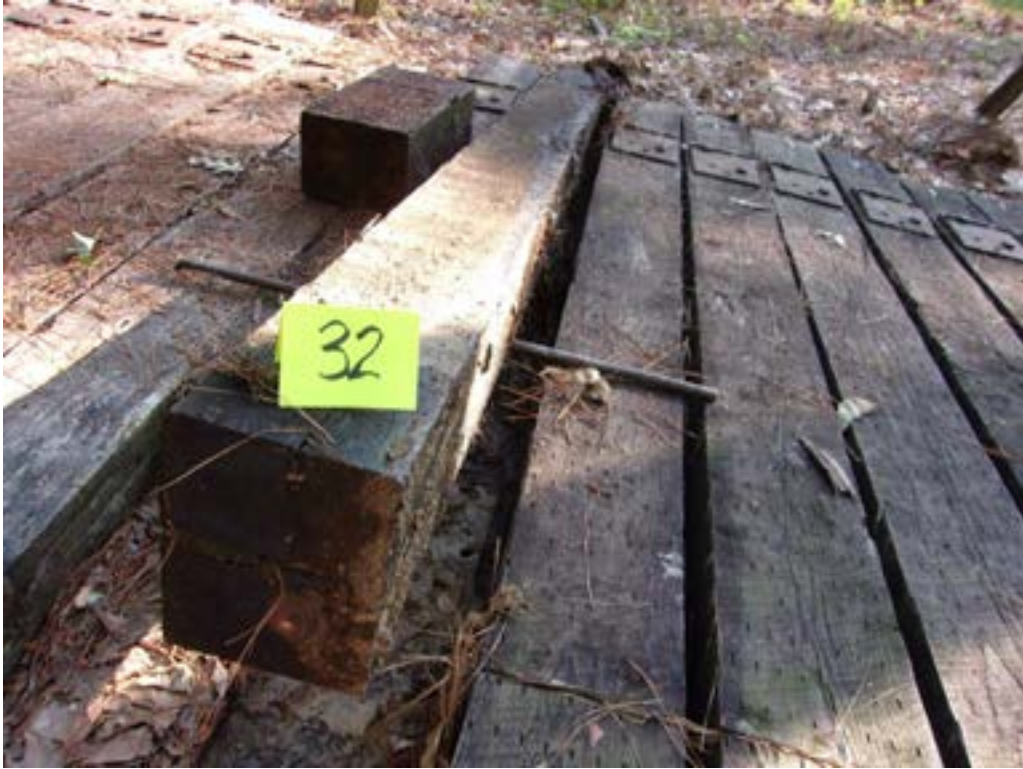
**Figure 7 - Tie #32 red oak/creosote 7lbs (Koppers).**

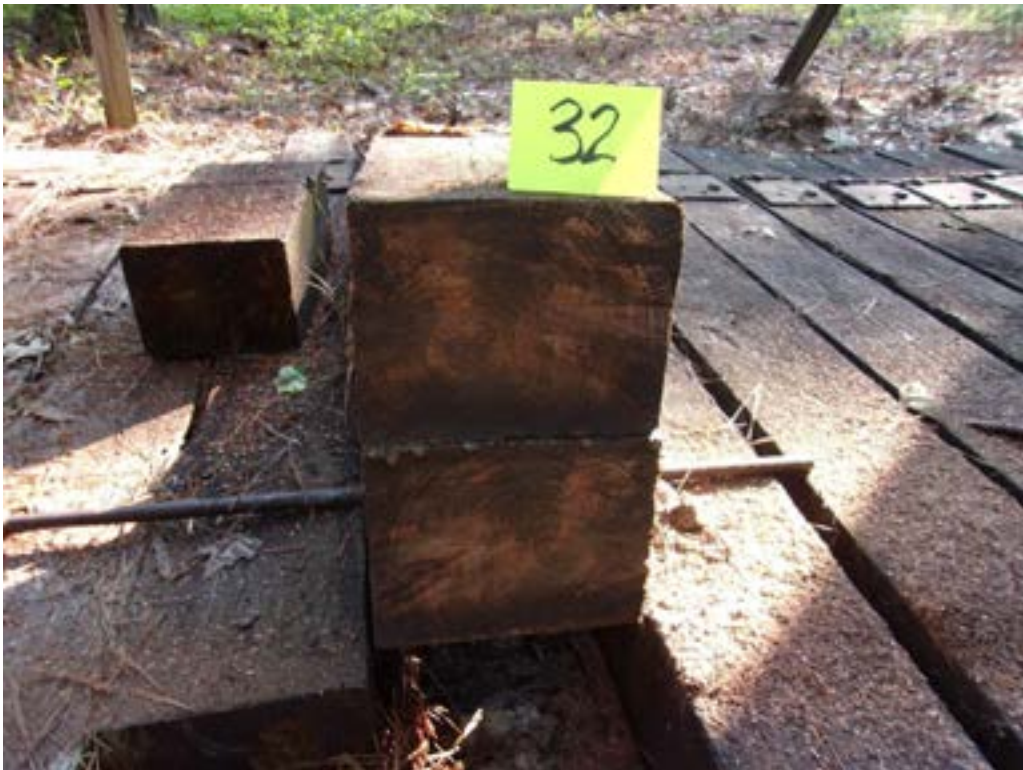
**Figure 8 - Tie #32 red oak/creosote 7lbs (Koppers).**

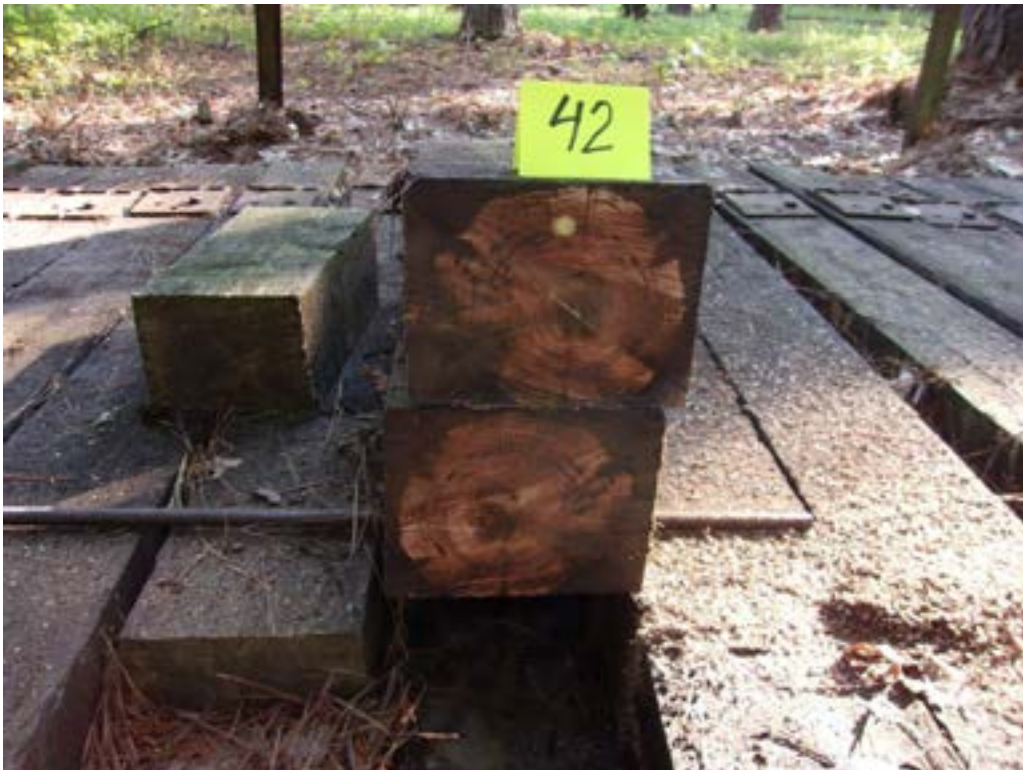
**Figure 10** - Tie #42 white oak/borate/creosote 7lbs (Koppers).

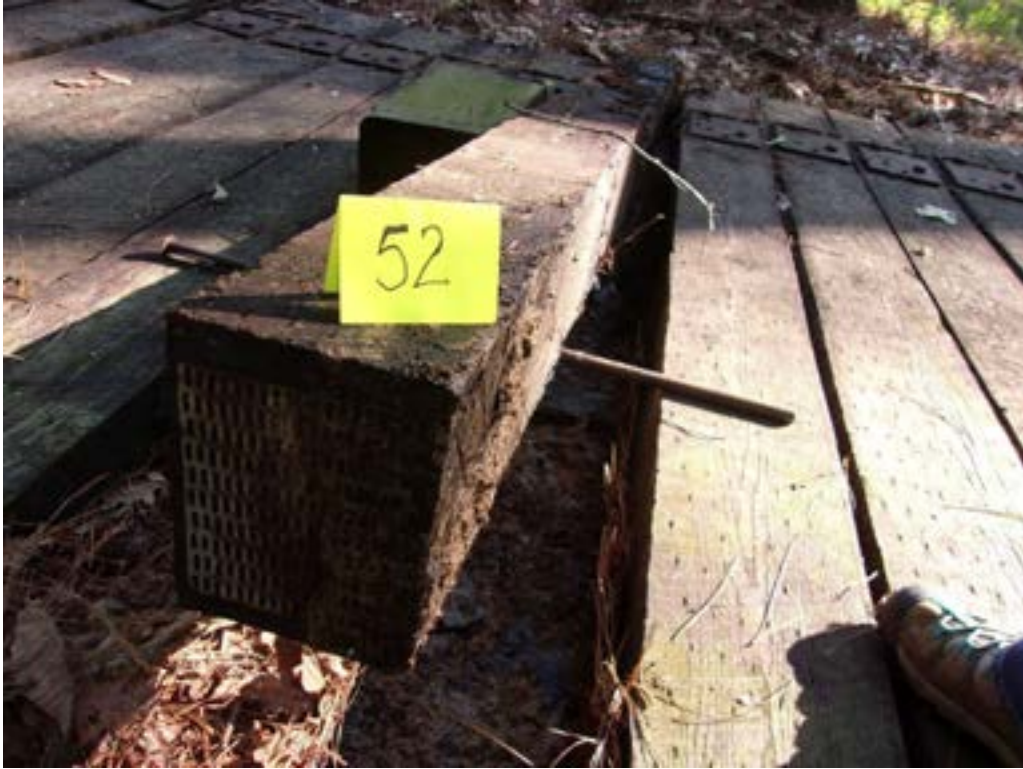
**Figure 11** - Tie #52 red oak/borate/creosote 6lbs (Koppers).

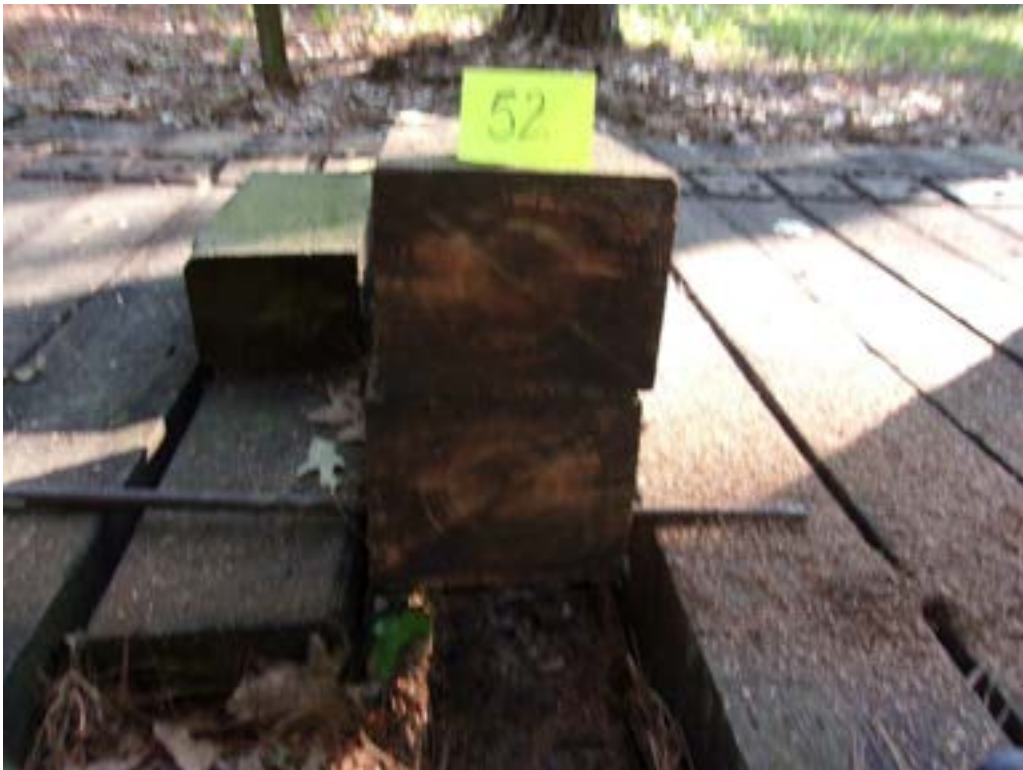
**Figure 12** - Tie #52 red oak/borate/creosote 6lbs (Koppers).

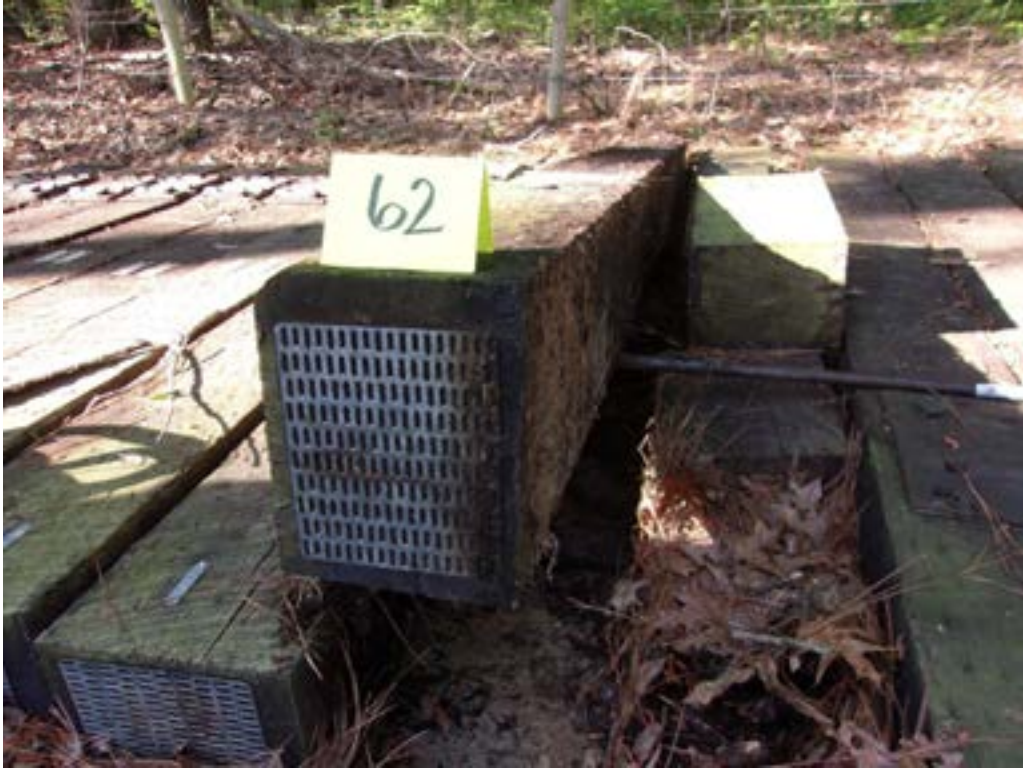
**Figure 13** - Tie #62 red oak/1 step creosote borate (Stella Jones).

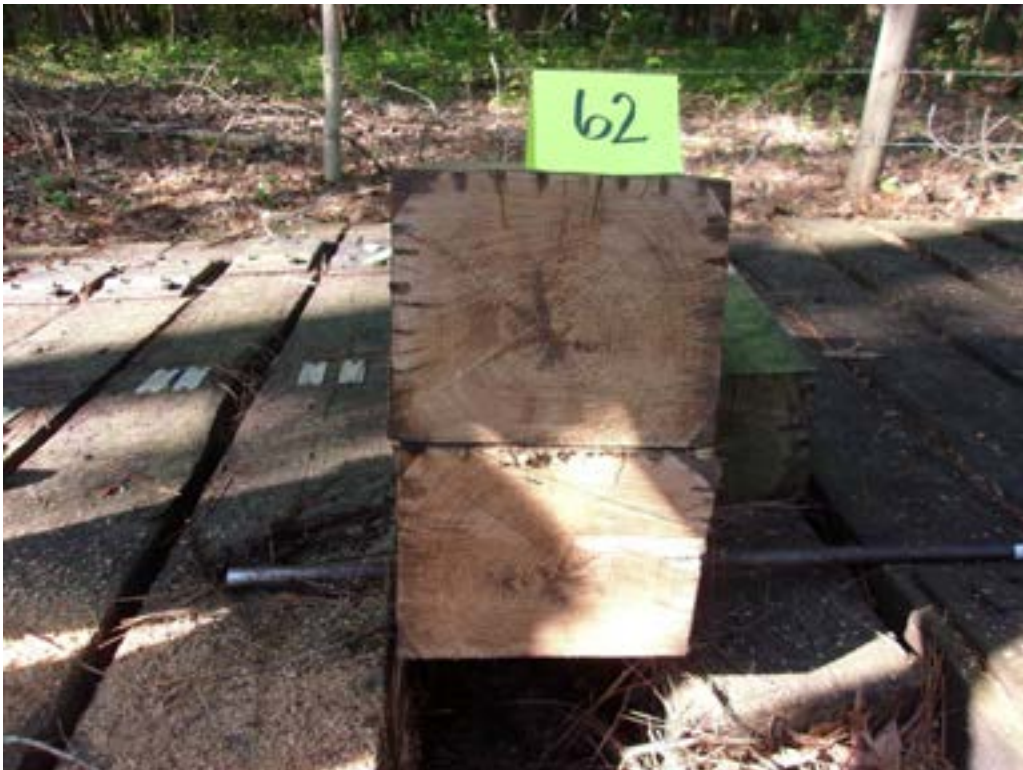
**Figure 14** - Tie #62 red oak/1 step creosote borate (Stella Jones).

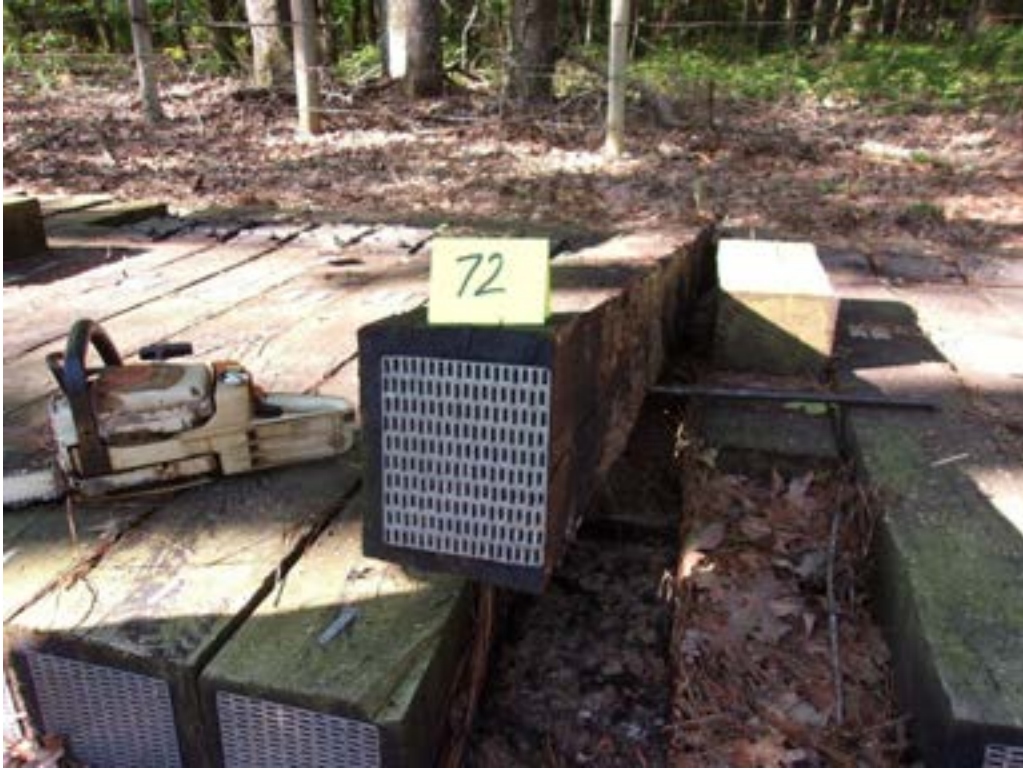
**Figure 15** - Tie #72 white oak/creosote (Stella Jones).

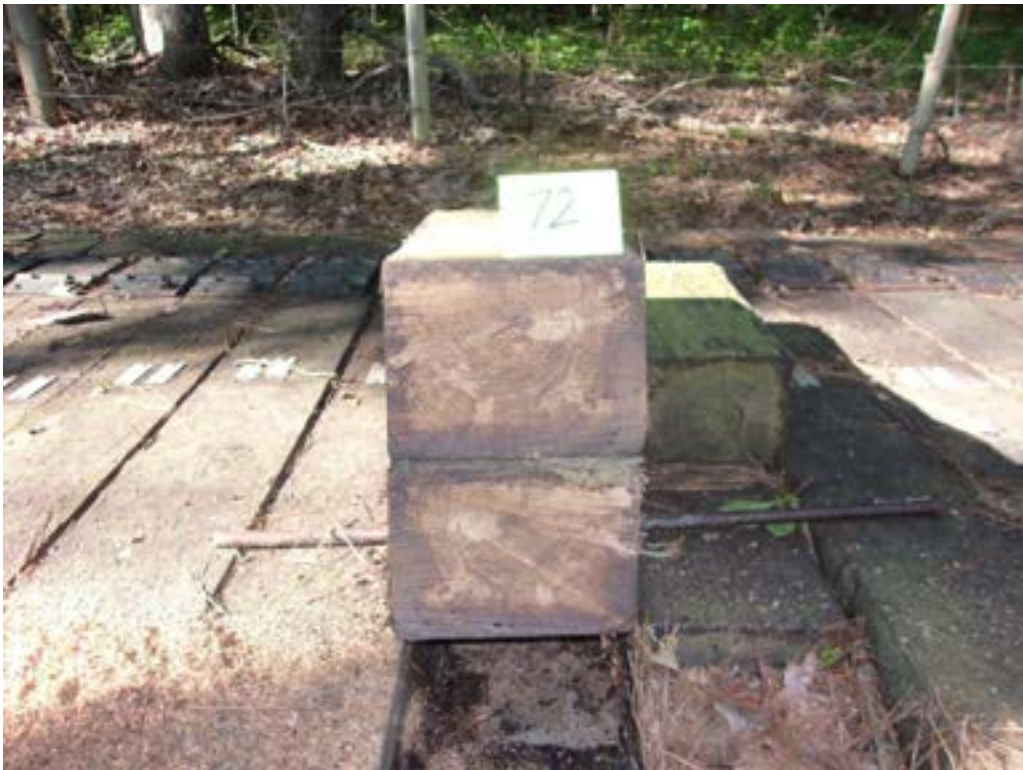
**Figure 16** - Tie #72 white oak/creosote (Stella Jones).

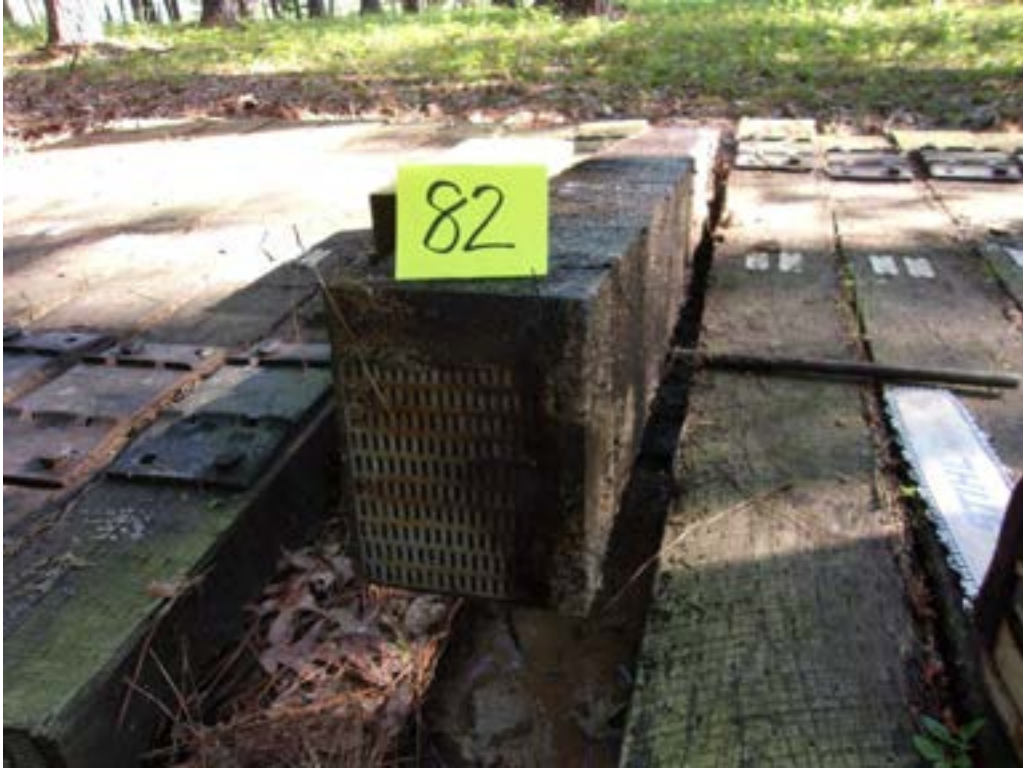
**Figure 17** - Tie #82 white oak/one step creosote borate (Stella Jones).

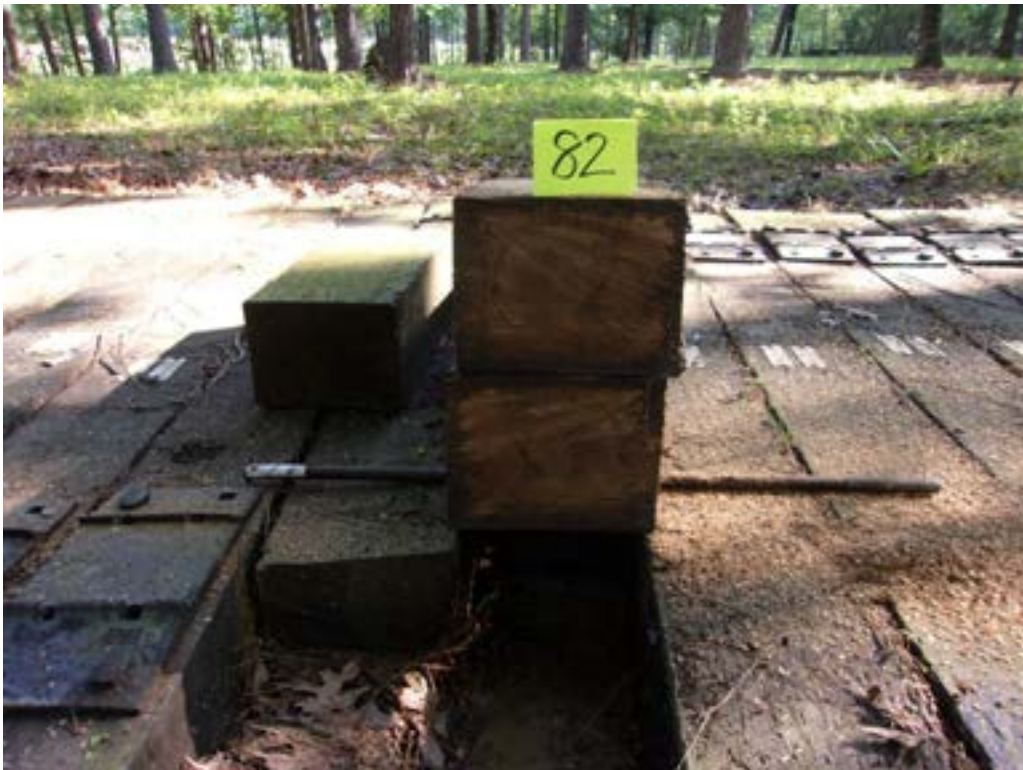
**Figure 18** - Tie #82 white oak/one step creosote borate (Stella Jones).

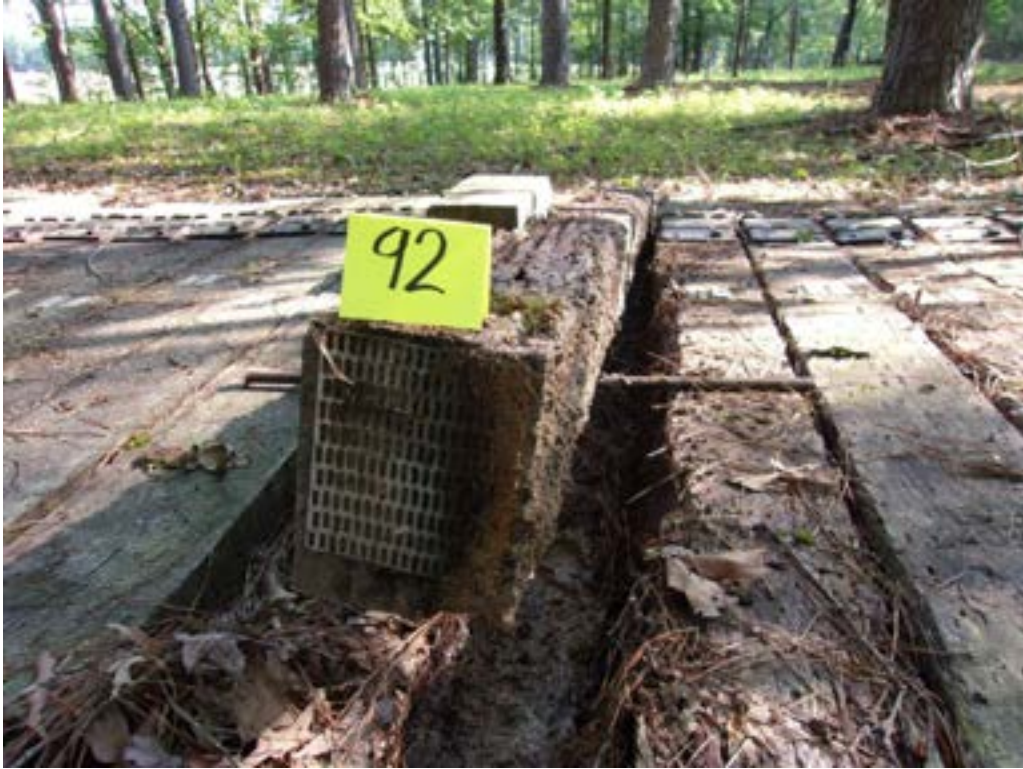
**Figure 19** – Tie # 92 untreated white oak.

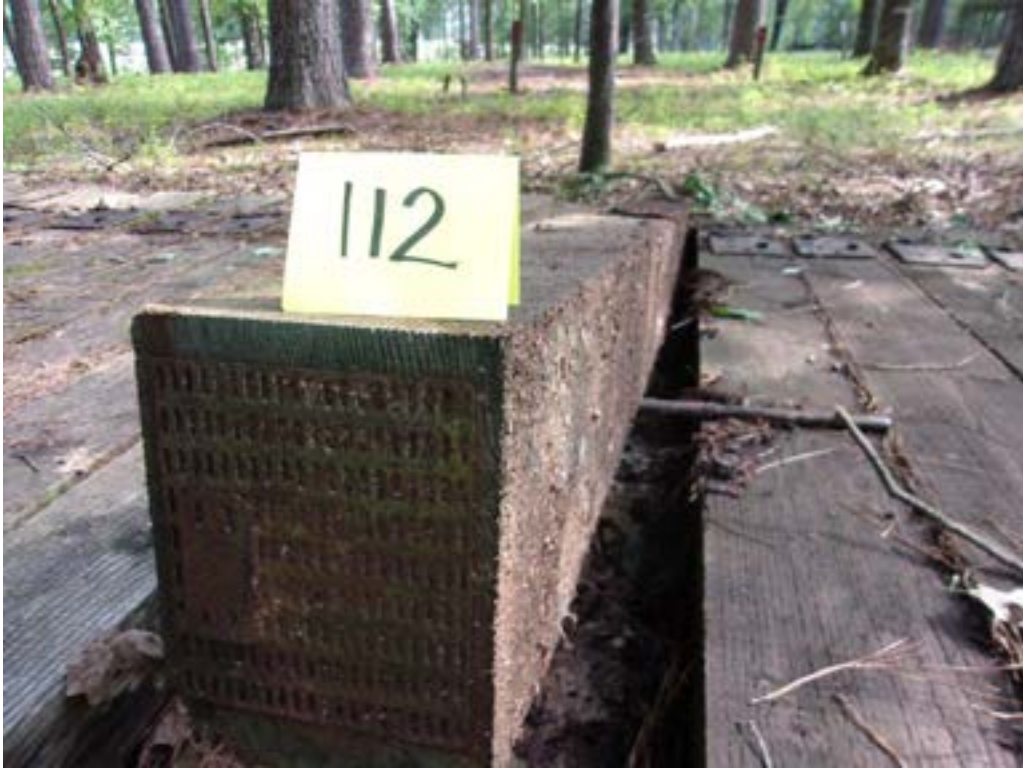
**Figure 23** – Tie #112 Douglas fir/DOT/ACZA (Lonza).

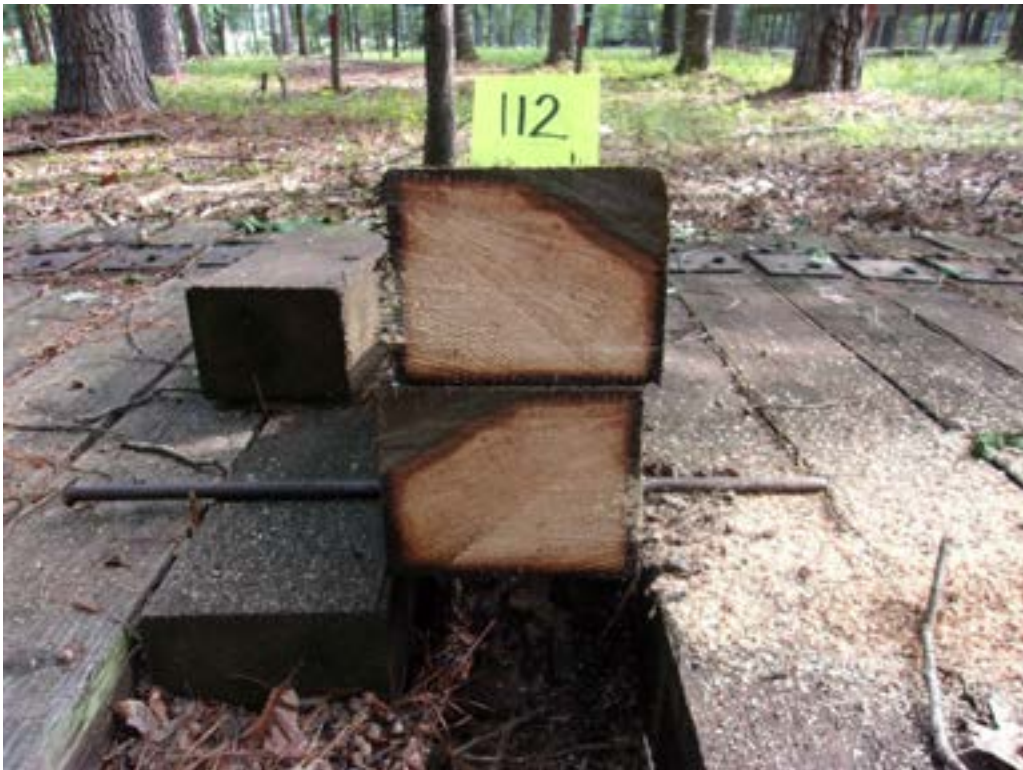
**Figure 24** - Tie #112 Douglas fir/DOT/ACZA (Lonza).

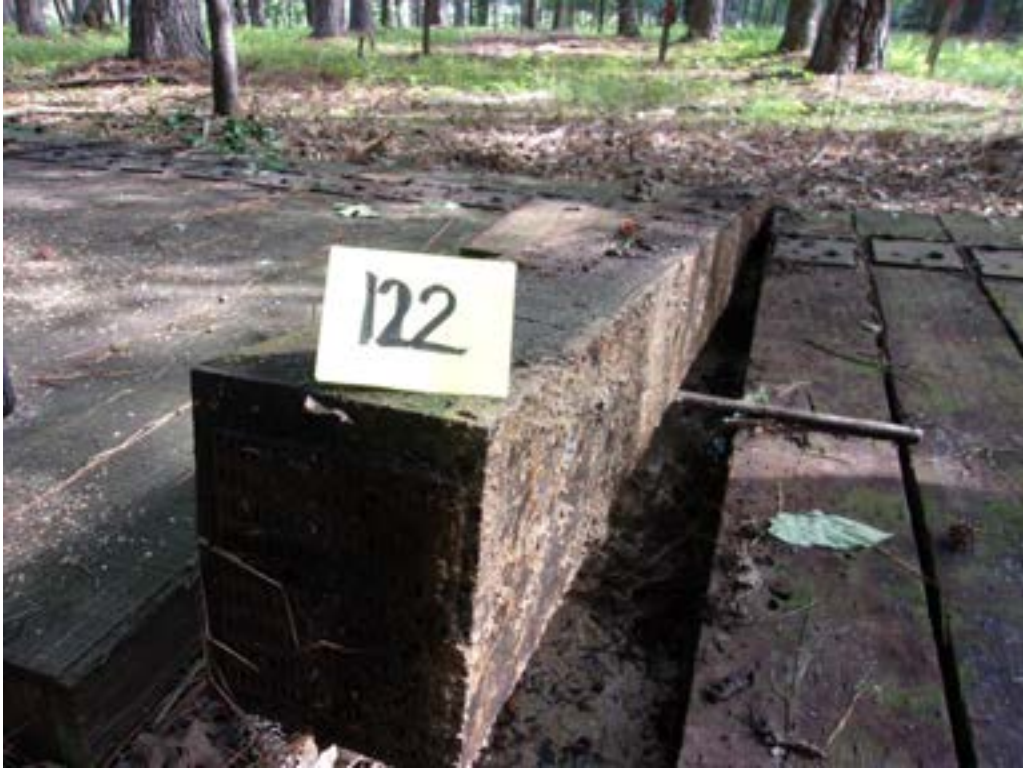
**Figure 25** – Tie #122 red oak/DOT/ACZA/oil (Lonza).

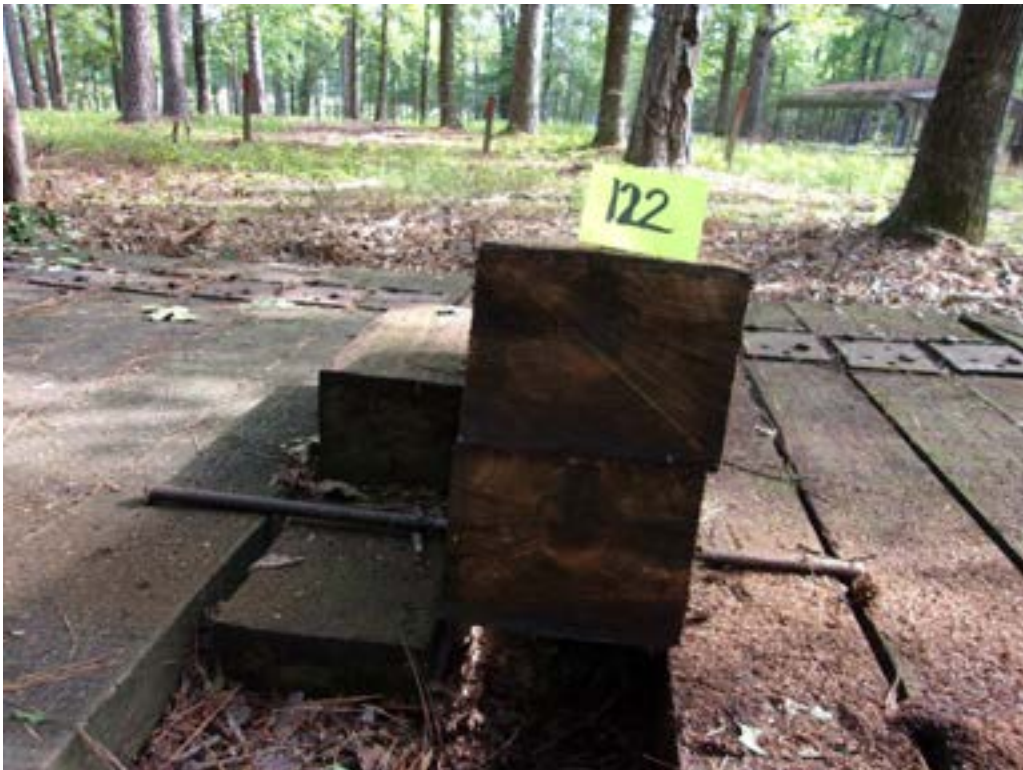
**Figure 26** - Tie #122 red oak/DOT/ACZA/oil (Lonza).

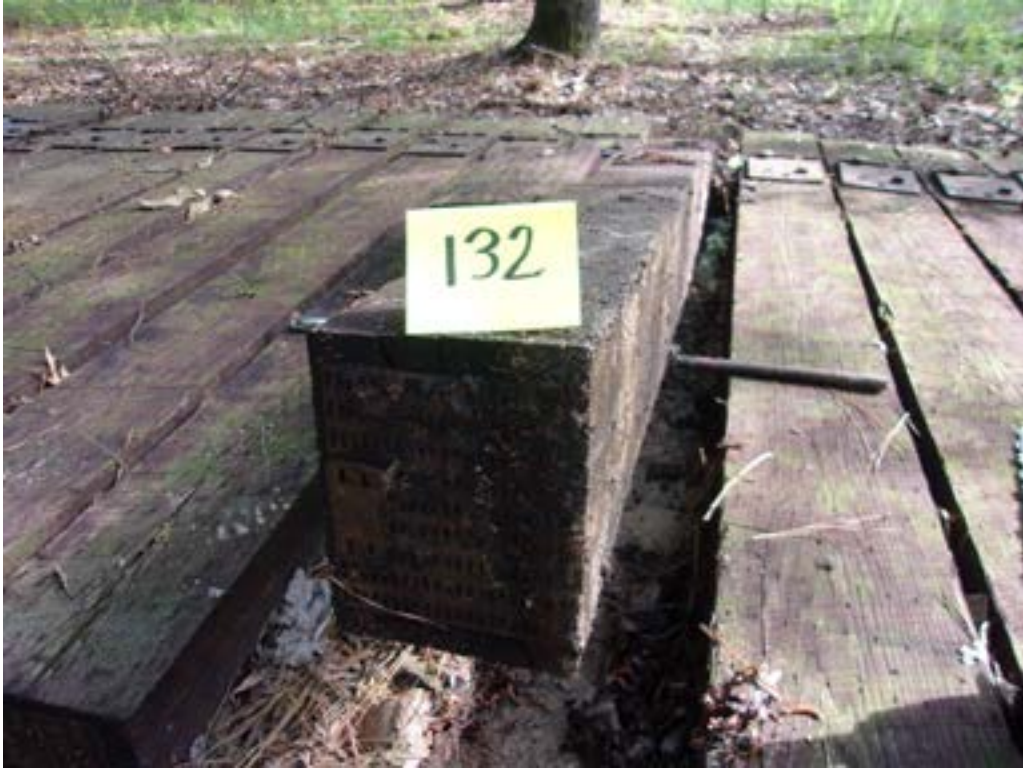
**Figure 27** – Tie #132 red oak/ACZA/oil (Lonza).

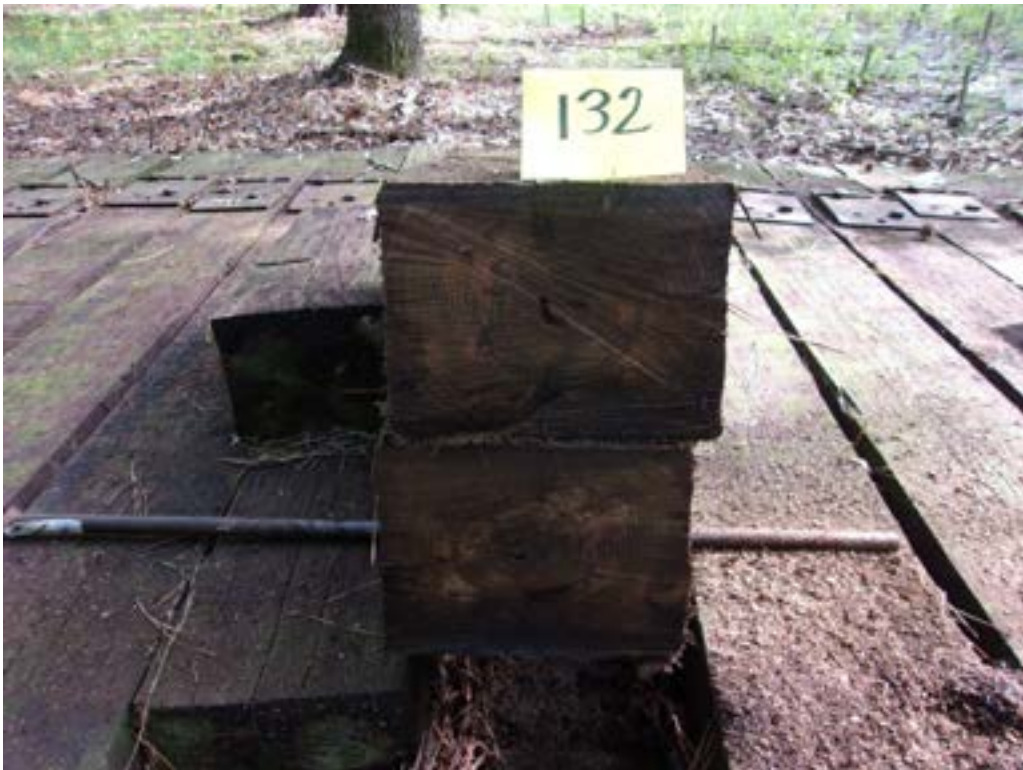
**Figure 28** - Tie #132 red oak/ACZA/oil (Lonza).

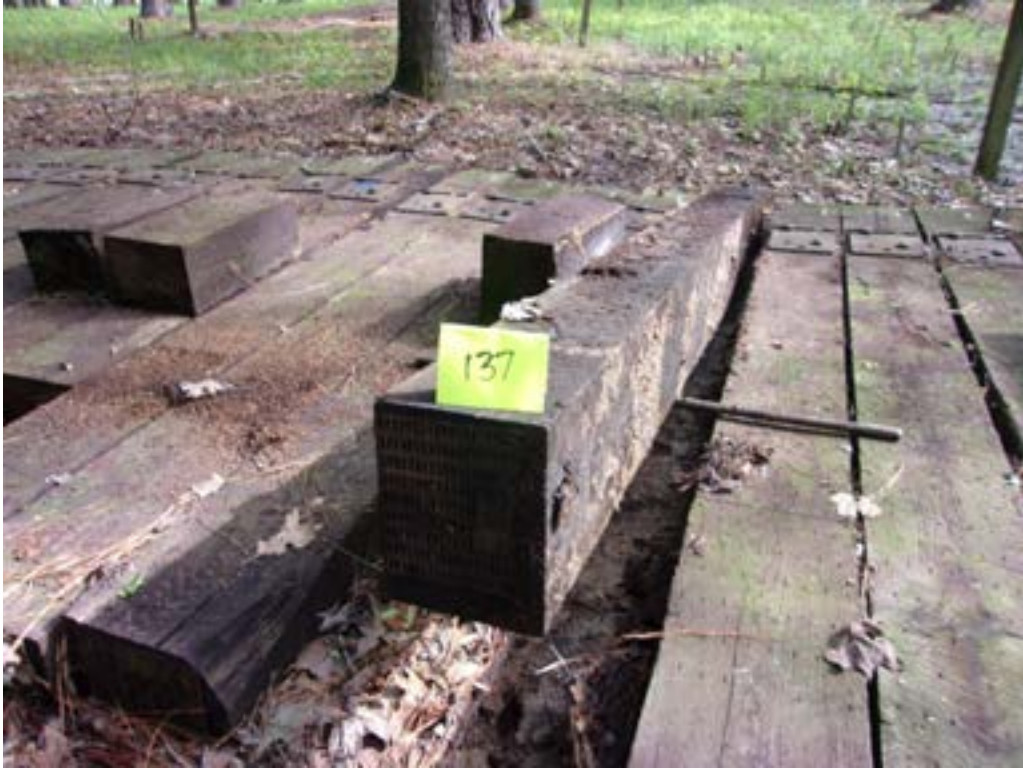
**Figure 29** – Tie #137 white oak/ACZA/oil (Lonza).

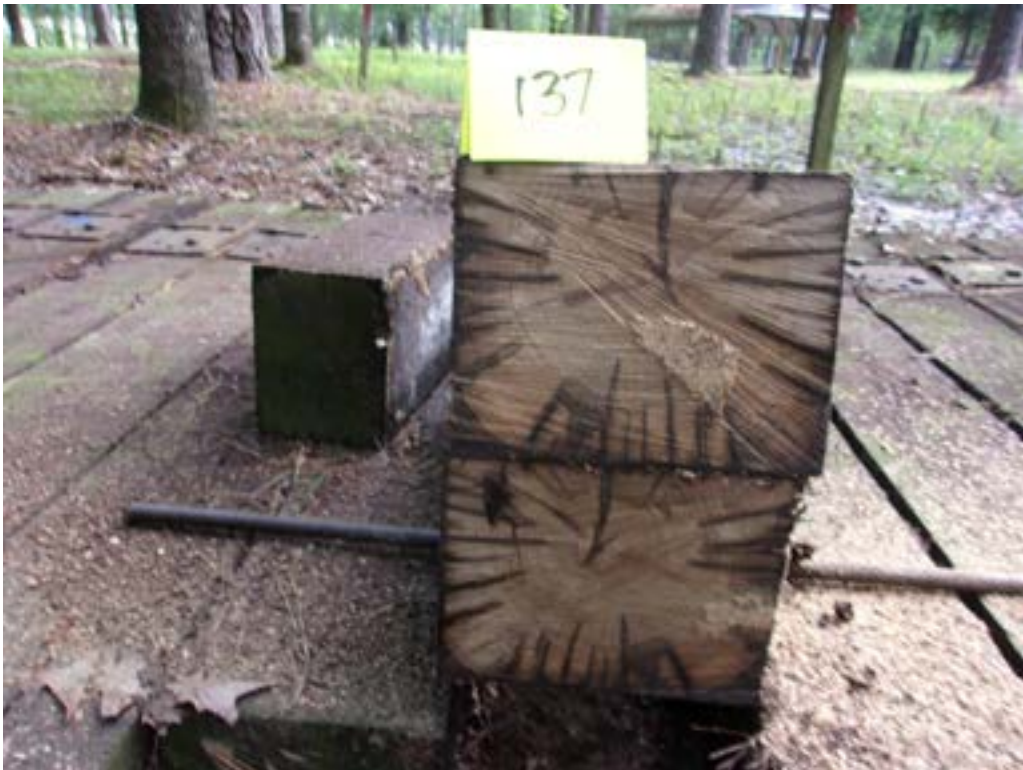
**Figure 30** - Tie #137 white oak/ACZA/oil (Lonza).

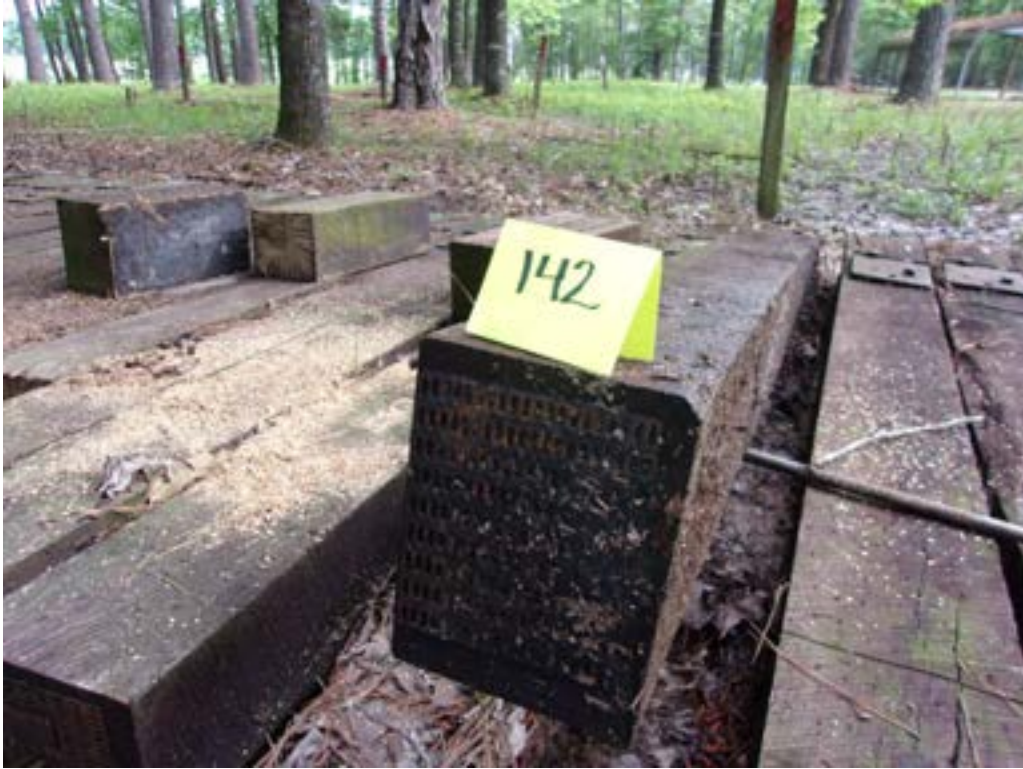
**Figure 31** – Tie #142 white oak/DOT/ACZA/oil (Lonza).

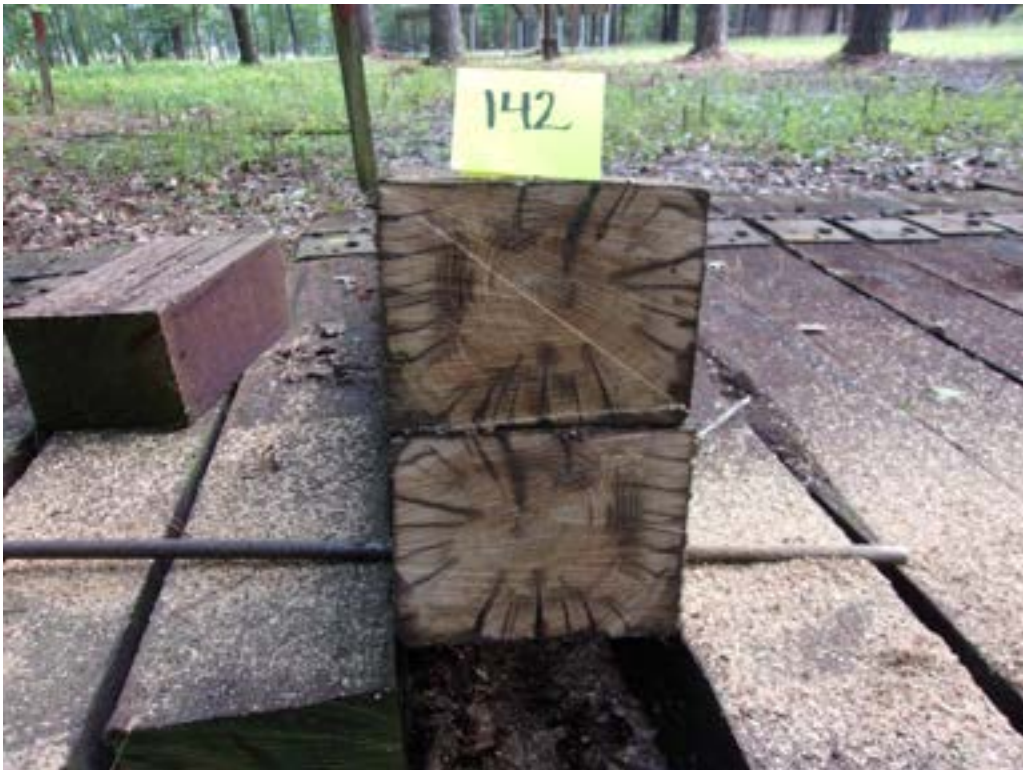
**Figure 32** - Tie #142 white oak/DOT/ACZA/oil (Lonza).

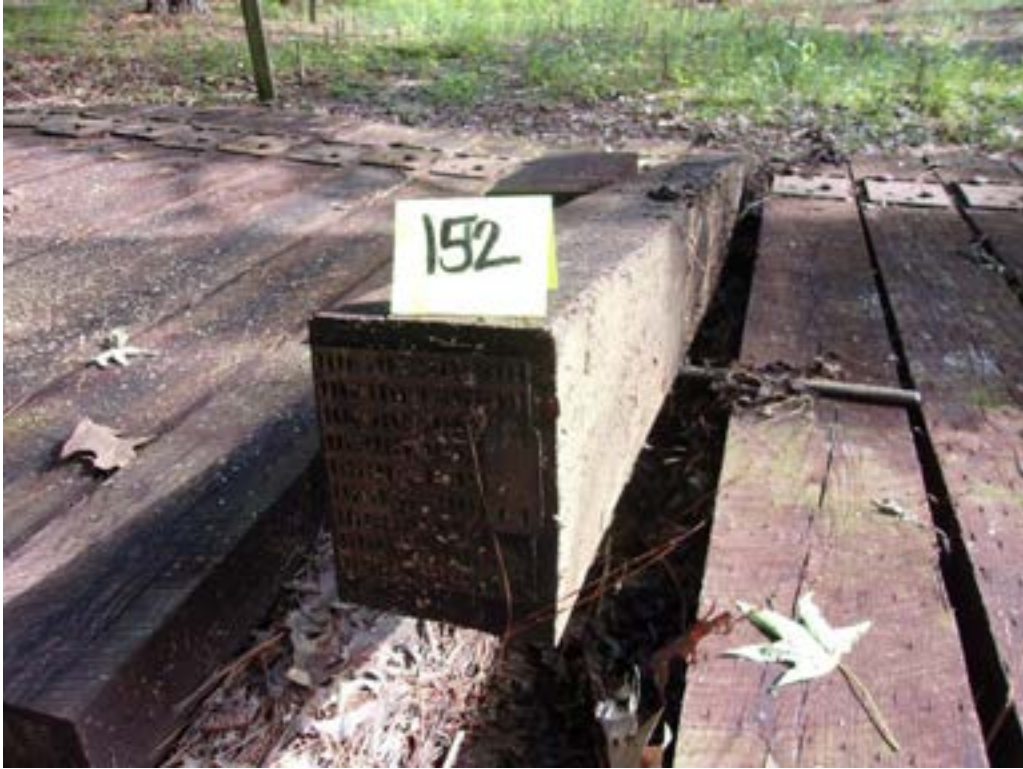
**Figure 33** - Tie # 152 red oak/DOT/ACZA/oil (Lonza).

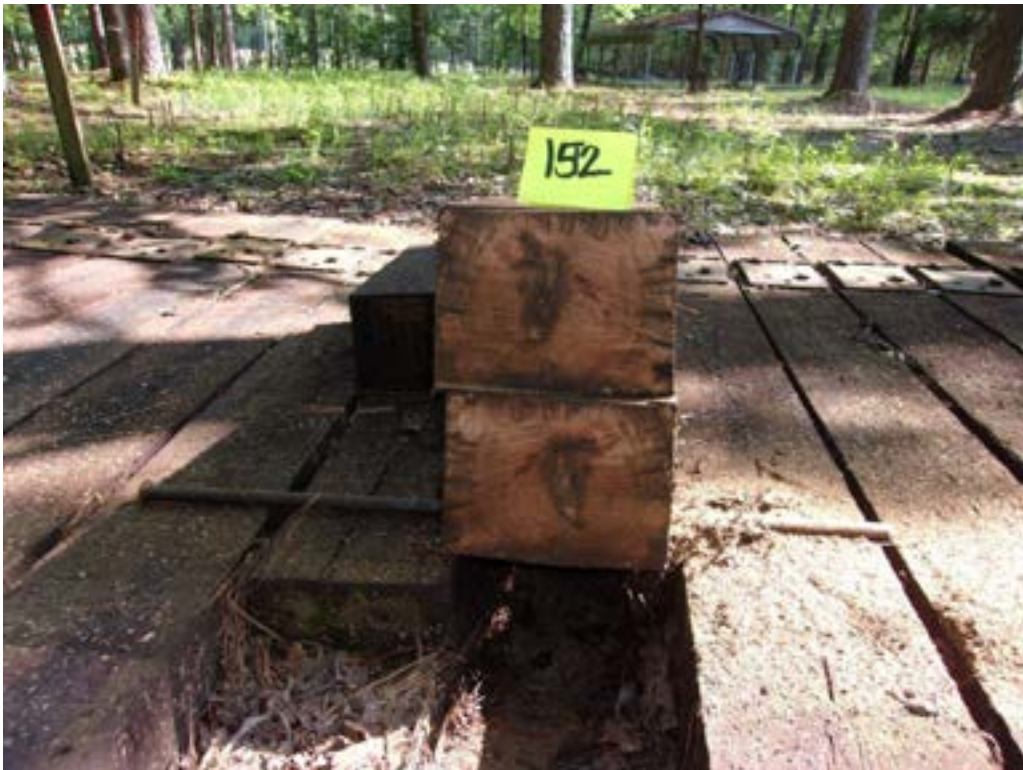
**Figure 34** - Tie # 152 red oak/DOT/ACZA/oil (Lonza).

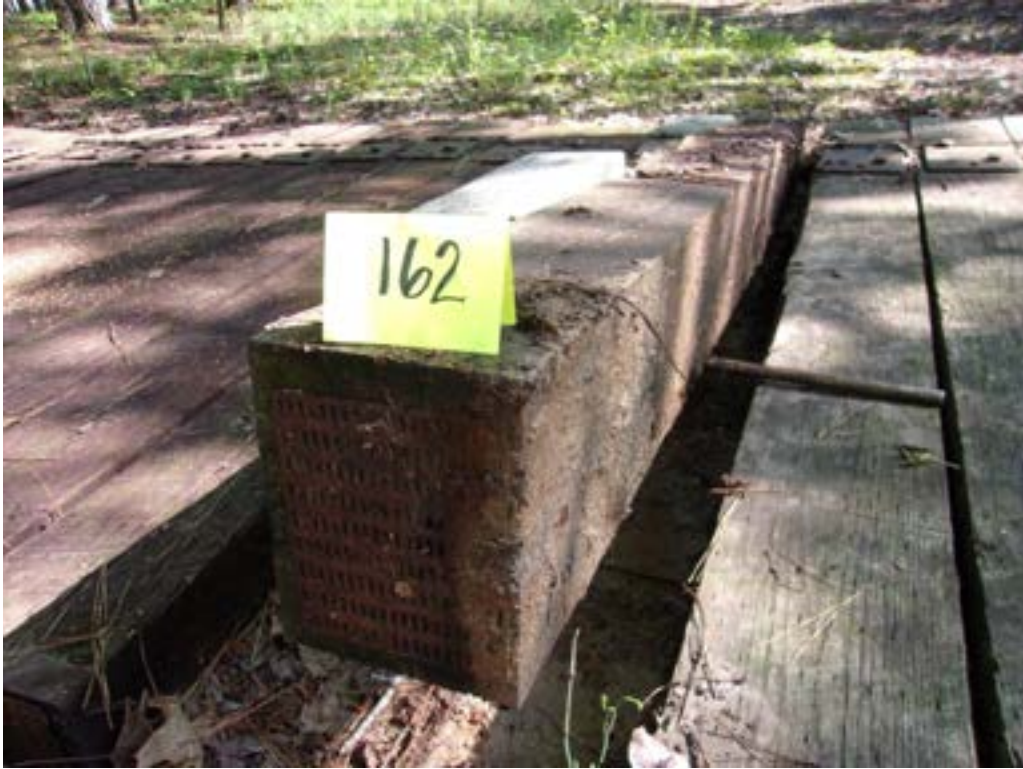
**Figure 35** – Tie #162 red oak/ACZA (Lonza).

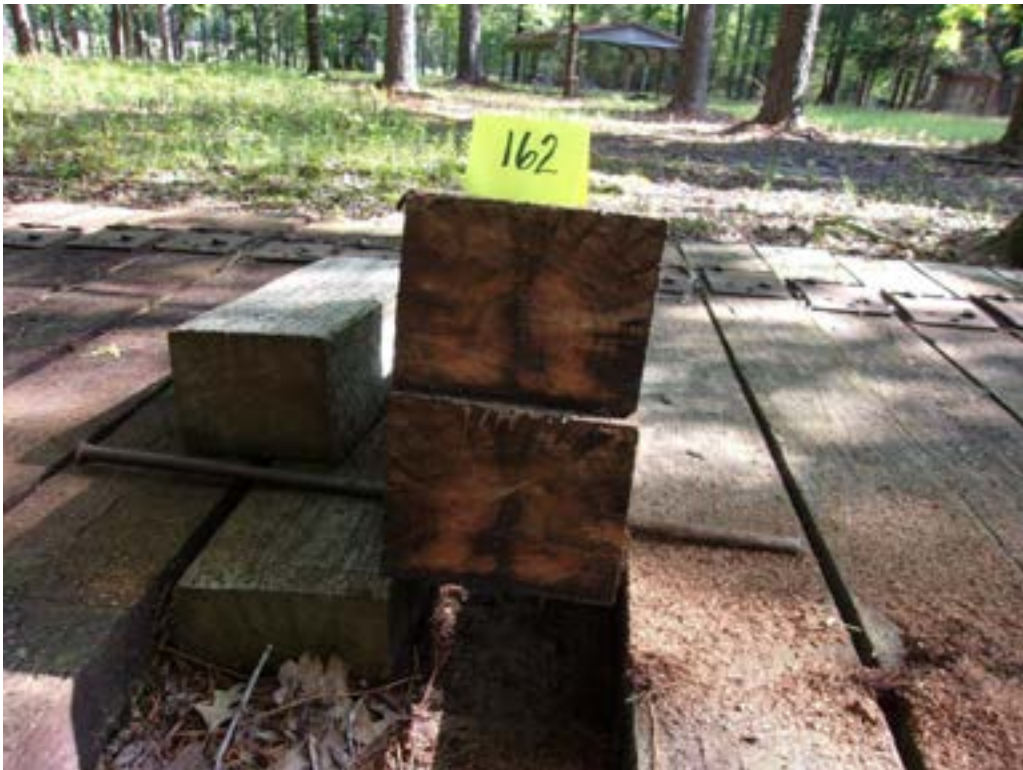
**Figure 36** - Tie #162 red oak/ACZA (Lonza).

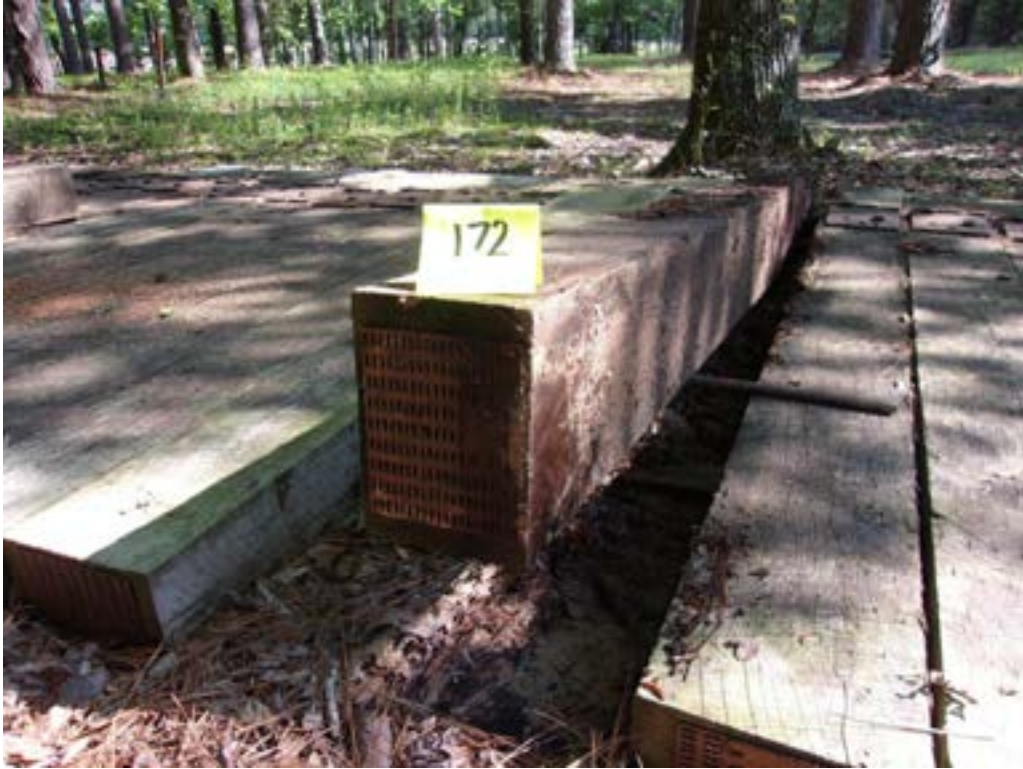
**Figure 37** – Tie #172 white oak/ACZA (Lonza).
