**FOREST AND WILDLIFE RESEARCH CENTER**

**Seventh Annual Evaluation of Phase II MSU/RTA Alternative Preservative Study**

**June 5, 2019**

## **Seventh Annual Evaluation of Phase II MSU/RTA Alternative Preservative Study**

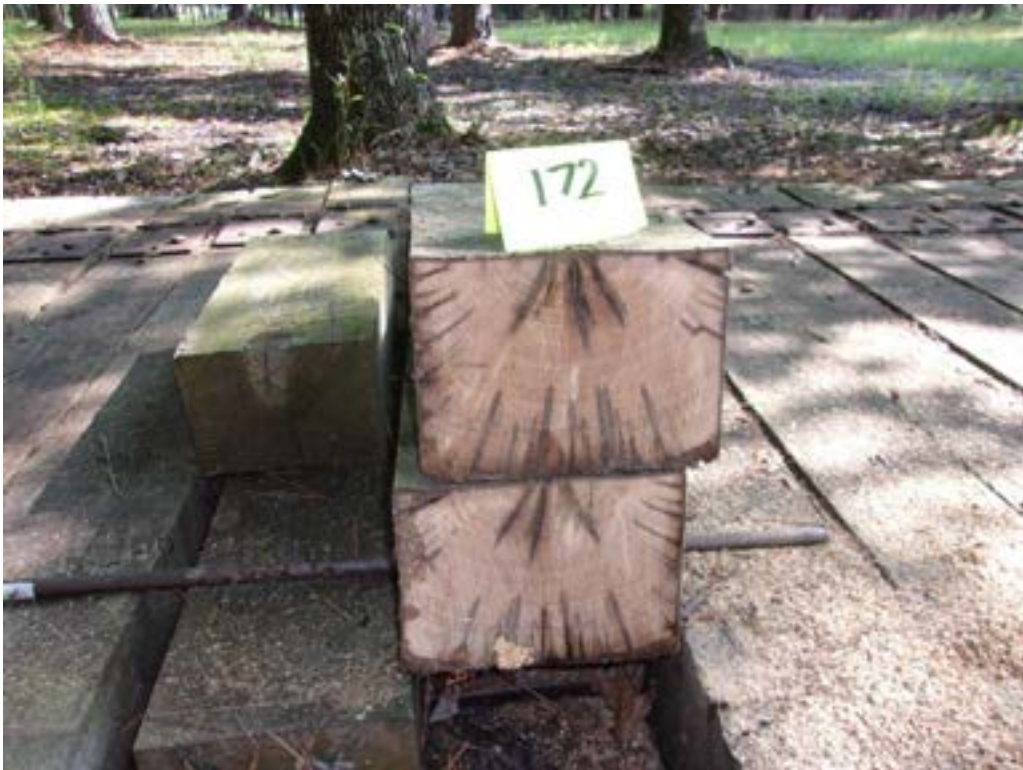
**Figure 38** - Tie #172 white oak/ACZA (Lonza).

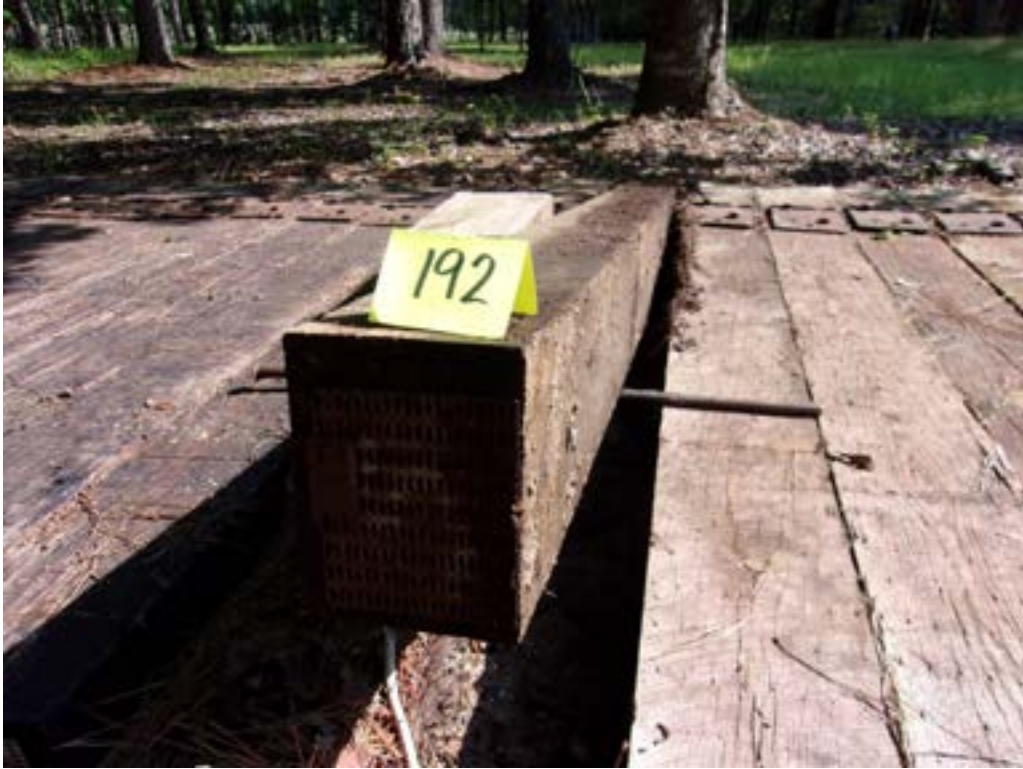
**Figure 41** – Tie #192 white oak/ACZA/ET (Lonza).

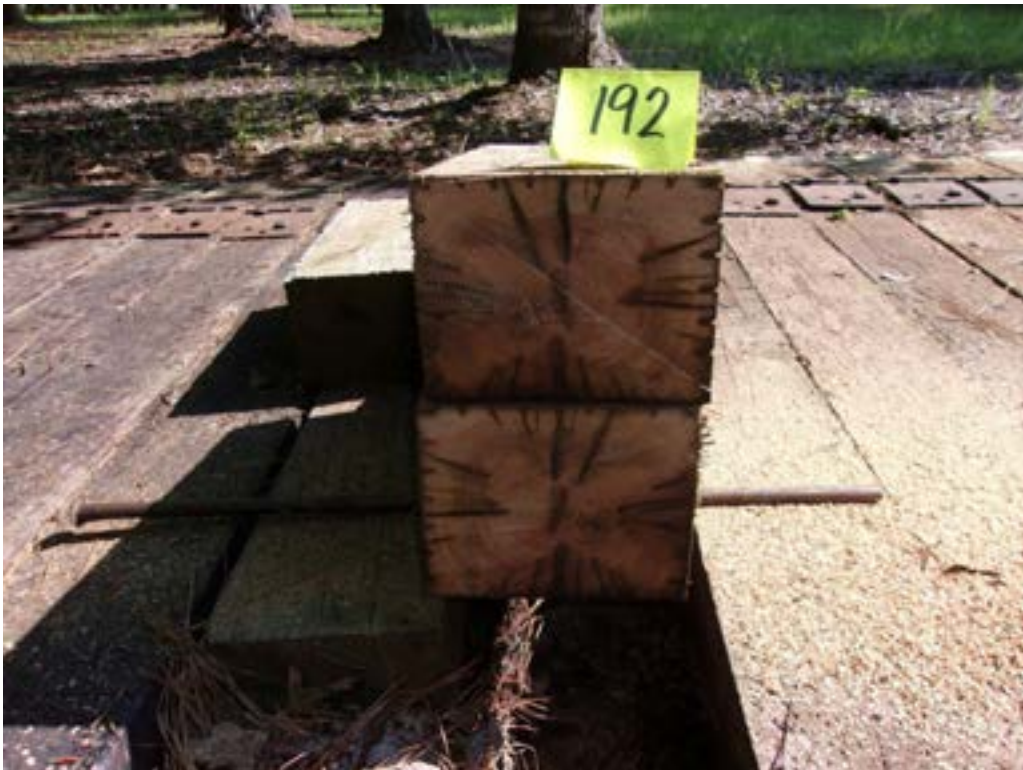
**Figure 42-** Tie #192 white oak/ACZA/ET (Lonza).

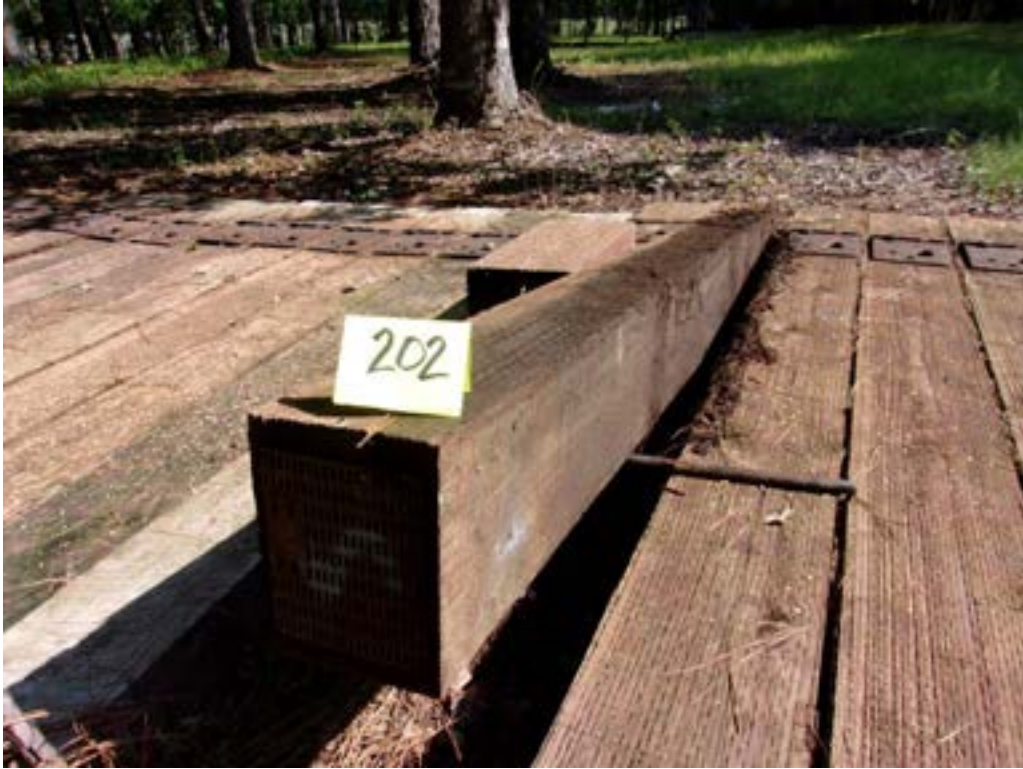
**Figure 43** – Tie #202 Douglas fir/ACZA/DOT/ET (Lonza).

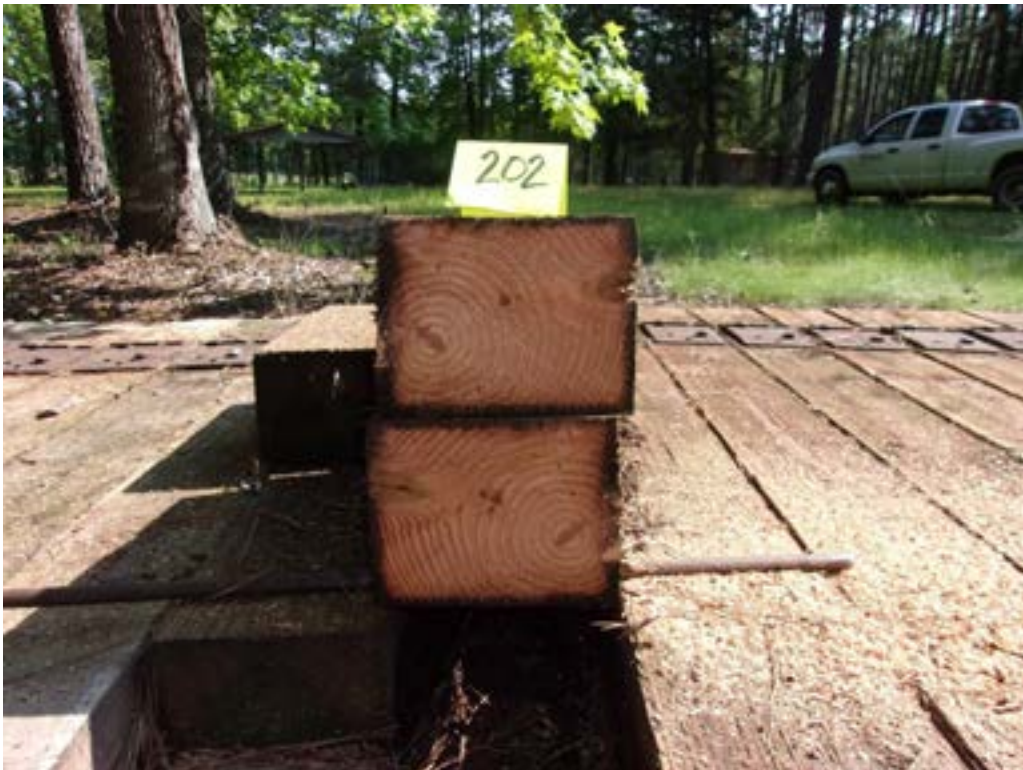
**Figure 44** - Tie #202 Douglas fir/ACZA/DOT/ET (Lonza).

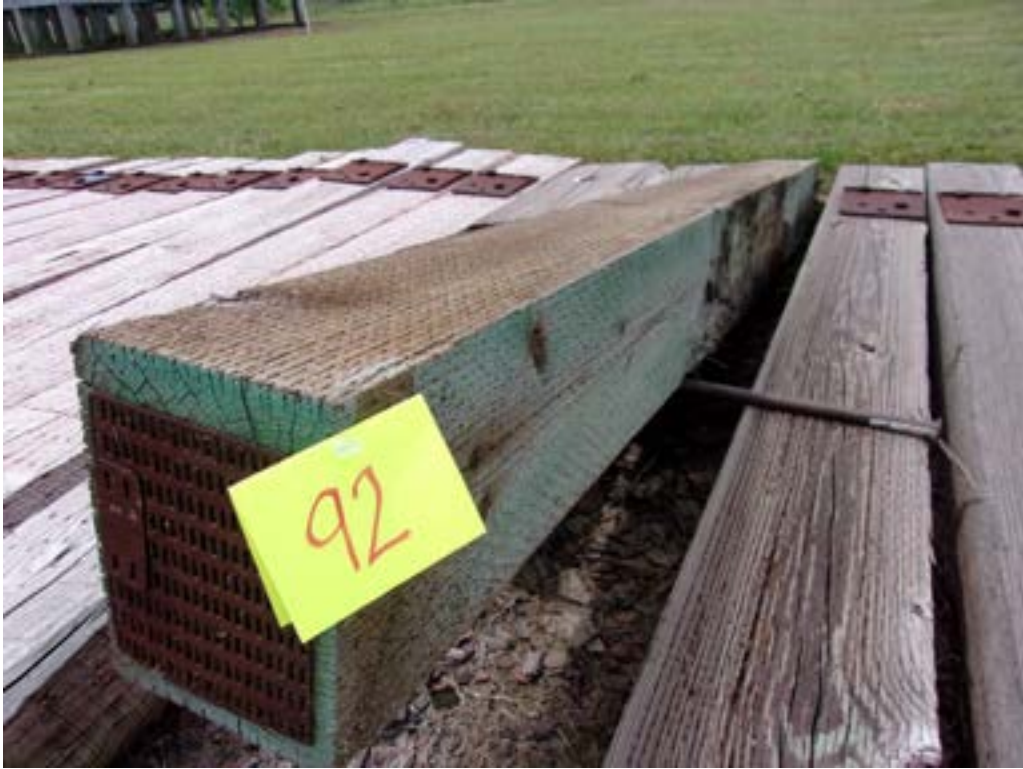
**Figure 71 – Tie #92 Douglas fir/DOT/ACZA (Lonza).**

88	633			10	10			check
89	632			10	10			check/LP/S-end plate loose
90	631			10	10			
91	695	DF-DOT-ACZA	x		x	x	x	cut 2016
92	694			10	10	x	x	cut 2019
93	693			10	10			check/end plat corroded/LP
94	692			10	10			end plate corroded/check
95	691			10	10			end plate corroded
96	699			10	10			end plate corroded/check
97	698			10	10			end plate corroded/check
98	697			10	10			end plate corroded/check/LP
