**MISSISSIPPI STATE
UNIVERSITY™**

**FOREST AND WILDLIFE RESEARCH CENTER
DEPARTMENT of SUSTAINABLE BIOPRODUCTS**

Fourteenth Annual Evaluation of MSU/RTA Alternative Preservative Study

August 22, 2022

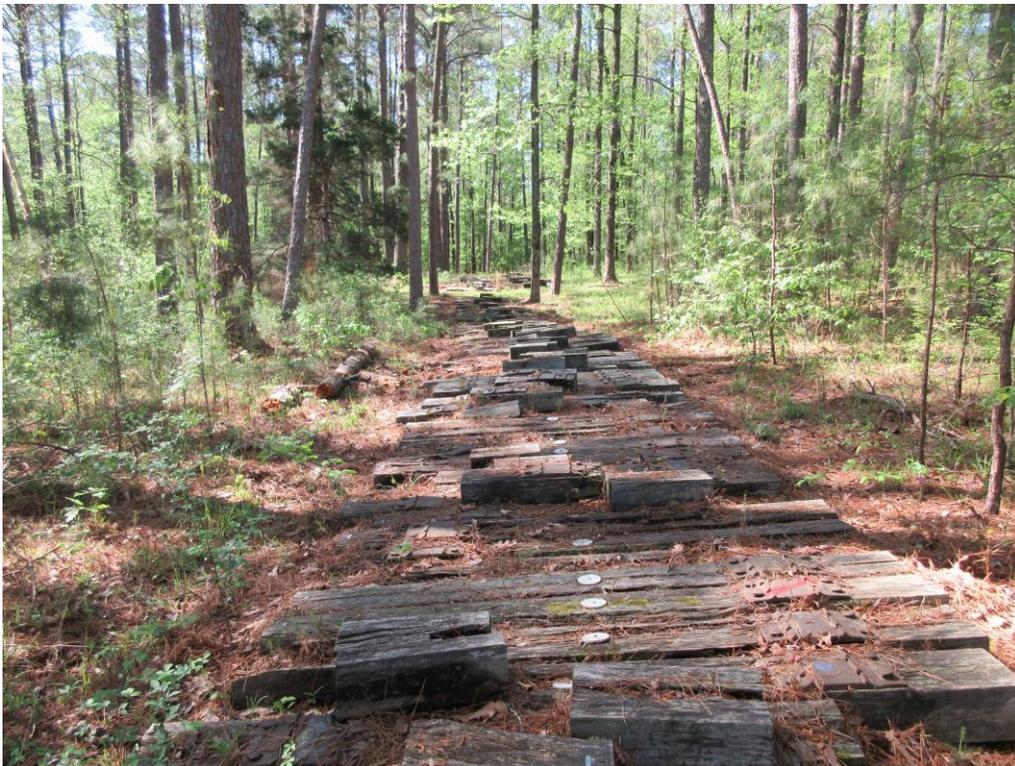
Figure 1 - An overall view of exposure Site 1 illustrating the conditions at the time of inspection.

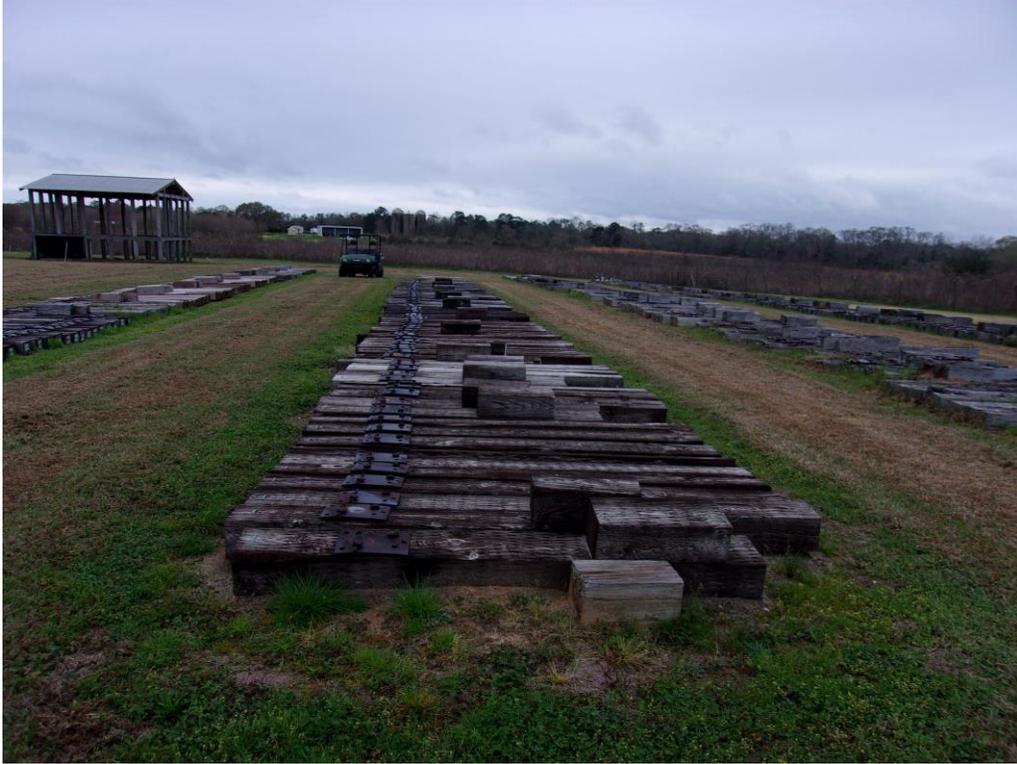
Figure 2 - A general photograph of Site 2 at the time of inspection.

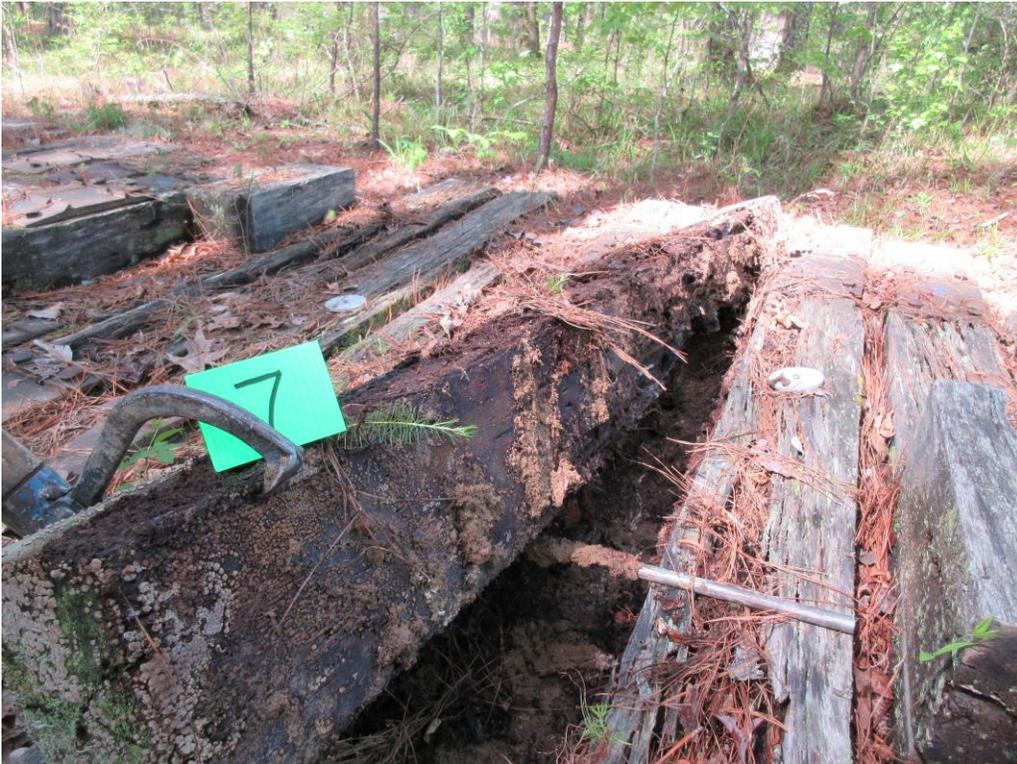
A1 - Tie #7 (Cedarcide/white oak) with heavy decay.

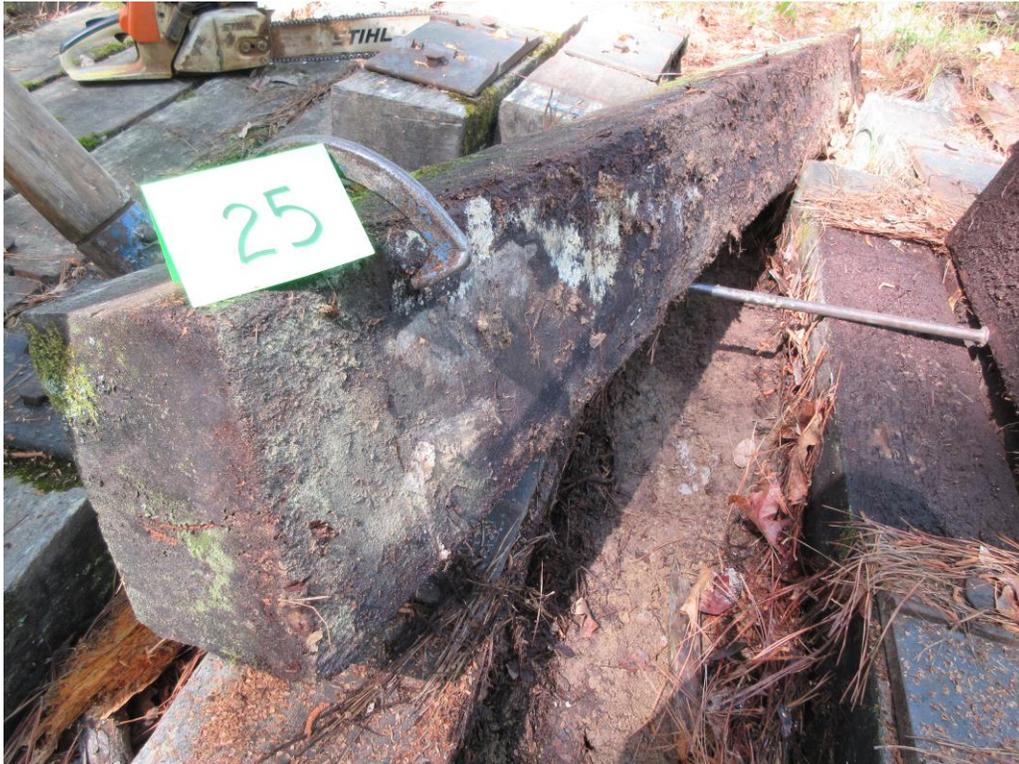
A5 – Tie #25 (Turada) with decay on bottom and side.

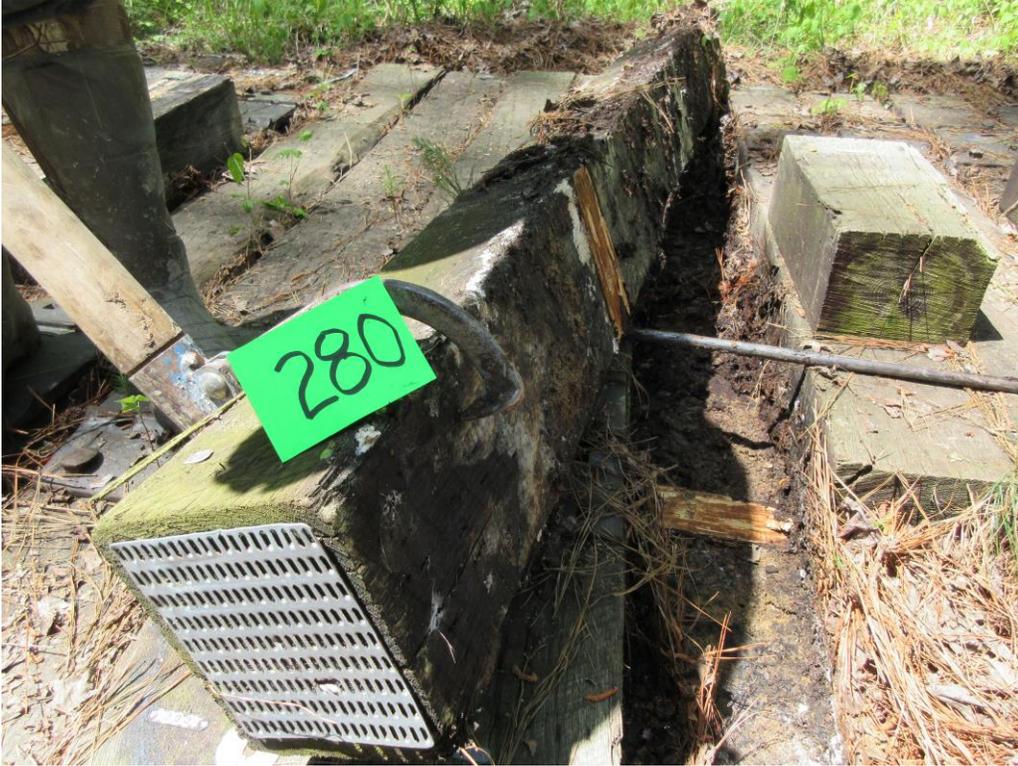
A57 - Tie #280 (Koppers/red oak/P2 creosote).

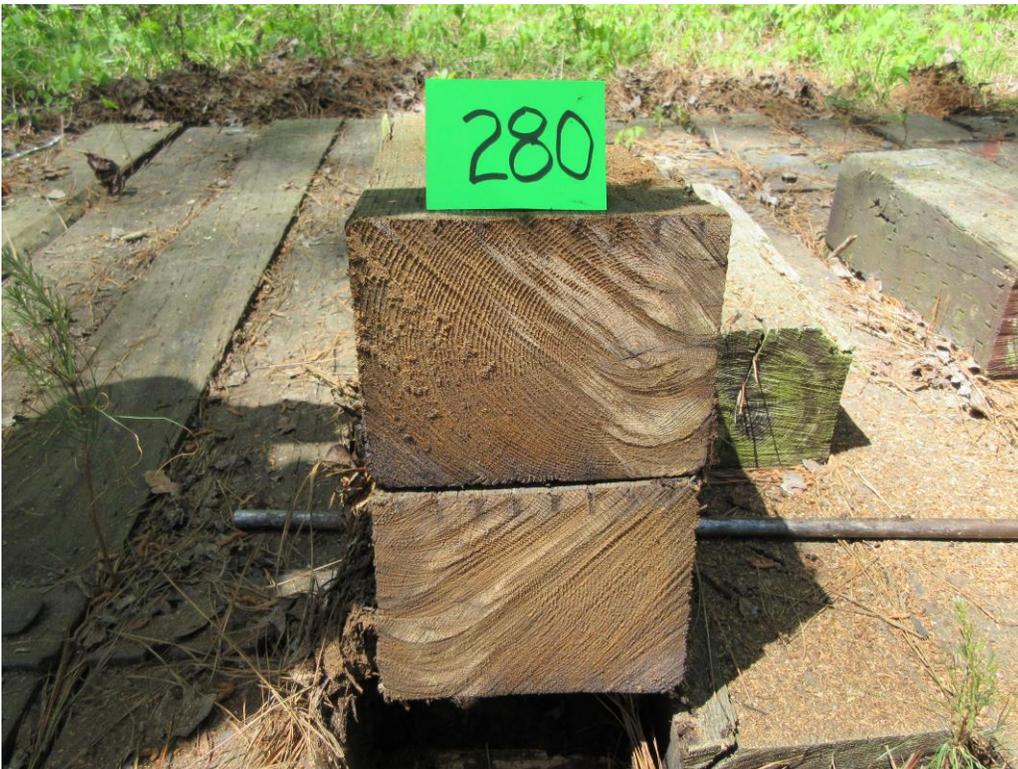
A58 - Tie #280 (Koppers/red oak/P2 creosote).

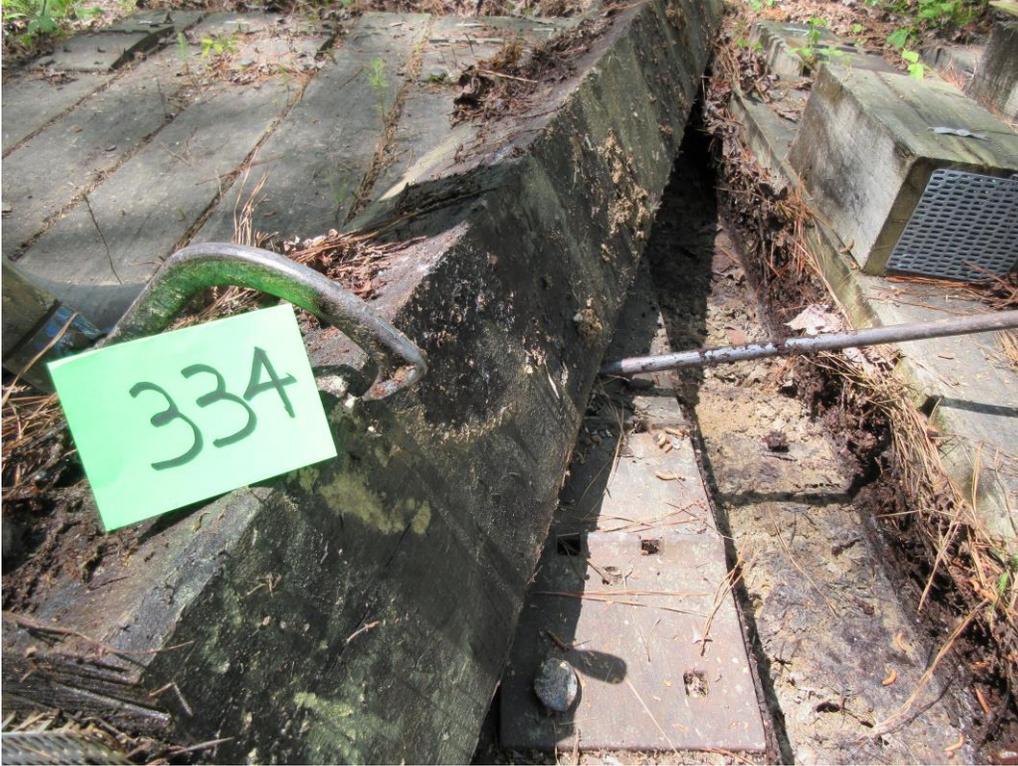
A59 Tie #334 (Merichem/white oak/CuNap).

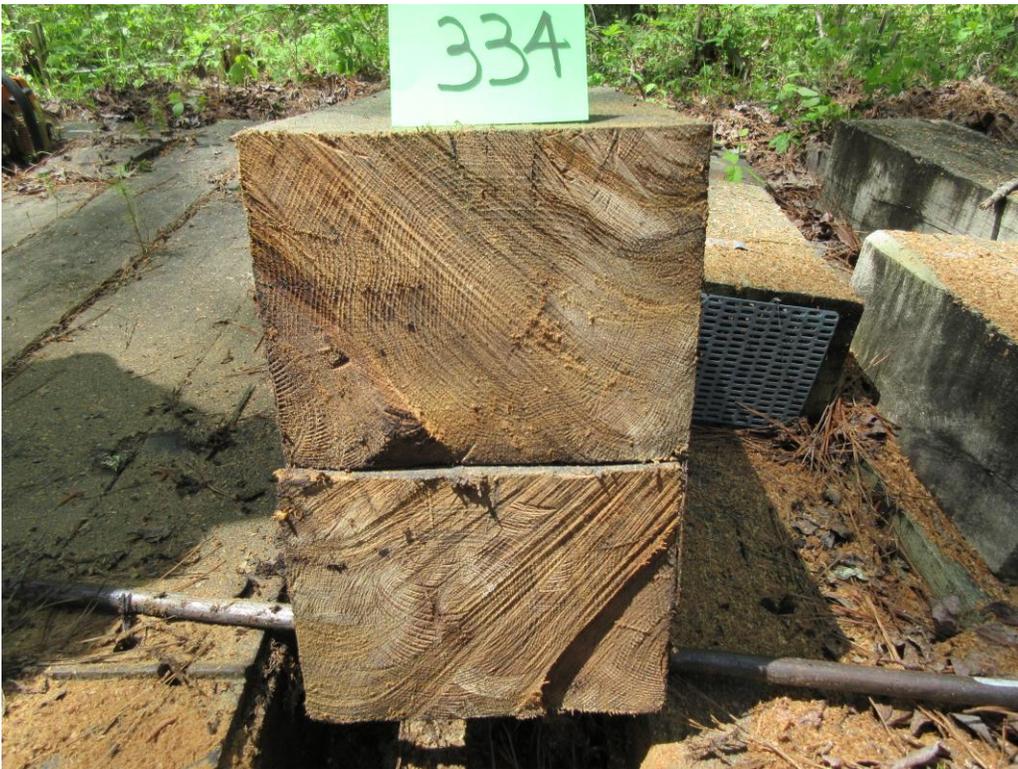
A60. Tie #334 (Merichem/white oak/CuNap).

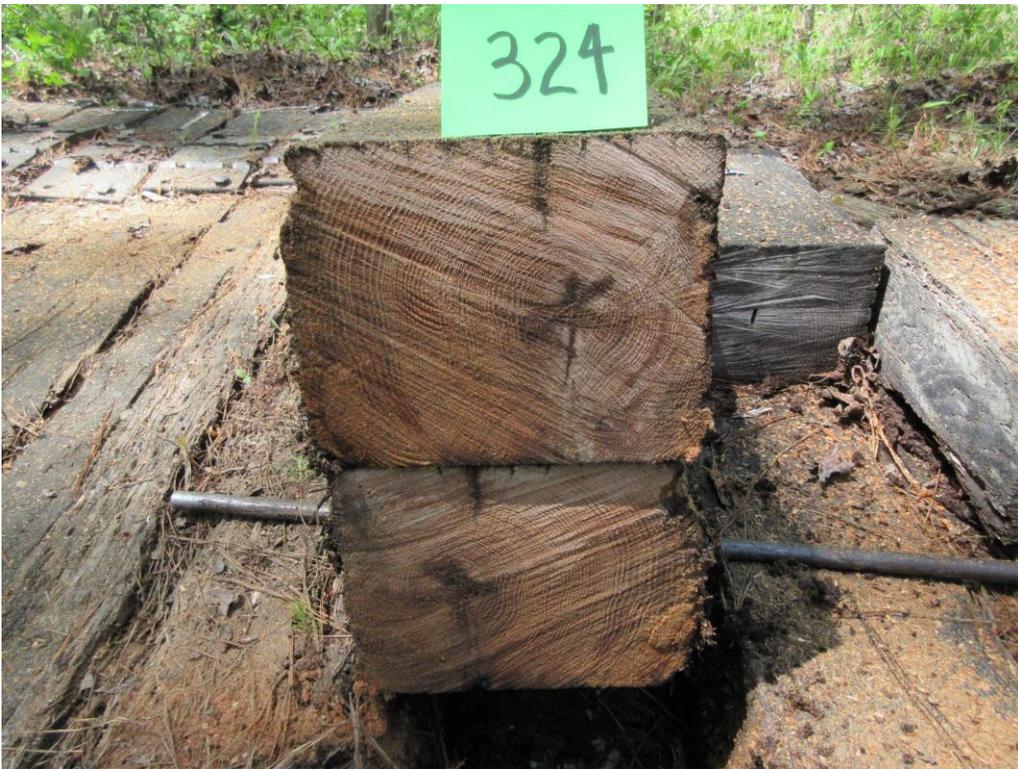
A64 - Tie #324 (Envirosafe/white oak).

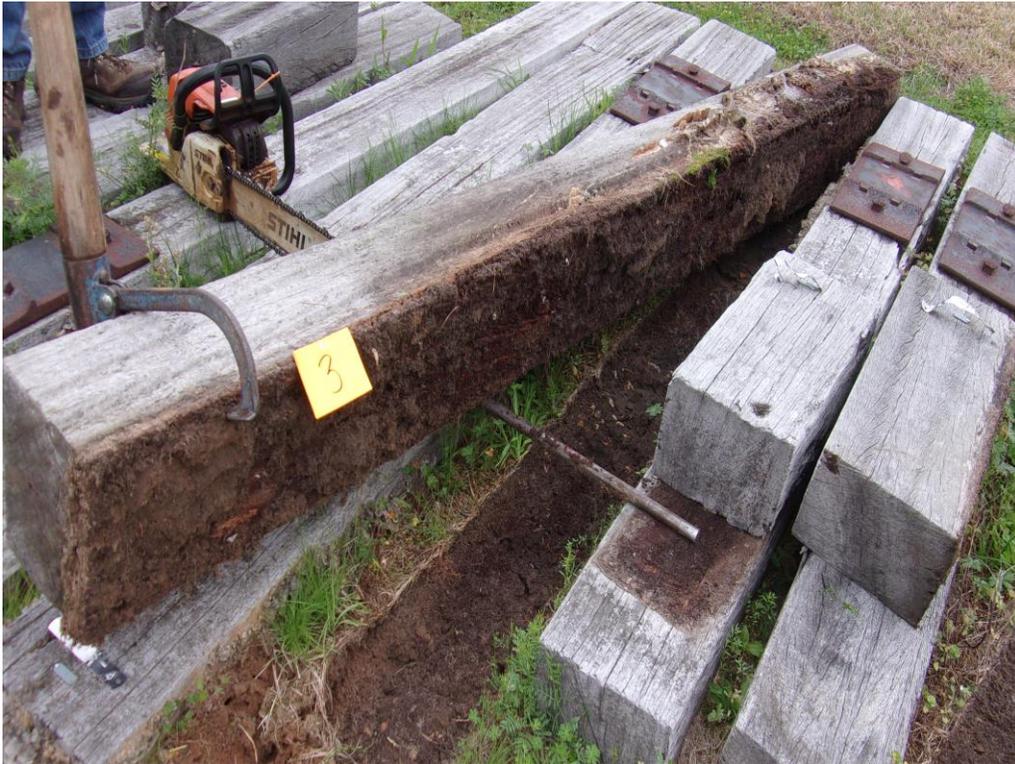
A65 - Tie #3 (Turada) with decay.

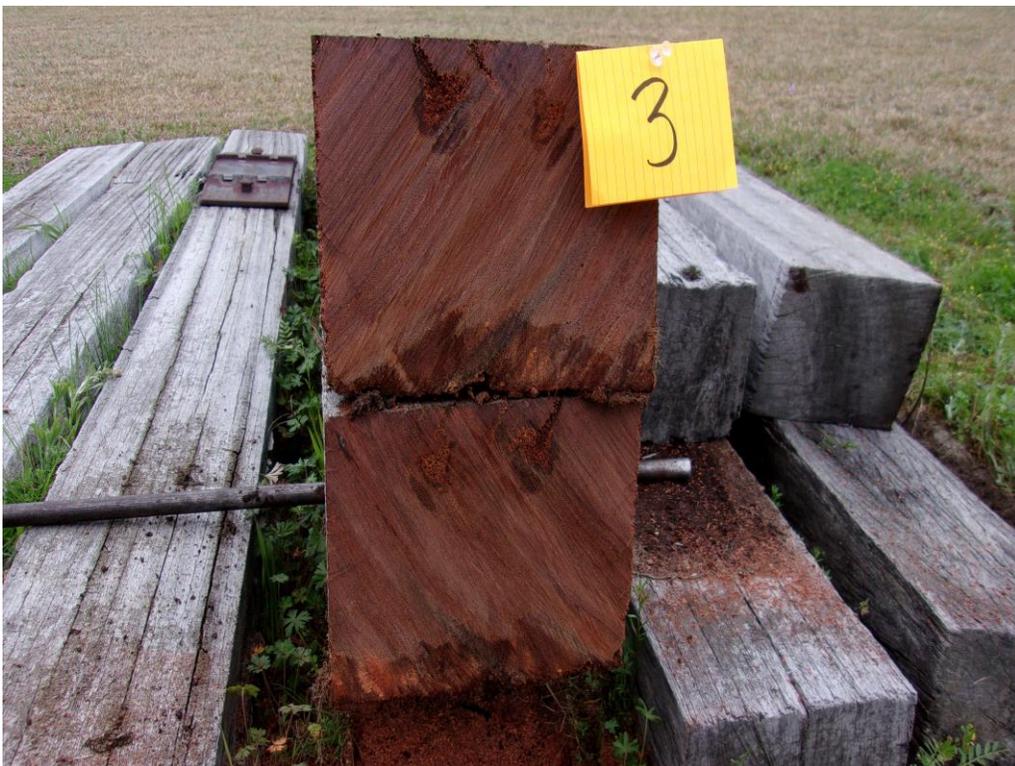
A66 - Tie #3 (Turada).

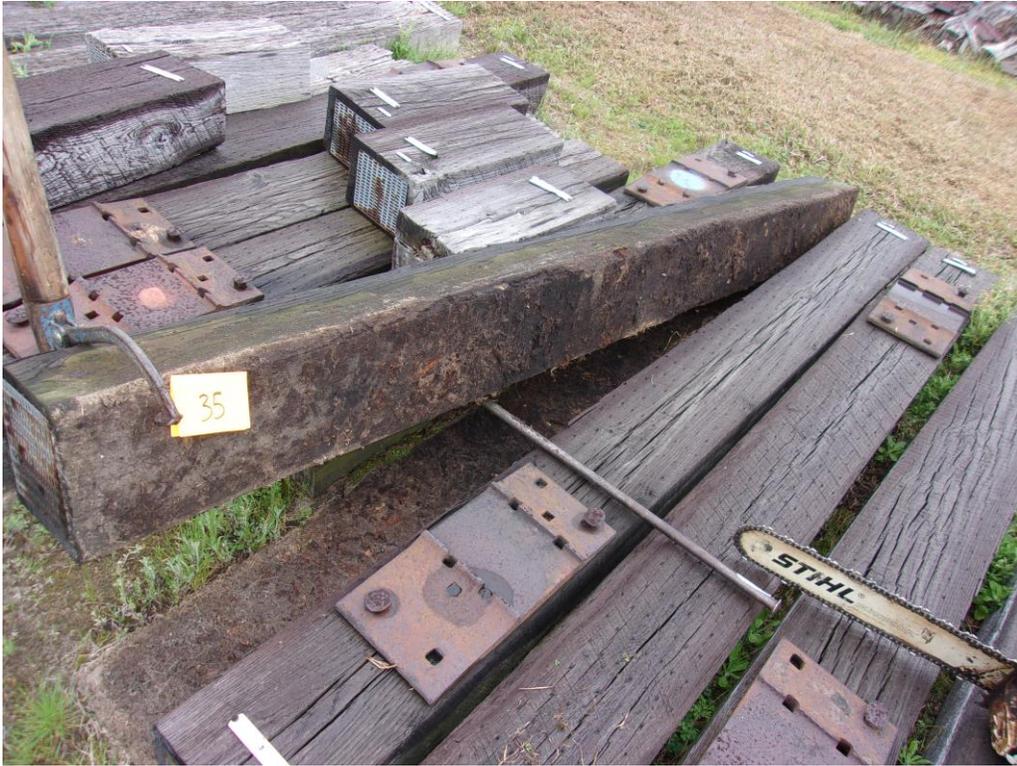
A71 – Tie #35 (Boatright/red oak/creosote 5pcf).

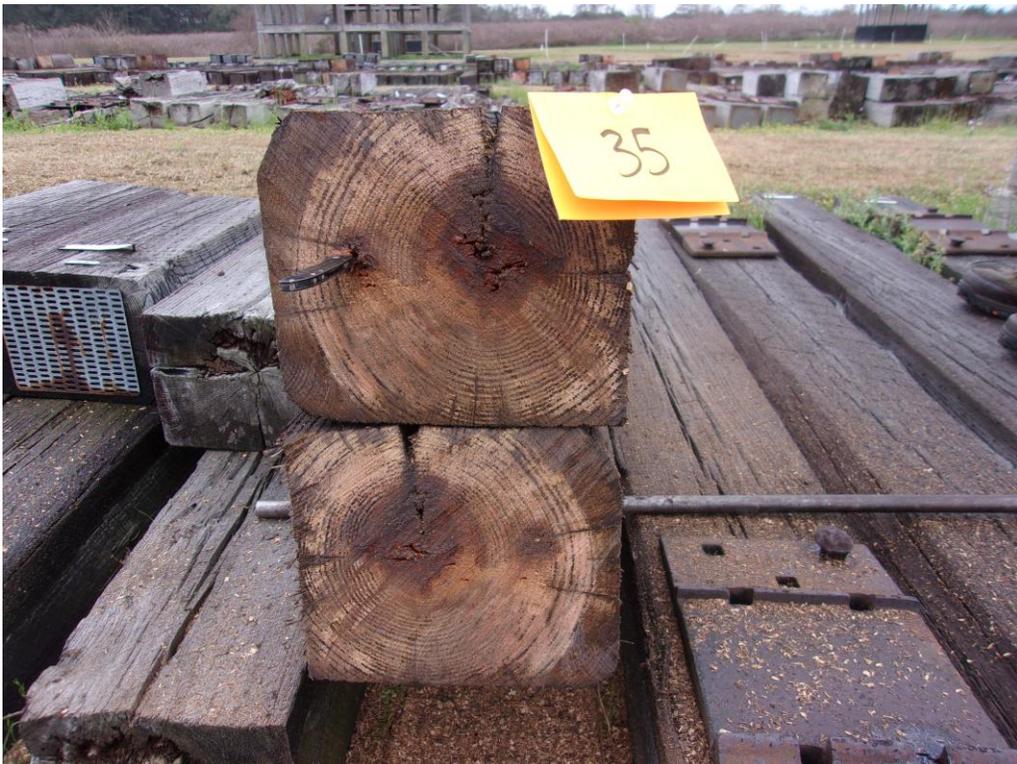
A72 – Tie #35 (Boatright/red oak/creosote 5pcf) internal decay.

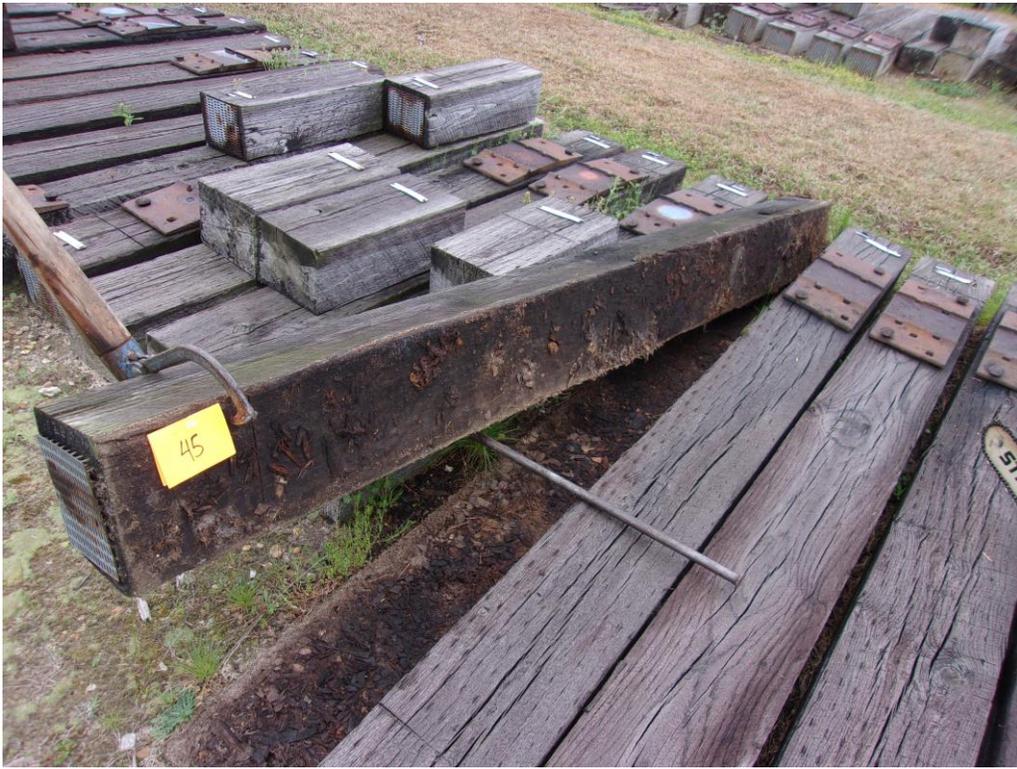
A73 - Tie #45 (Boatright/red oak/borate-creosote 5pcf).

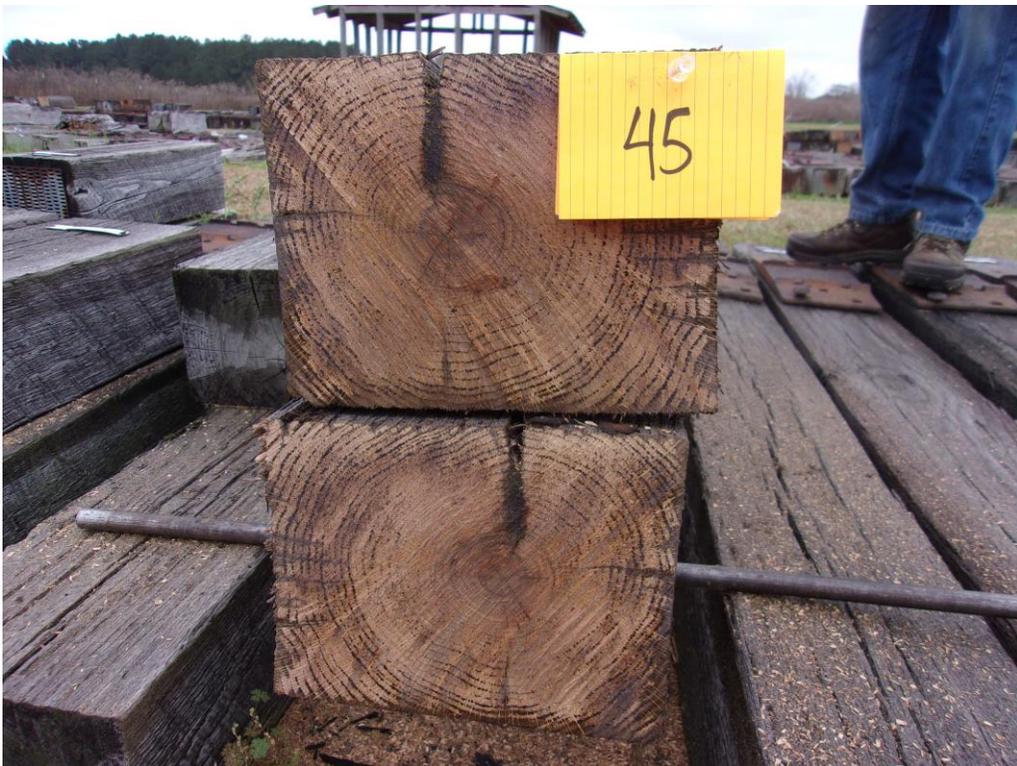
A74 - Tie #45 (Boatright/red oak/borate-creosote 5pcf).

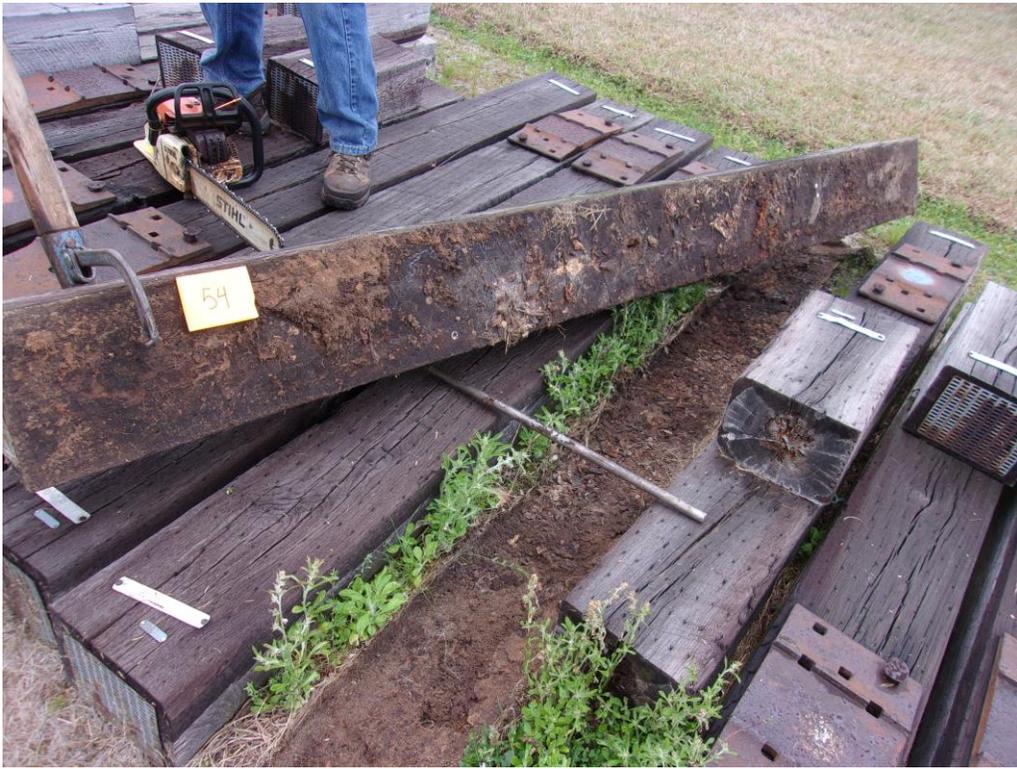
A75 - Tie #54 (Boatright/white oak//creosote to refusal).

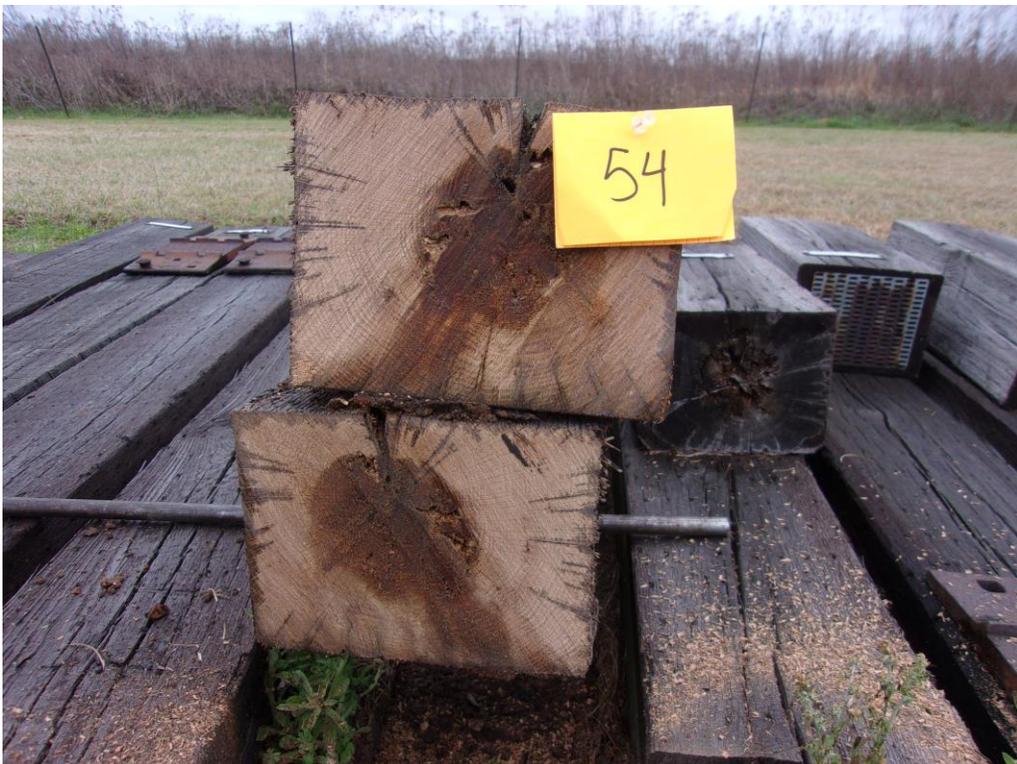
A76 - Tie #54 (Boatright/white oak//creosote to refusal) with internal decay.

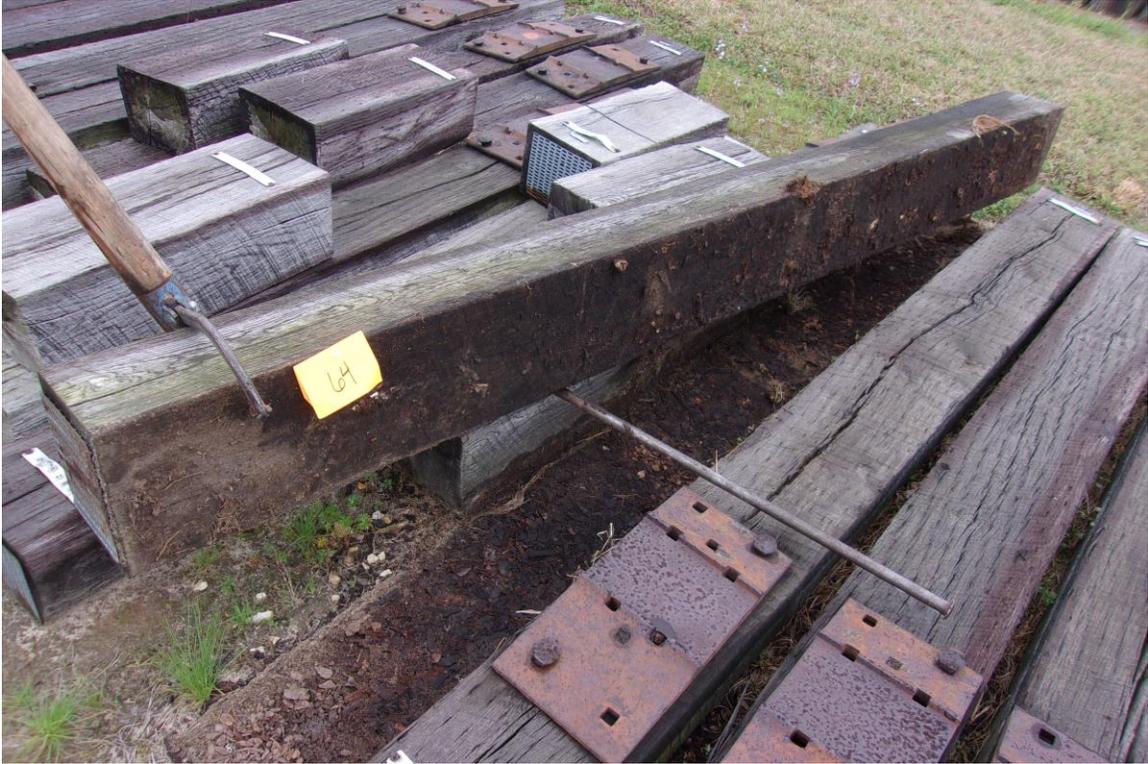
A77 - Tie #64 (Boatright/white oak/borate-creosote to refusal).

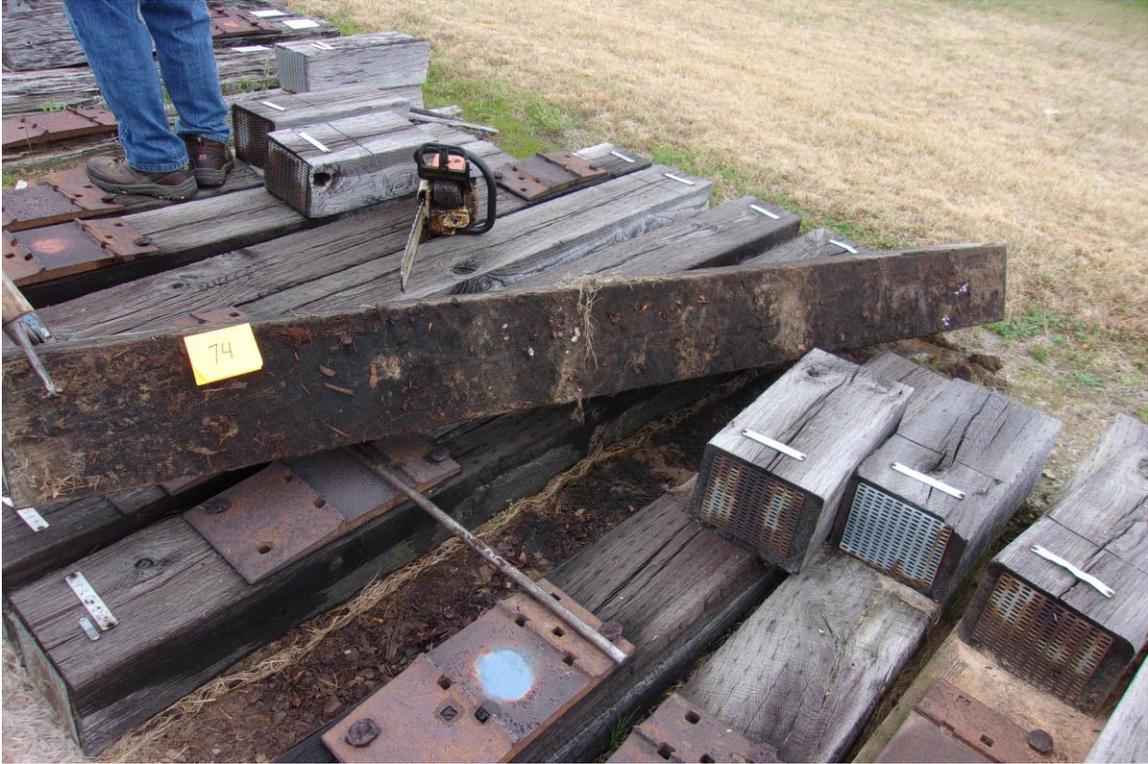
A79 - Tie #74 (Boatright/red oak/borate-creosote 7pcf).

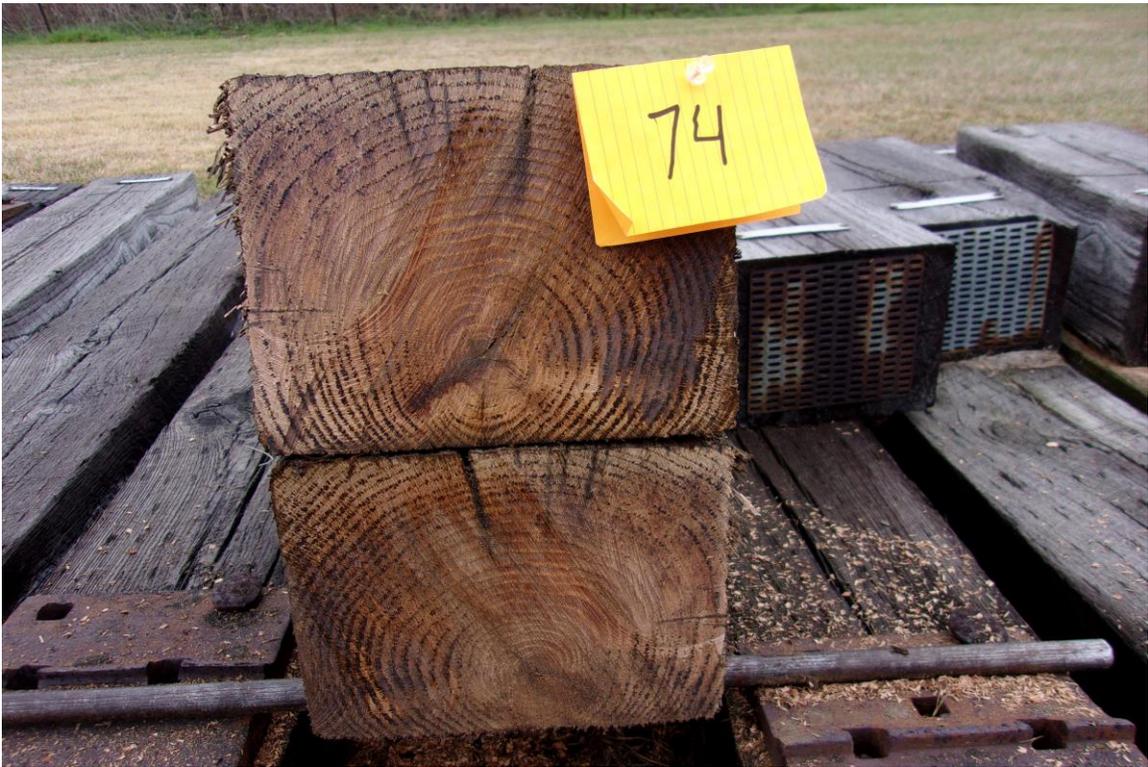
A80 - Tie #74 (Boatright/red oak/borate-creosote 7pcf).

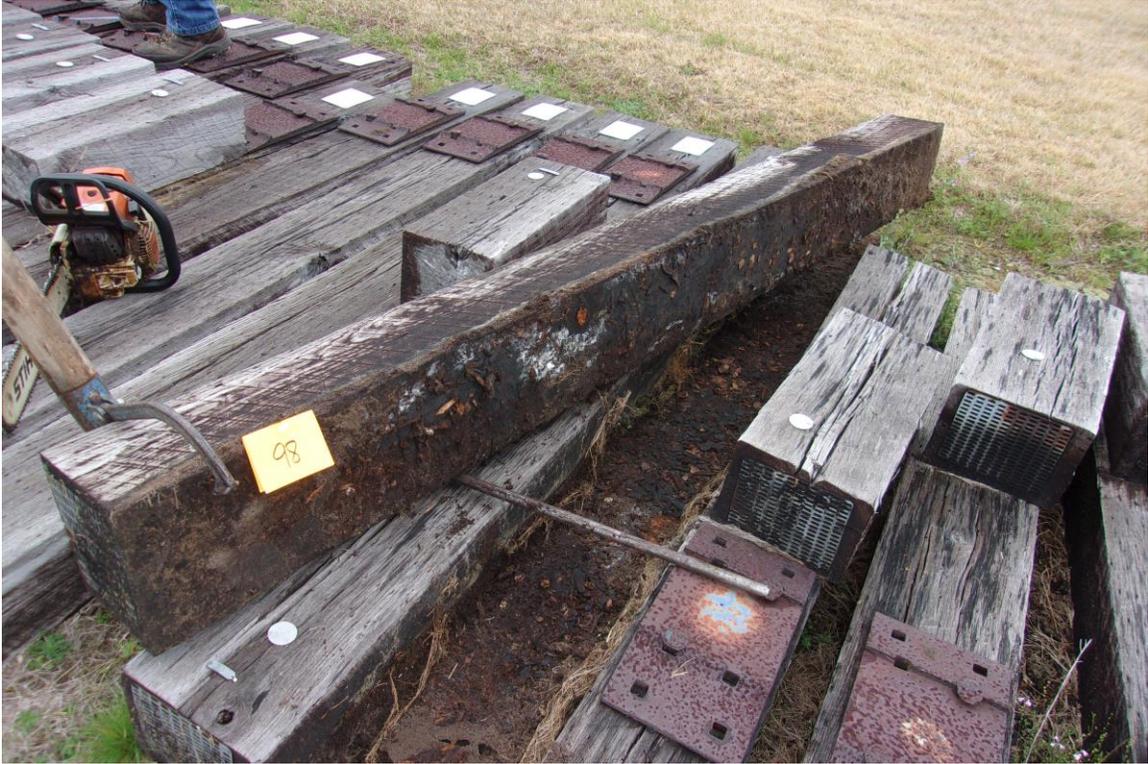
A83 - Tie #98 (Nisus/red oak/borate/oil A).

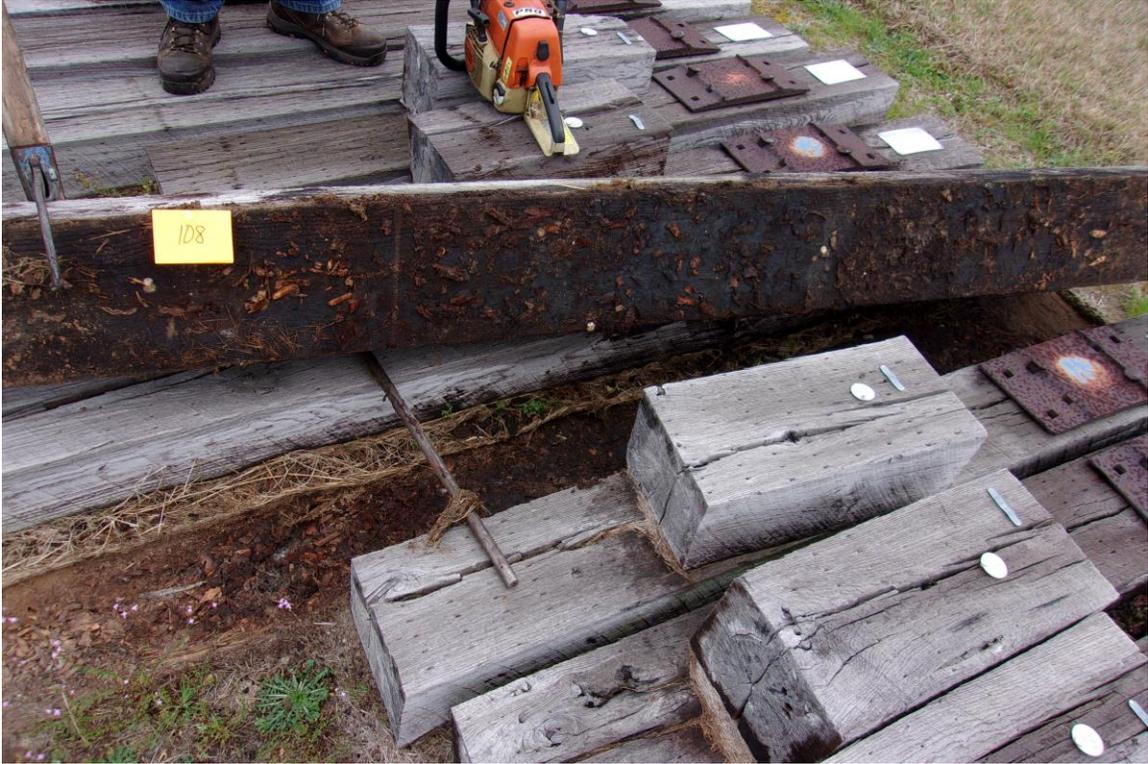
A85 – Tie #108 (Nisus/red oak/borate/oil B).

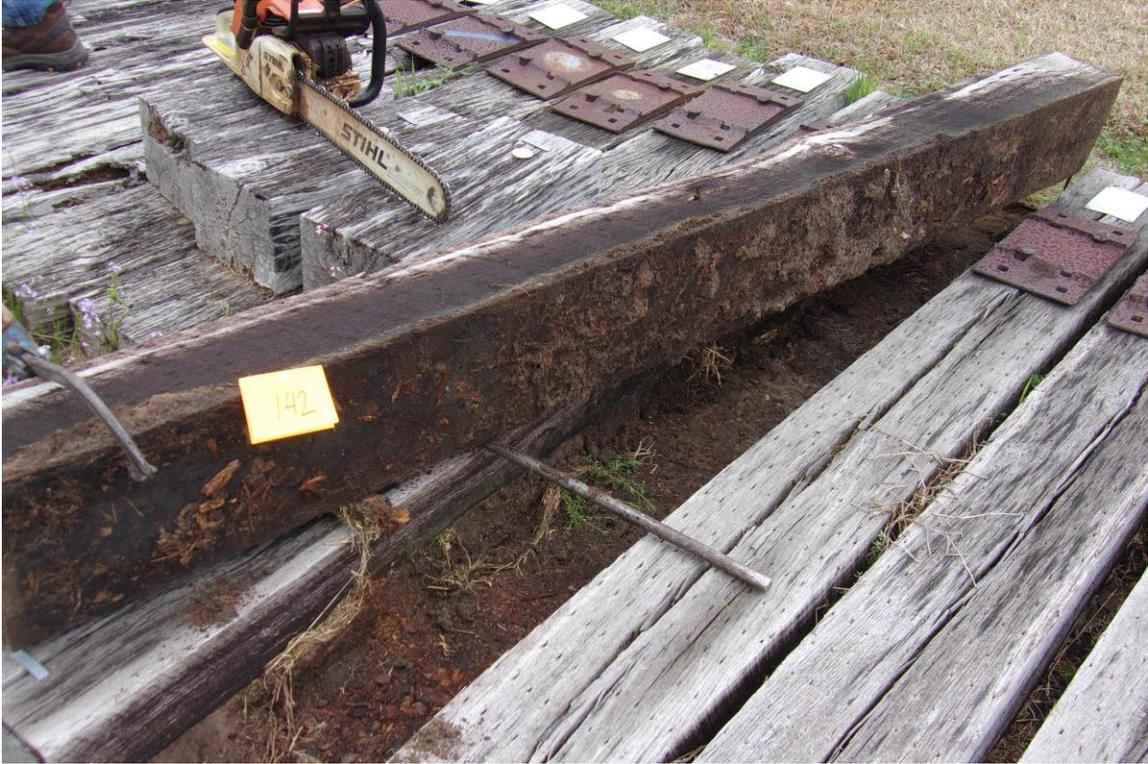
A91 - Tie #142 (Nisus/white oak/borate/oil A).

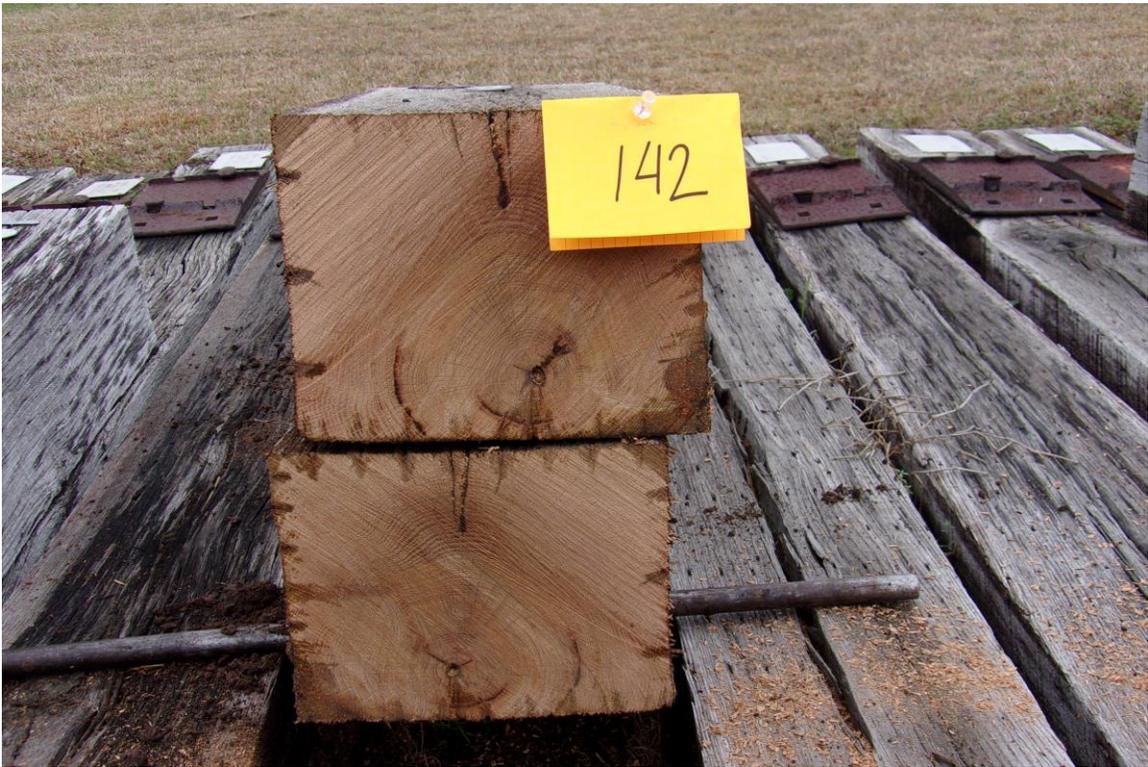
A92 - Tie #142 (Nisus/white oak/borate/oil A).

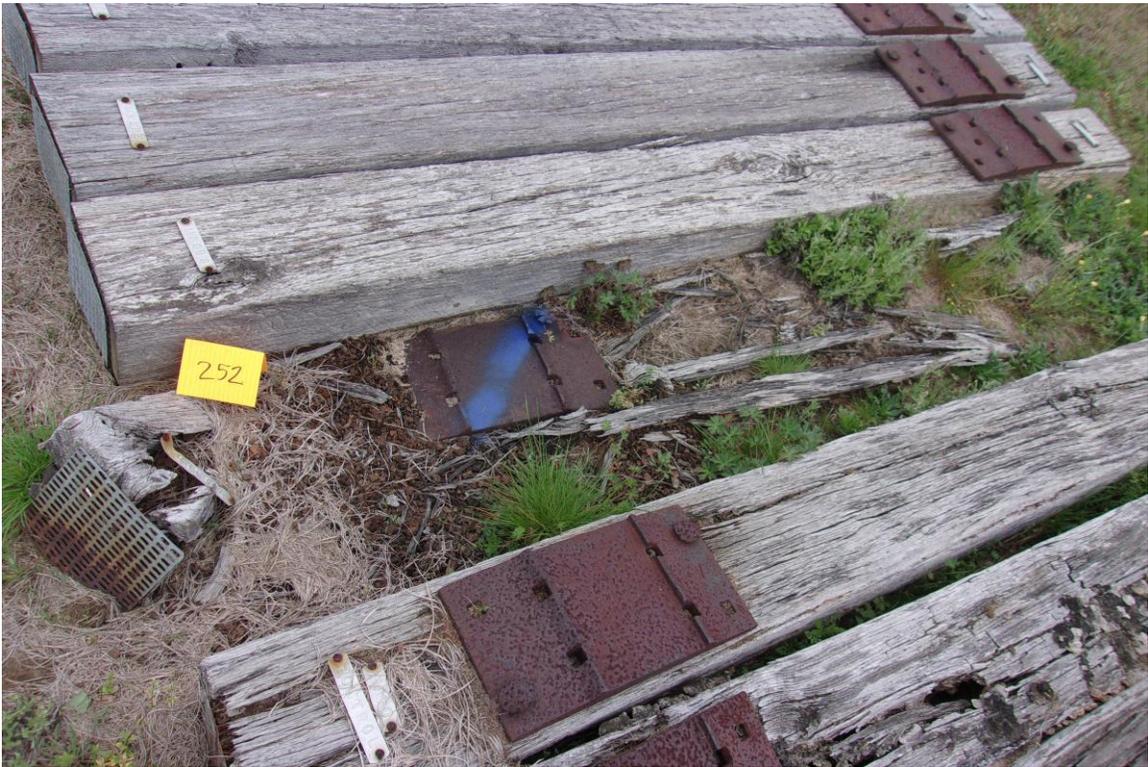
A98 - Tie #252 (untreated/red oak).

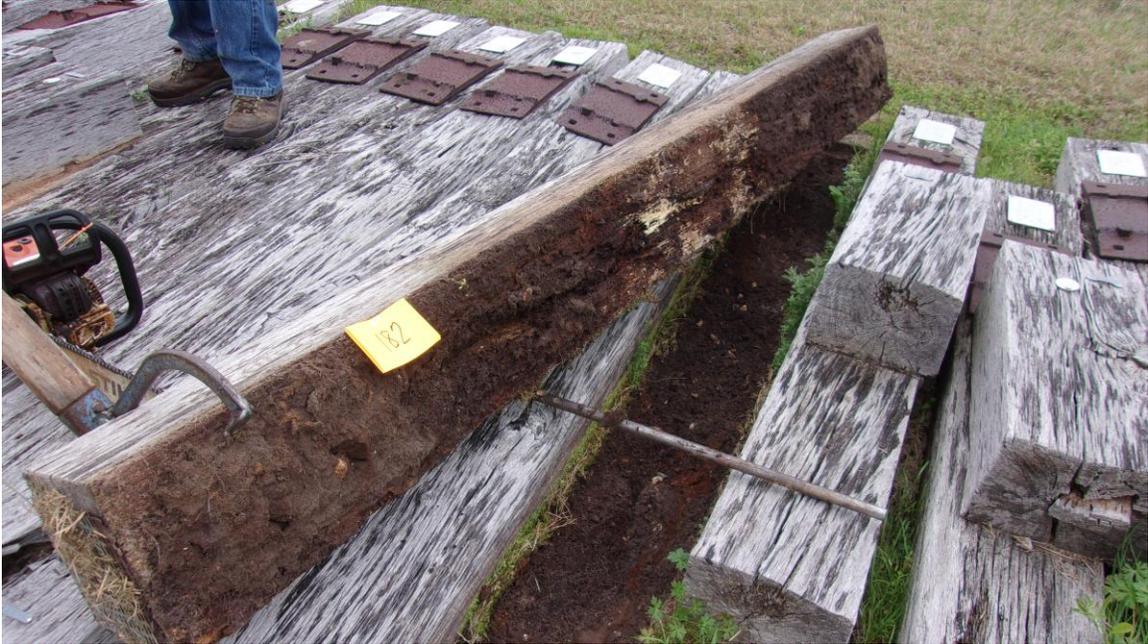
A99 - Tie #182 (Lonza/white oak) with decay evident.

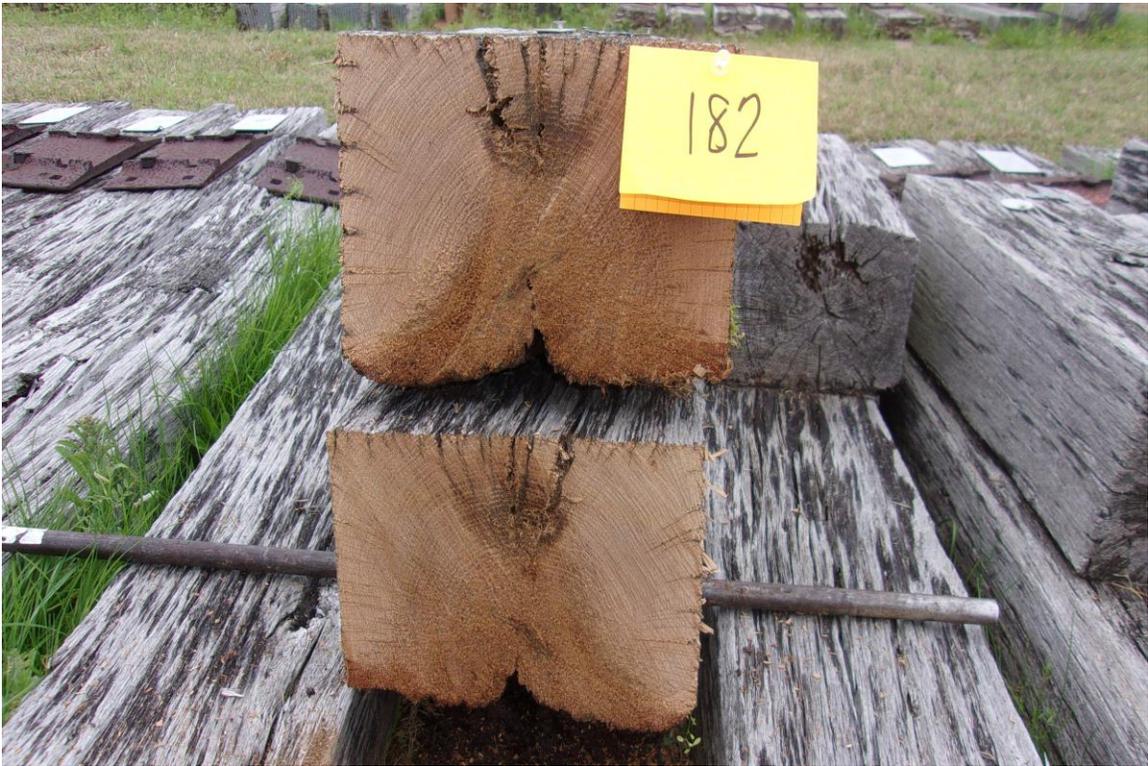
A100 - Tie #182 (Lonza/red oak).

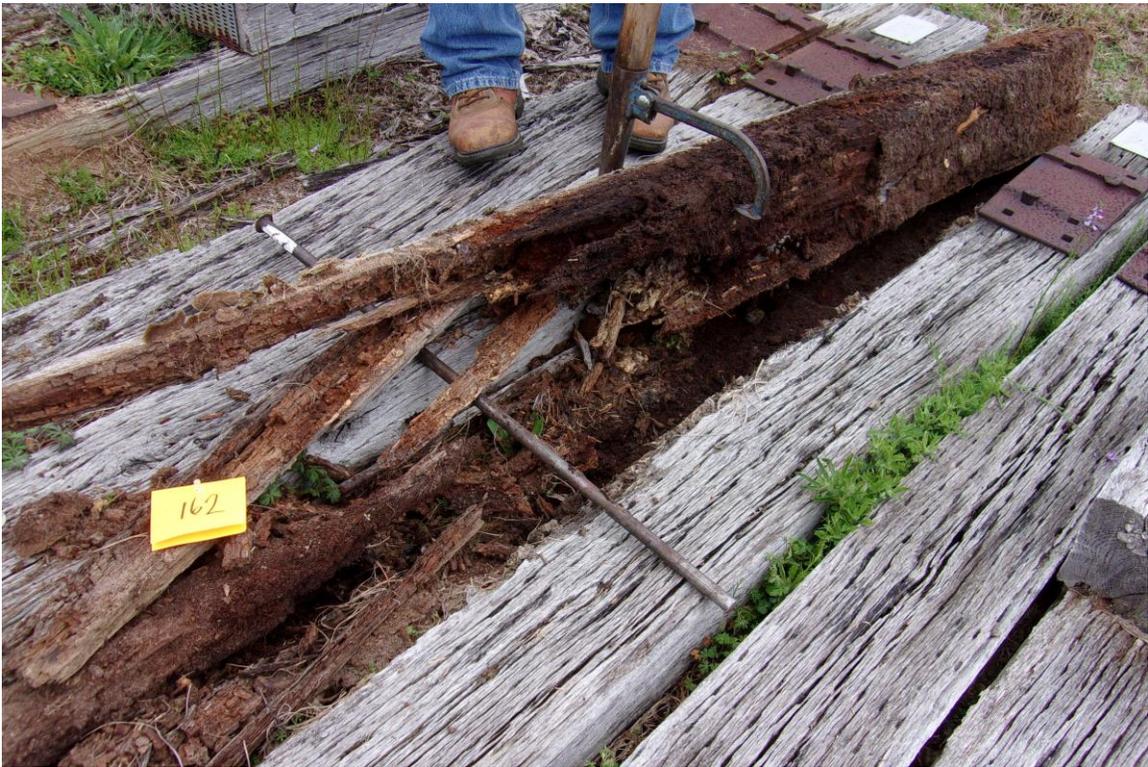
A102 - Tie #162 (Nisus/white oak/boron).
