**MISSISSIPPI STATE
UNIVERSITY™**

**FOREST AND WILDLIFE RESEARCH CENTER
DEPARTMENT of SUSTAINABLE BIOPRODUCTS**

Fourteenth Annual Evaluation of MSU/RTA Alternative Preservative Study

August 22, 2022

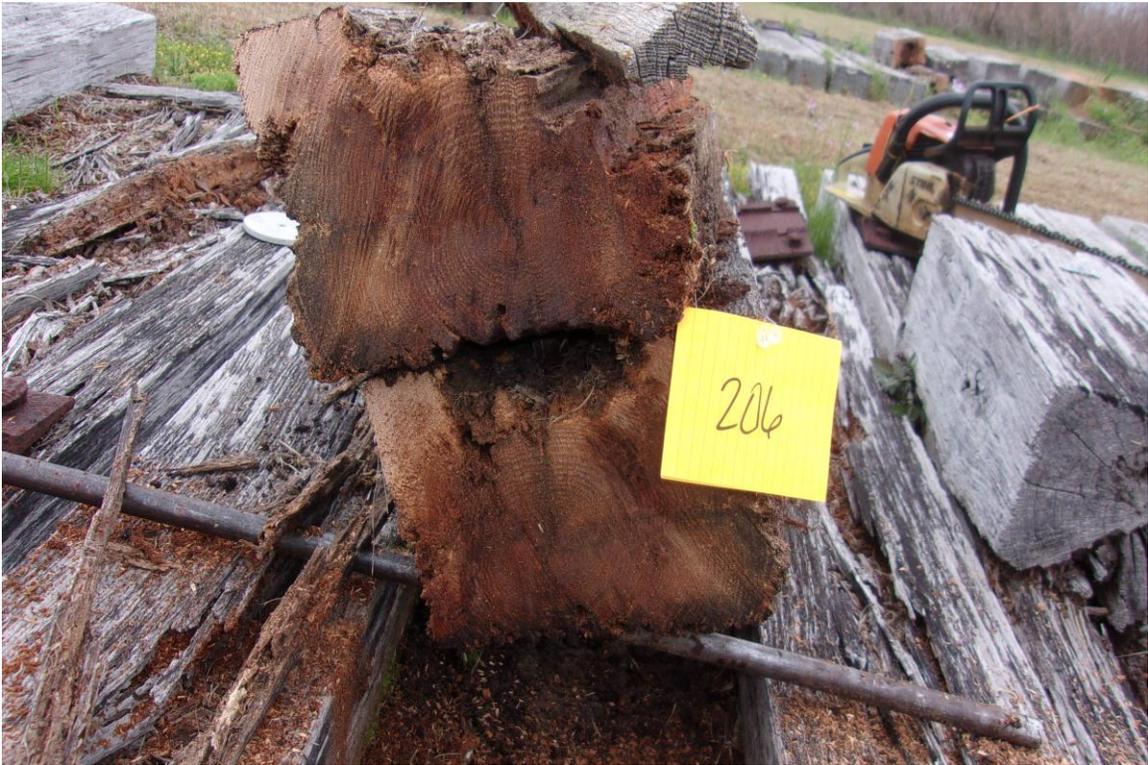
A108 - Tie #206 (Cedarcide/red oak).

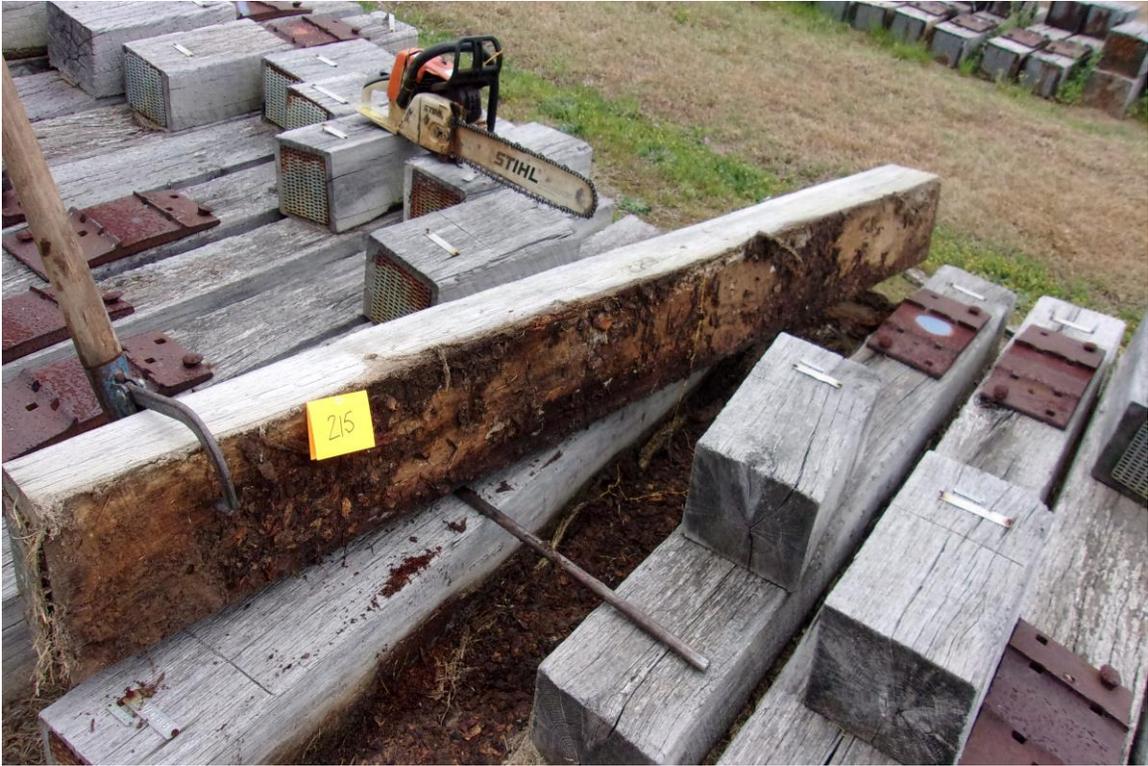
A109 - Tie #215 (Merichem/white oak/borate/CuNap).

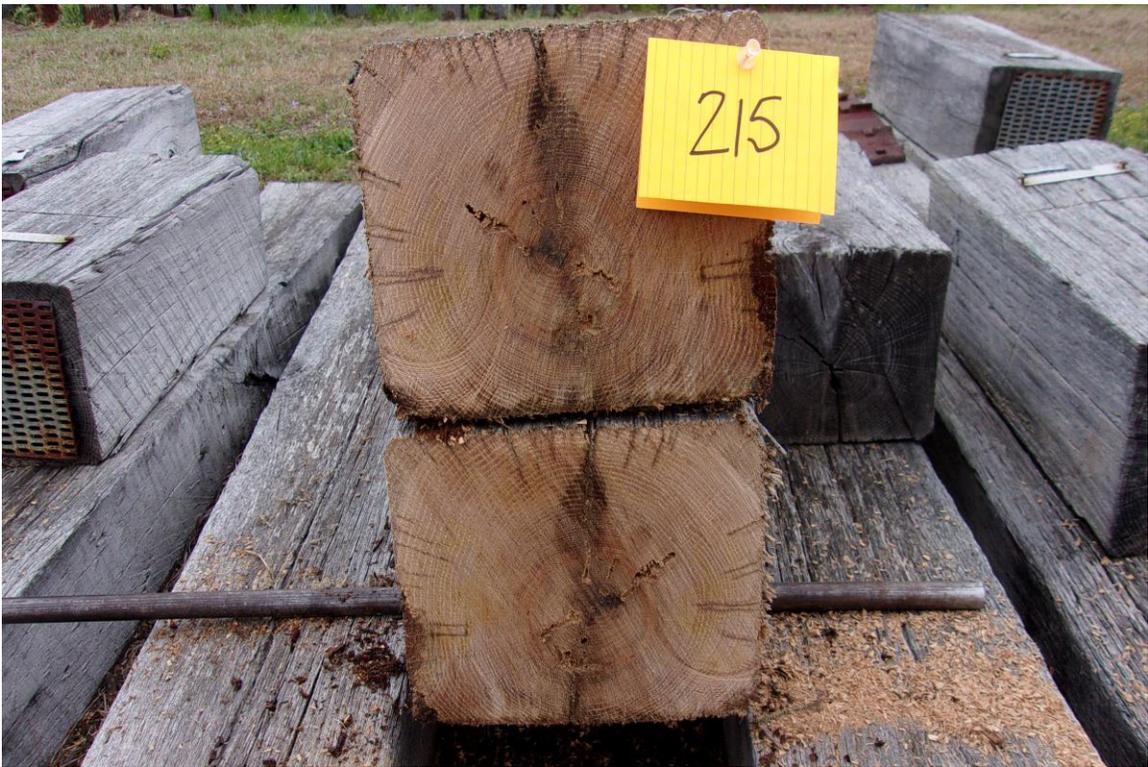
A110 - Tie #215 (Merichem/white oak/borate/CuNap).

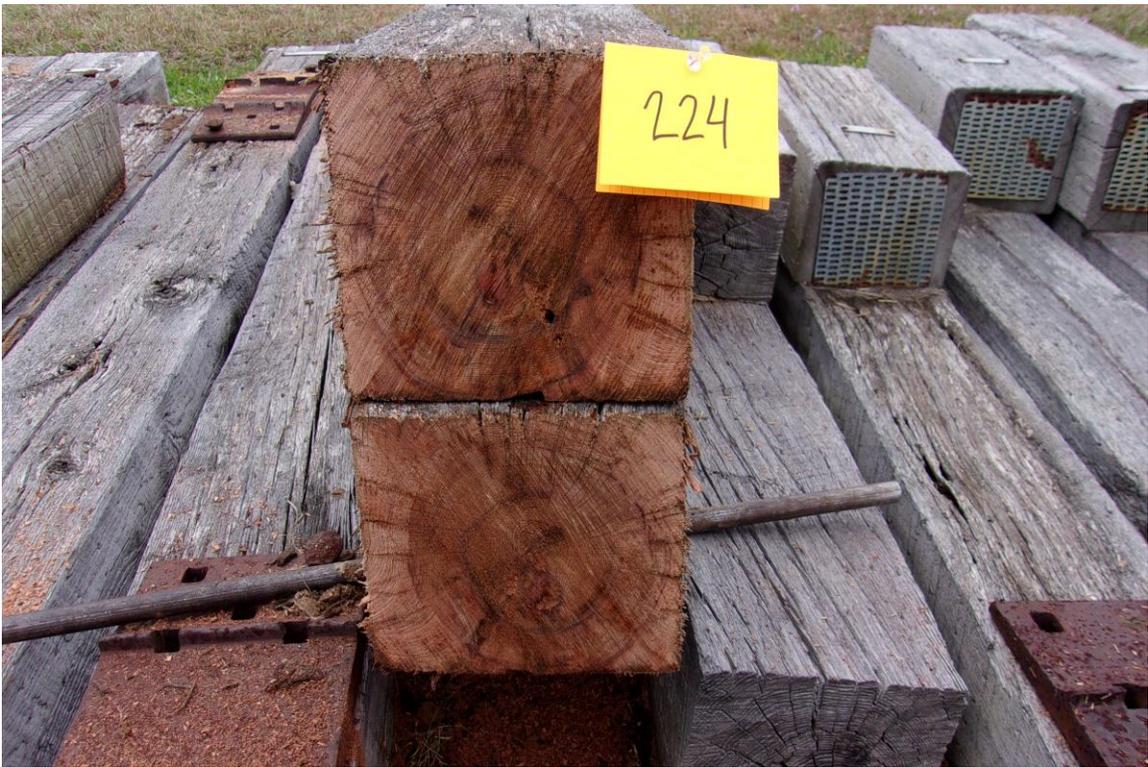
A112 - Tie #224 (Merichem/red oak/CuNap).

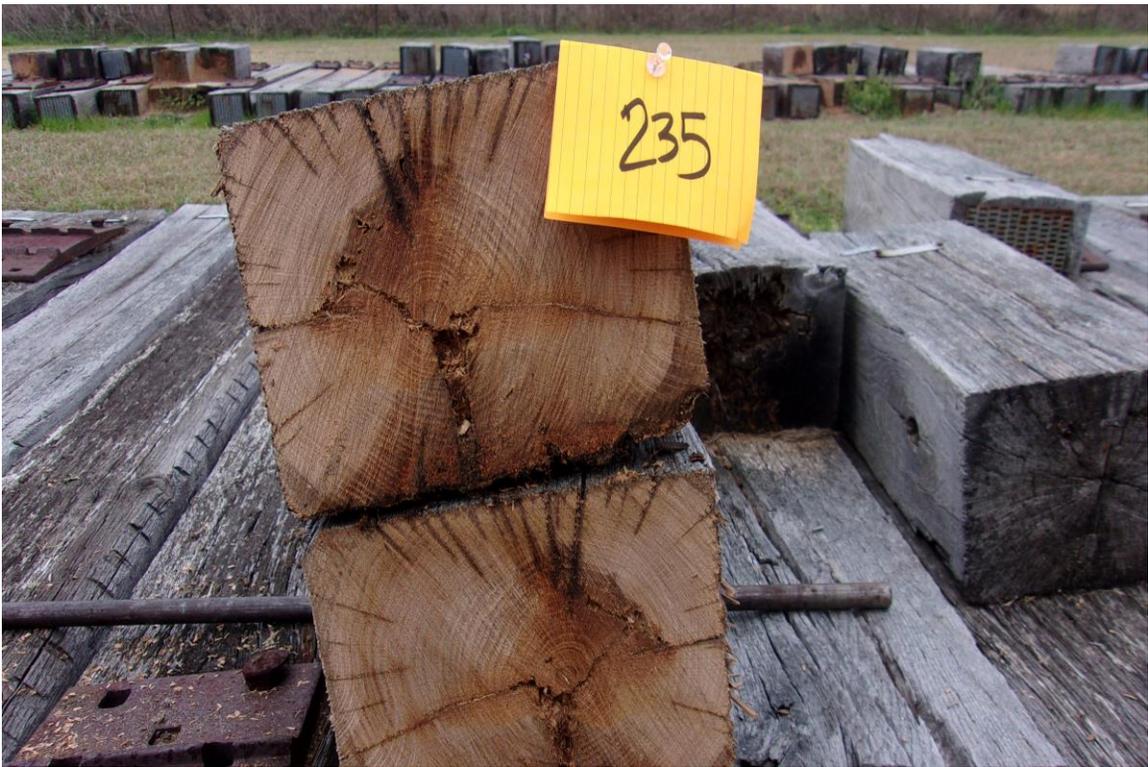
A114 - Tie #235 (Merichem/white oak/CuNap).

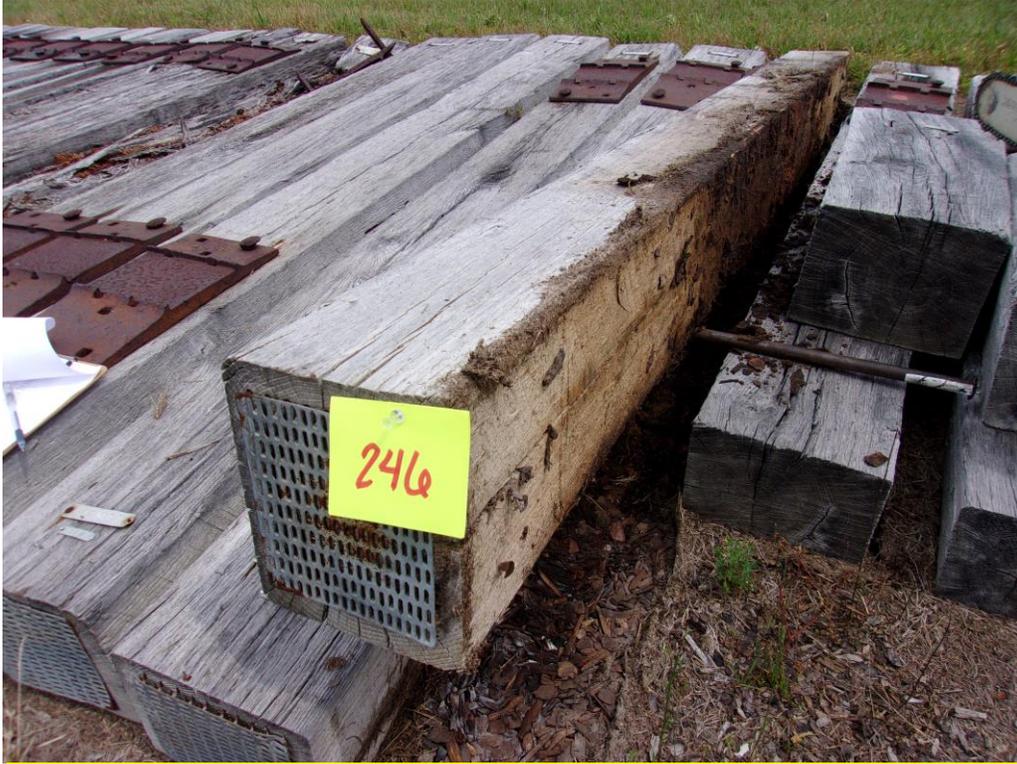
A115 - Tie #246 (Merichem/red oak/borate/CuNap) with trace termite damage.

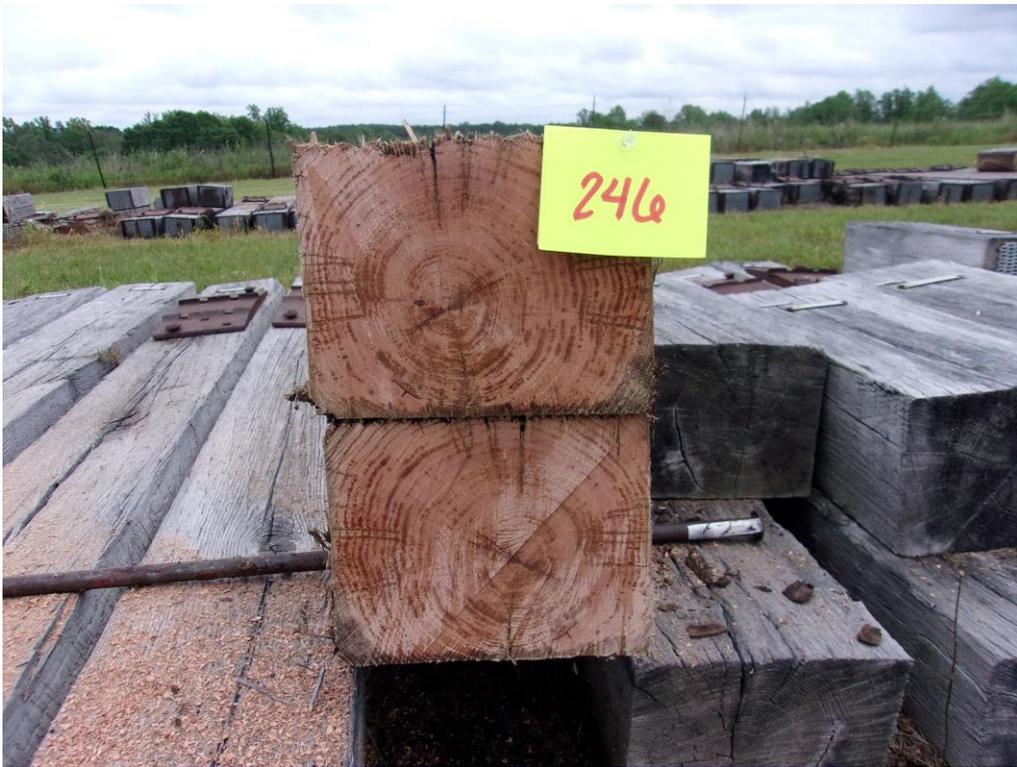
A116 - Tie #246 (Merichem/red oak/borate/CuNap).

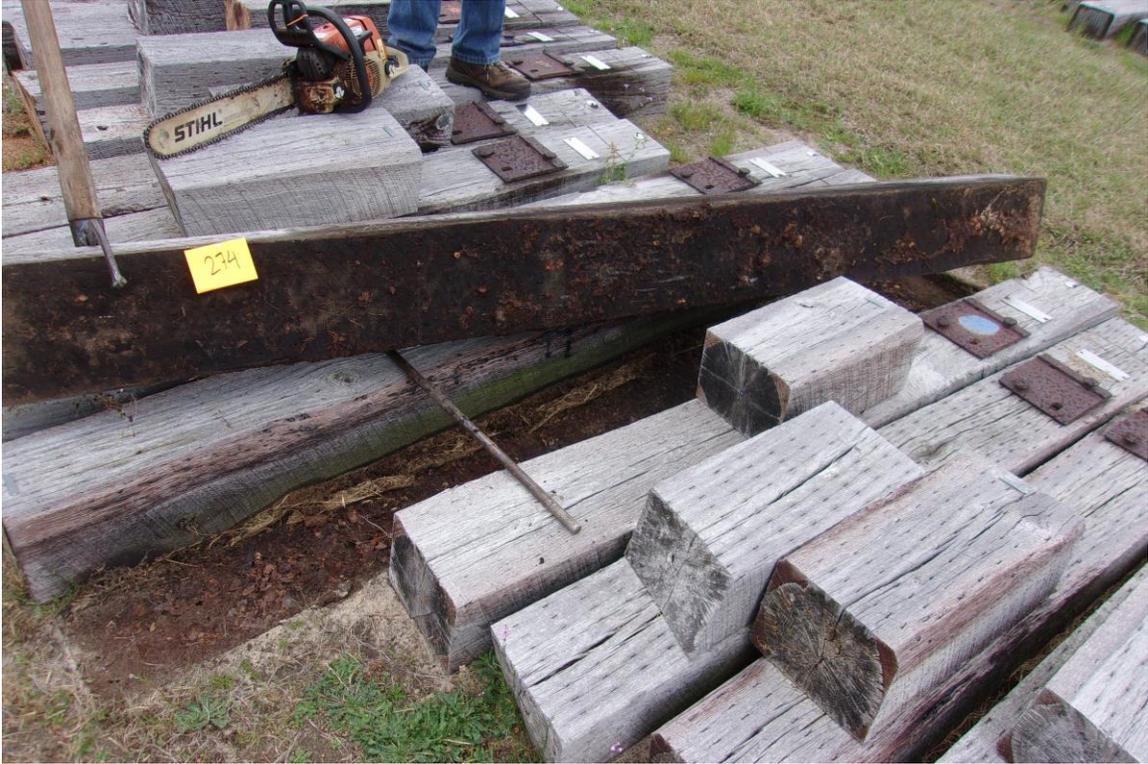
A117 - Tie #274 (KMG/white oak).

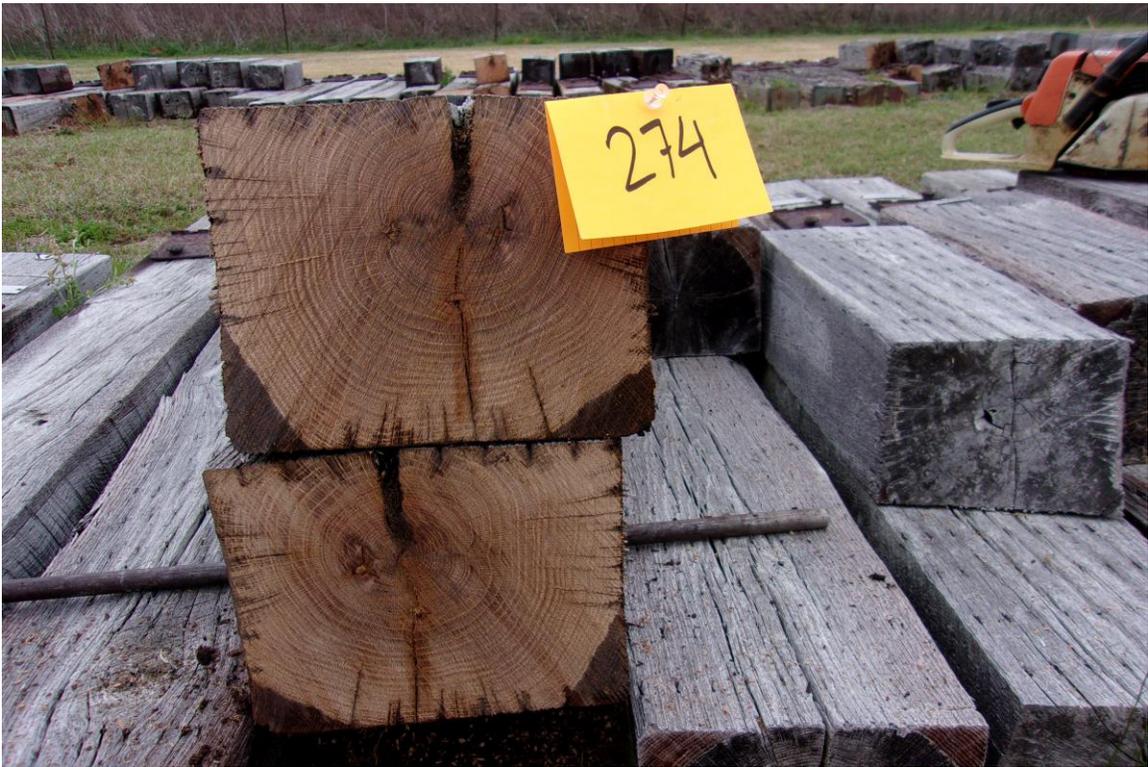
A118 - Tie #274 (KMG/white oak).

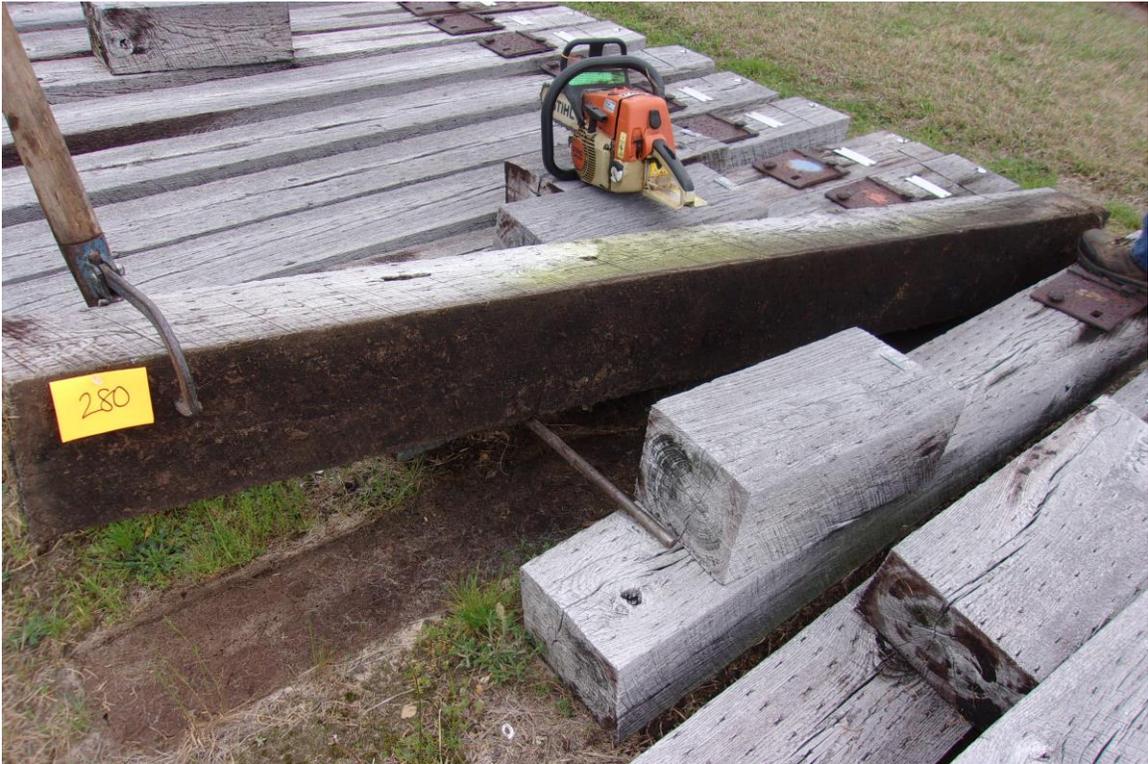
A119 - Tie #280 (KMG/red oak).

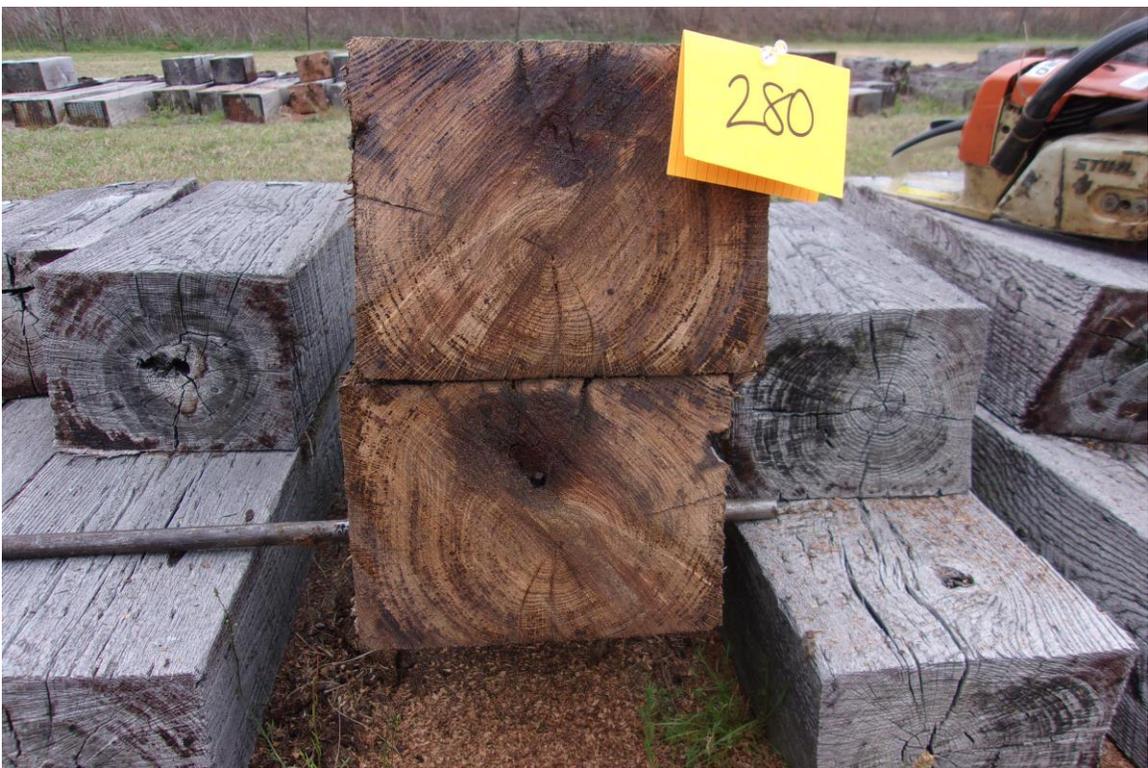
A120 - Tie #280 (KMG/red oak).

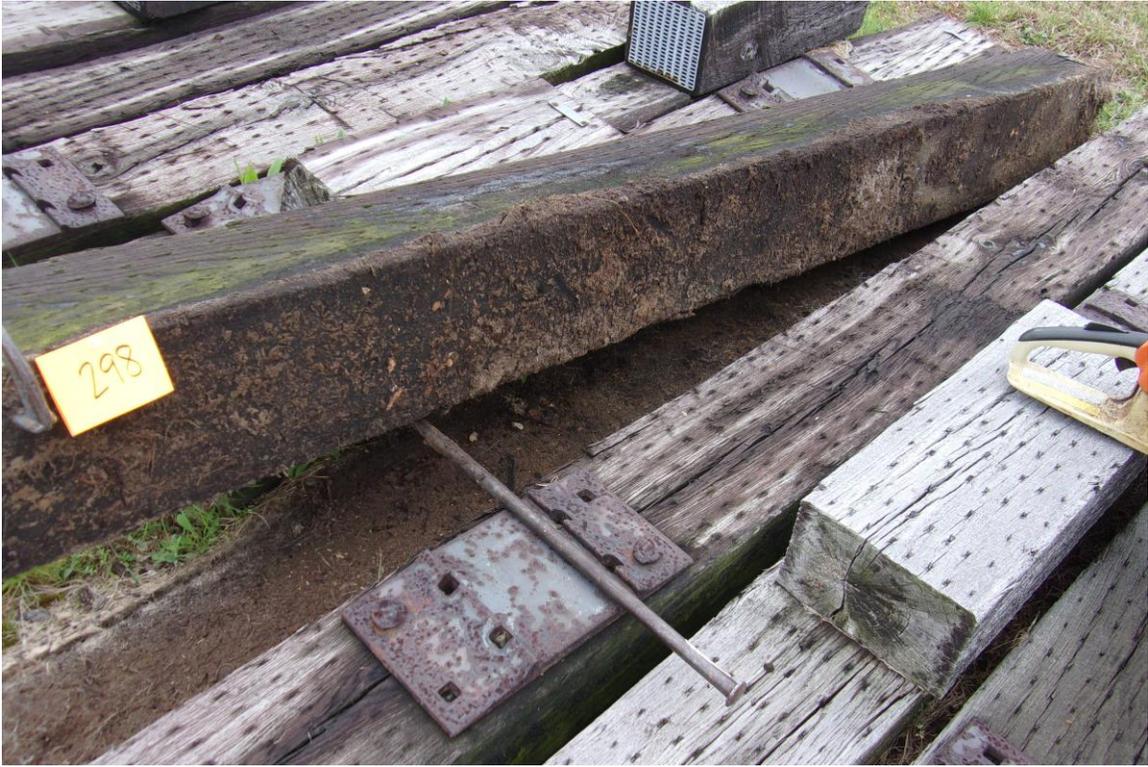
A121 - Tie #298 (Koppers/white oak/P2).

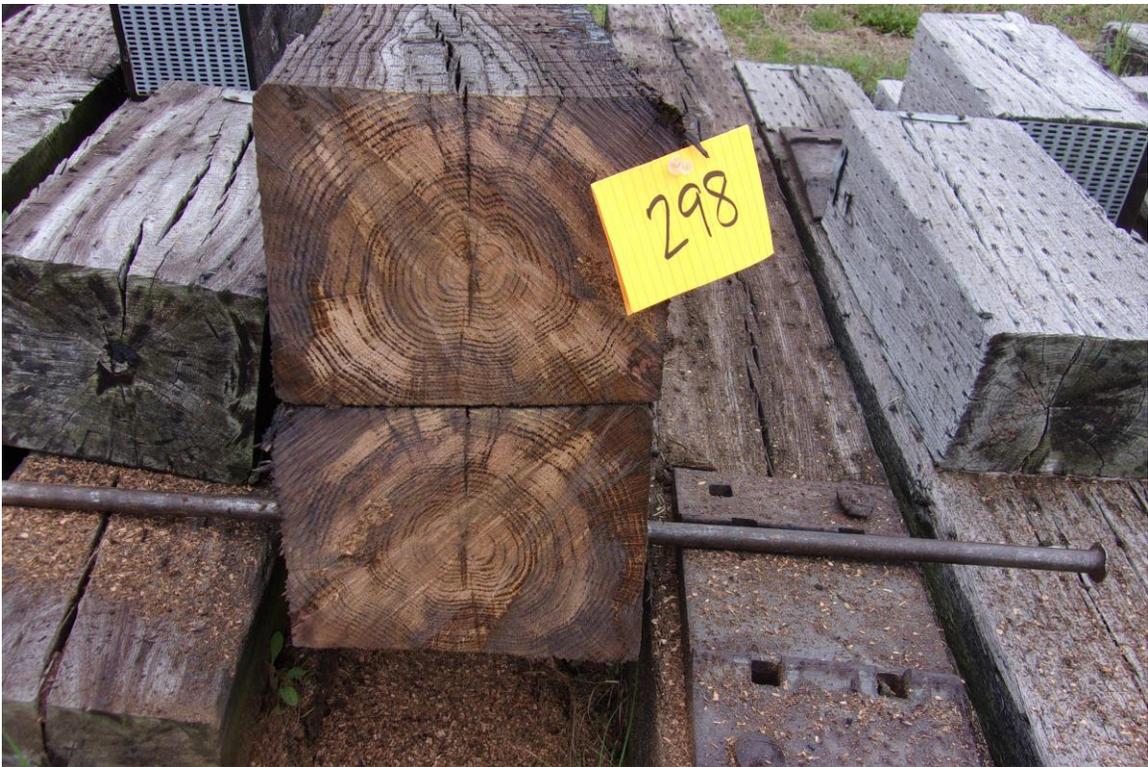
A122 - Tie #298 (Koppers/white oak/P2).
